Morro Bay Volunteer Monitoring Program

Stream Profiling Update

Winter 2004

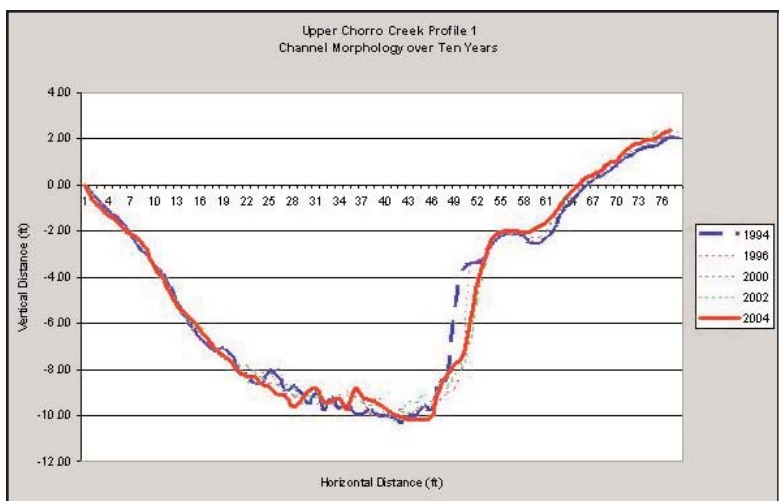
The following plot of Upper Chorro Creek shows that from 1994 through 2004, there has been relatively little change in the creek bed and banks. This stability was also apparent for

most of the sites on lower Chorro, Pennington and Dairy Creeks.

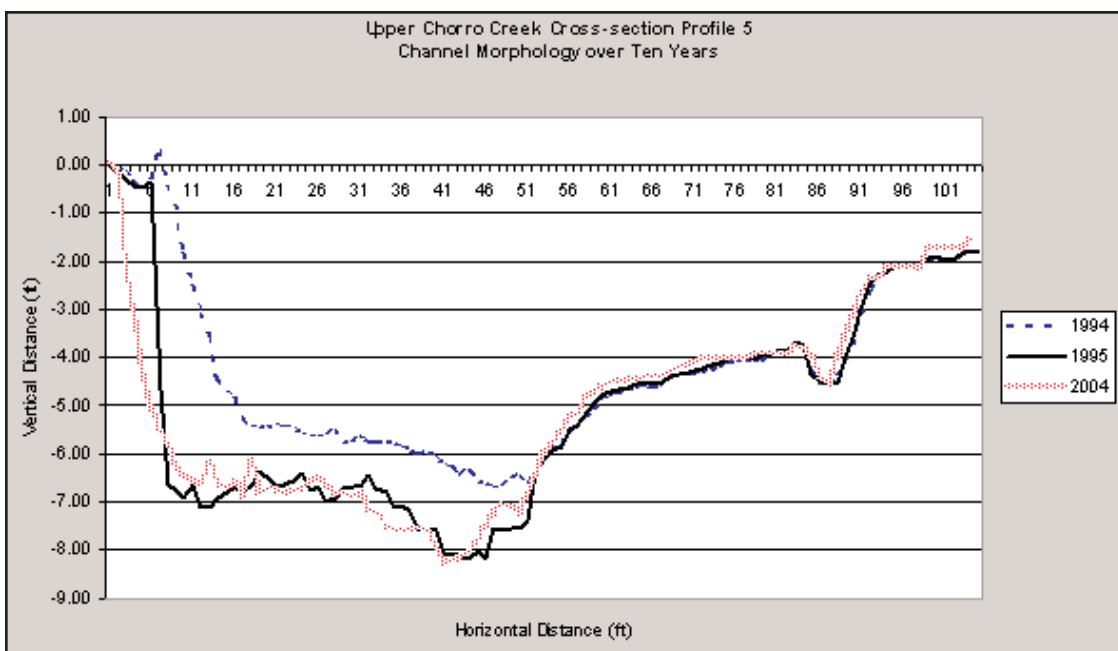
above the California Men's Colony on Camp SLO property. Profile #5 is the lowest profile in the watershed on that branch of the creek. During the intervening ten years, the left bank was cut back approximately four feet, while the bed degraded by approximately one foot. Annual surveys show that the majority of this erosion occurred between the 1994 and 1995 surveys, and that there has been relatively little change in the bank since 1995. The major changes in the 1994-5 season are likely due to

the Highway 41 fire in the upper watershed followed by heavy winter rains. There has been little change since. This is likely due to the fact that the flow is not directly concentrated against the toe of the bank, and an increasing amount of vegetation at the toe of this bank (specifically an incredible number of sycamore saplings) continues to add protection. It appears that only flows exceeding bankfull are likely to cause further erosion on this bank.

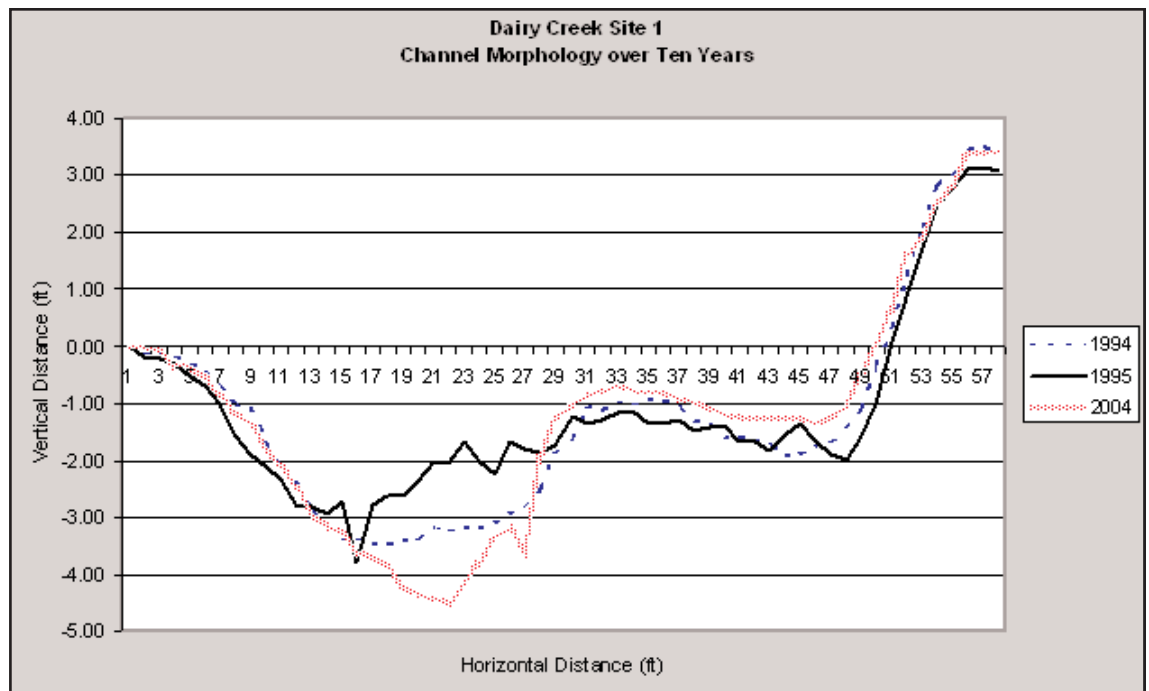
While the Chorro site exhibited signs of degradation subsequent to the Highway 41 fire, Dairy Creek shows just the opposite. In 1995, we see aggradation or deposition of sediment leading to a raising of the creek bed elevation at the cross-section.

Over time, the deposited material is moved further downstream and a return to the pre-1994 elevation is reached.

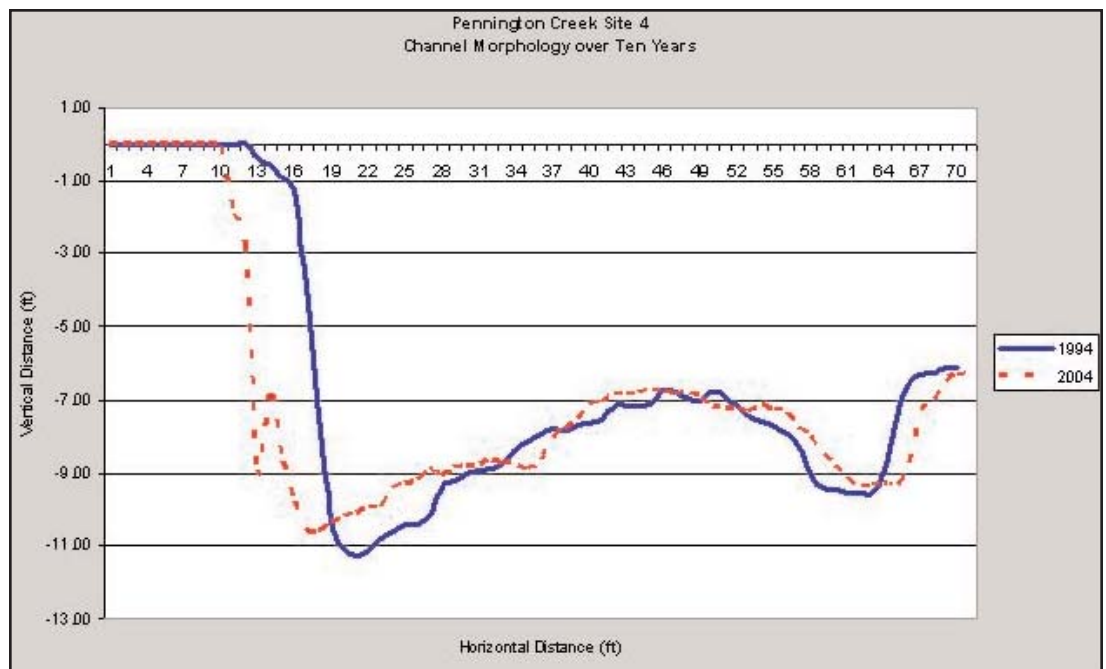
This last plot is from Pennington Creek, profile #4 which is the next to lowest transect along Pennington Creek. This site has a huge cut-bank on the left side of the channel that is approximately 10 feet high. Over the past ten years it has cut back about six feet at the top and two feet at the bottom. With a transition from a nearly vertical bank in 1993 to one with a 2:1 slope in 2004, it appears to be evolving toward a bank with some increased stability. However, unlike the cut-bank in the profile on Chorro Creek, flow is concentrated on the left side of the channel at the toe of this bank, and there is little to no protective vegetation. Annual surveys show that some portion of the bank has

eroded every year between 1993 and 2004 so it is very likely that it will continue to be destabilized and cut back by even moderate storm flows. Since 1993 there has also been an obvious degradation of what is essentially a midchannel bar between the main channel on the left and an alternate channel on the right, as well as erosion of the far right bank.
