Morro Bay Volunteer Monitoring Program

Algae Documenting Update

Winter 2004

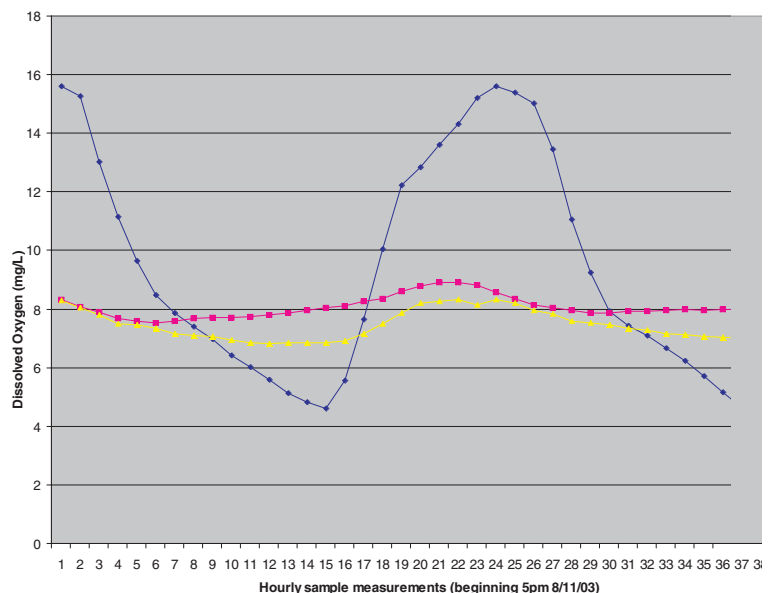
Diurnal Dissolved Oxygen Levels on Chorro Creek

The graph depicts the dissolved oxygen levels at three sites on Chorro Creek over a 35 hour period: at Camp SLO (blue), at Canet Rd. (pink) and at Twin Bridges (yellow). The wide swings in DO levels at Twin Bridges is stressful for aquatic life. Regulations set 7 mg/L as the level to protect aquatic life.

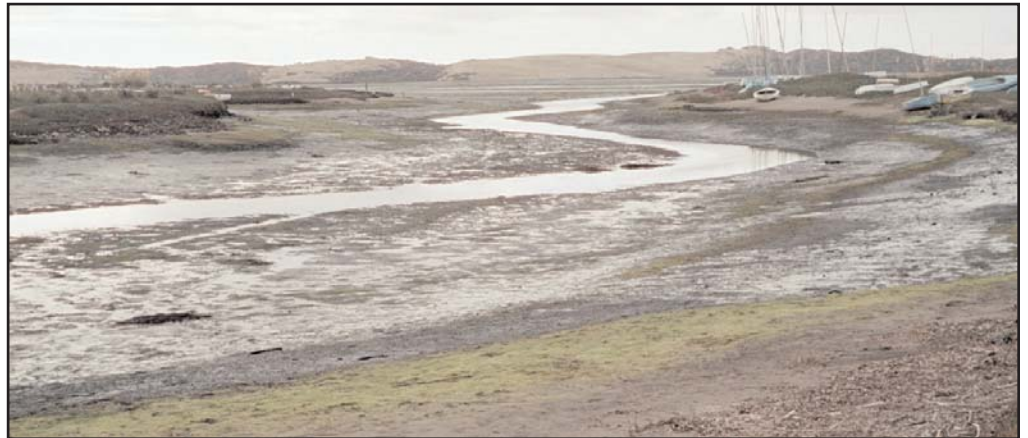
November 2004: The photo shows typical algal growth in Cuesta Inlet for most of the year. In photos taken at the same time last year, no algae were present in Cuesta Inlet. However, algal growth was high elsewhere in the bay during the same time period.

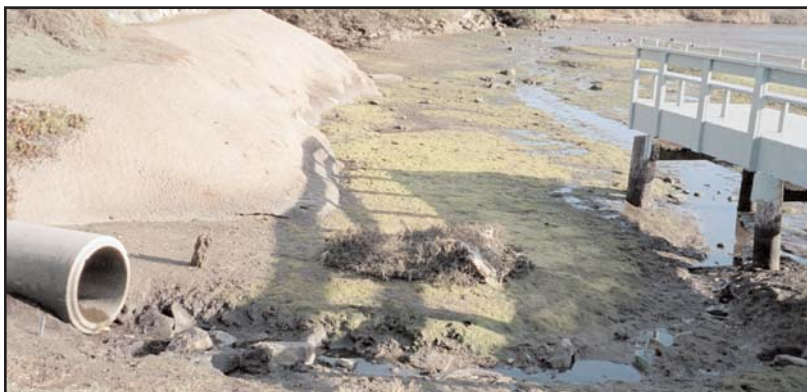
November 2004: The culvert near Baywood Pier carries urban runoff directly into the bay. A permanent plume of algae is typically present just below the culvert.

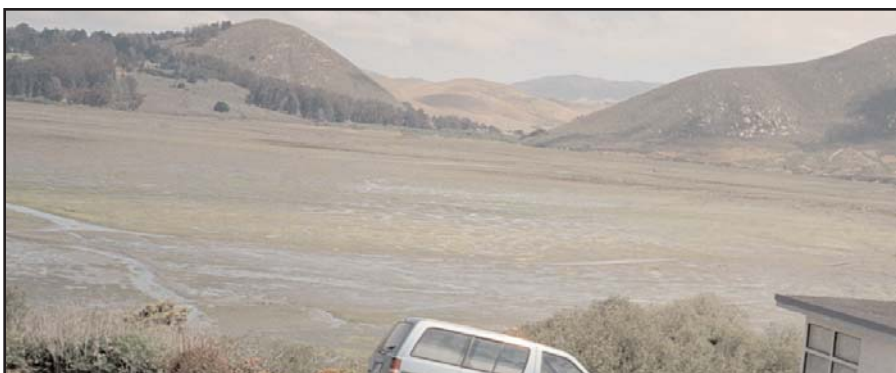
May 2004: This overview shot from near the Audubon Lookout in Los Osos shows the extent of algal growth that we commonly observe.

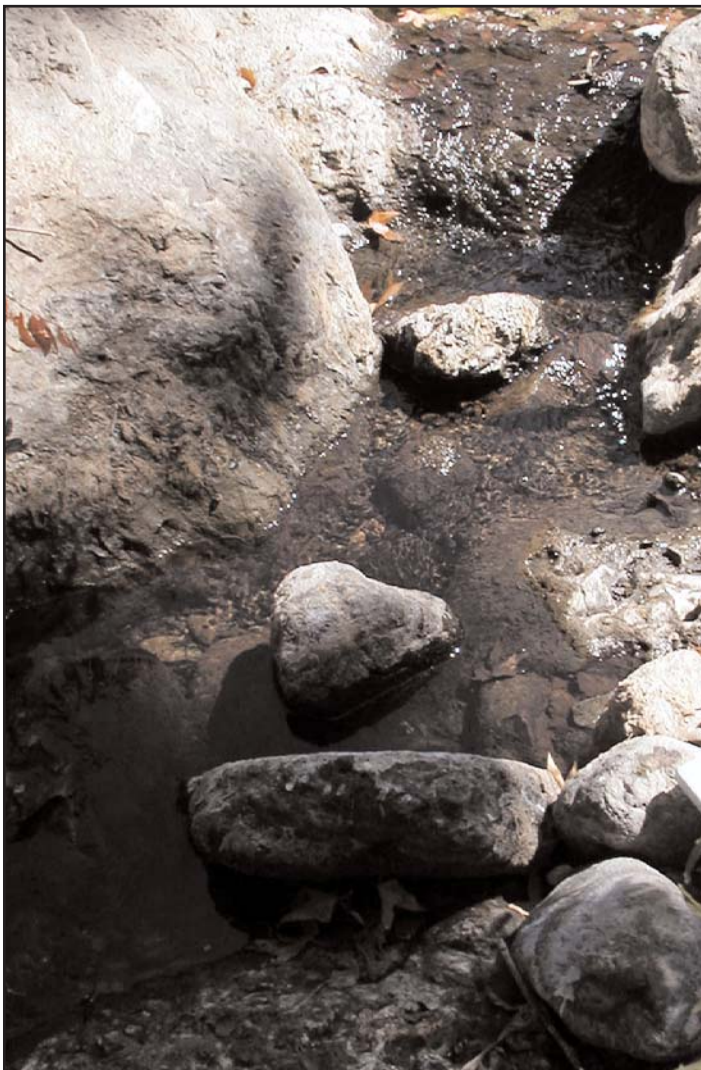
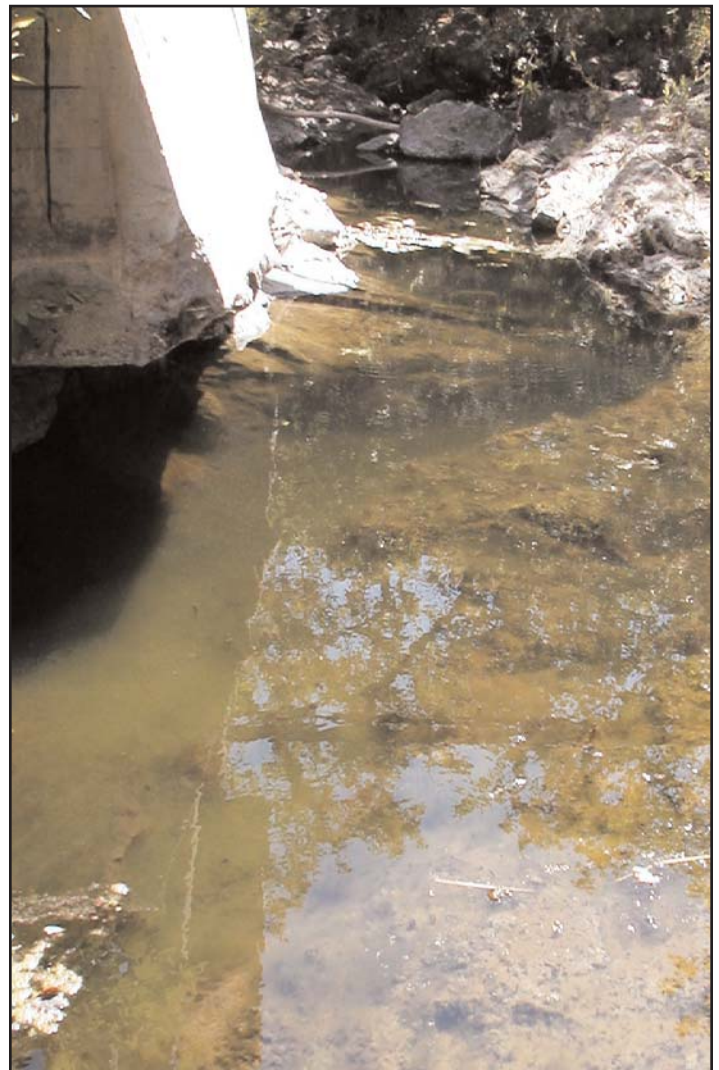
The photos are of Chorro Creek at Camp San Luis Obispo in August 2004. The photo on the left was taken in a shaded spot and the photo on the right was taken in a sunny spot. The difference in algal growth is marked. This site is above the CMC wastewater treatment plant, which discharges its treated effluent into the creek. Although this type of nutrient source is typically considered a culprit when it comes to excess algal growth, Chorro Creek shows a great deal of algae above the plant outfall. The data collected thus far points to a lack of canopy cover and the resulting increased sunlight exposure as a more likely cause of algal growth in this particular system.

The 2004 monitoring spanned from May through November. Algae were observed consistently at all of the sites through October and had mostly disappeared by November. The 2004 monitoring also included observations at both shady and sunny spots at each site to track the impact of canopy cover and shading on algal growth. A pretty clear trend emerged of increased algal growth in sunny areas as compared to shaded areas at each site.
