Morro Bay National Estuary Program

Morro Bay Eelgrass Report 2013

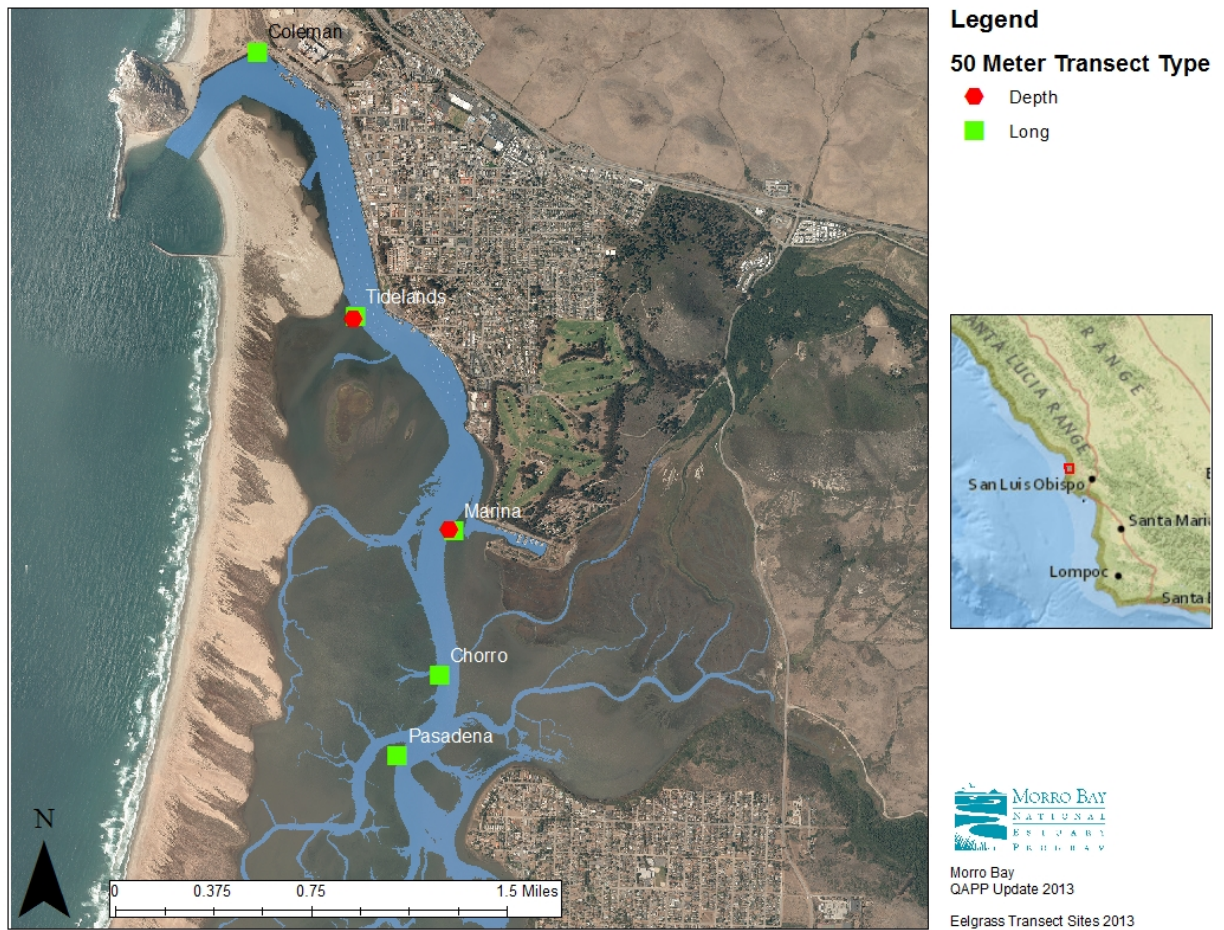
Figure 15: Transect Monitoring Locations

Transect fieldwork was conducted during extreme low tides during the late fall, as this period provides the best tidal windows for accessing sites. The timing of transect monitoring typically coincides with the imagery flight and can provide a useful qualitative assessment of conditions on the intertidal mudflats. Transect monitoring did not occur in 2011. Monitoring took place at five locations in 2012 and 2013. In 2013, the five transects were monitored over four days, November 1 and November 13 through 16. Staff accessed the sites by boat and conducted monitoring on foot. Figure 15 indicates the location of the five transects.

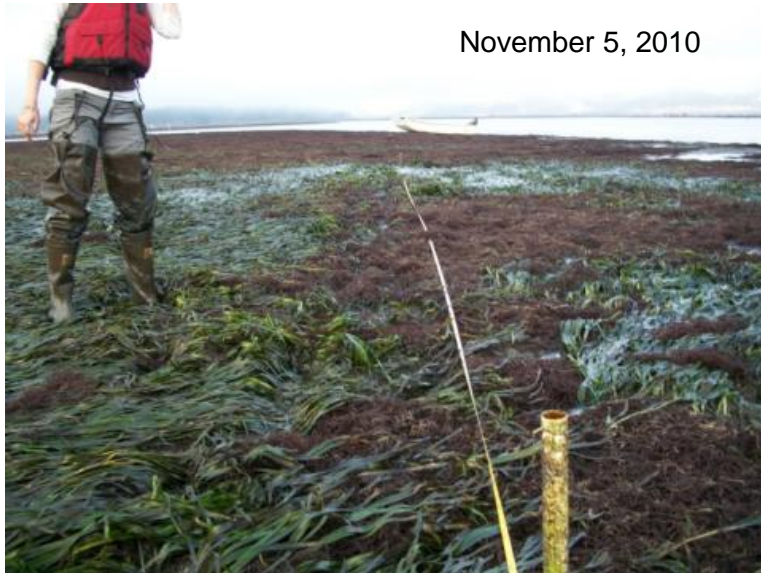
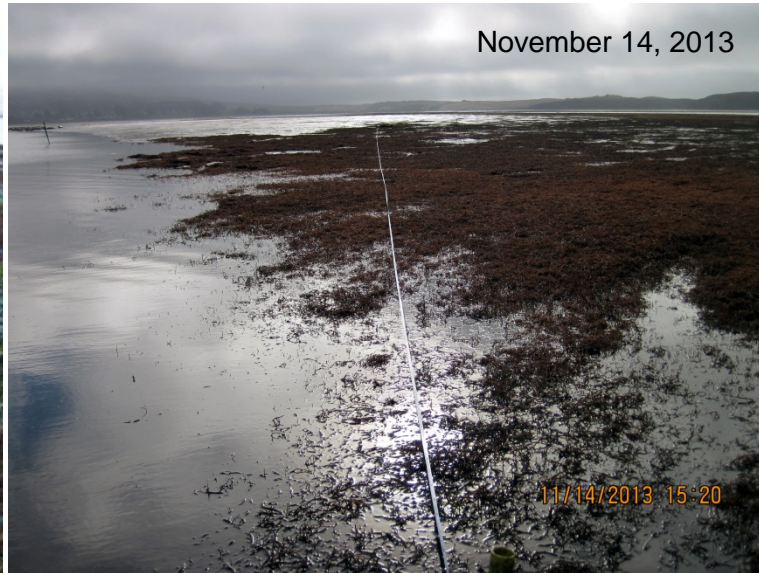
Pasadena Transect:

No intertidal eelgrass was observed along the transect in 2012 or 2013. Some eelgrass was present in 2010 and earlier. In deeper water near the transect, mature healthy subtidal eelgrass was present.

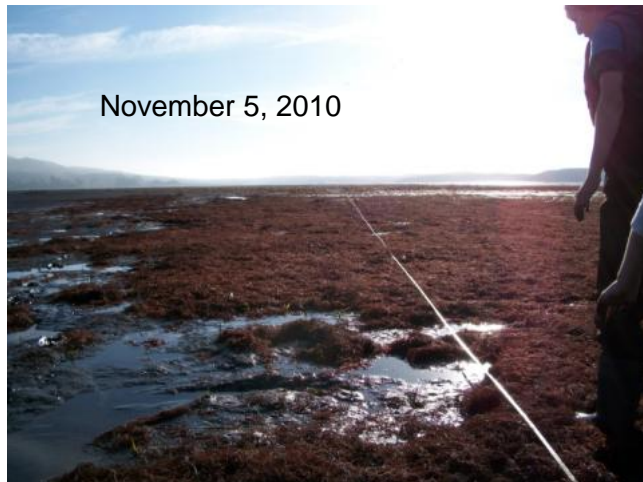
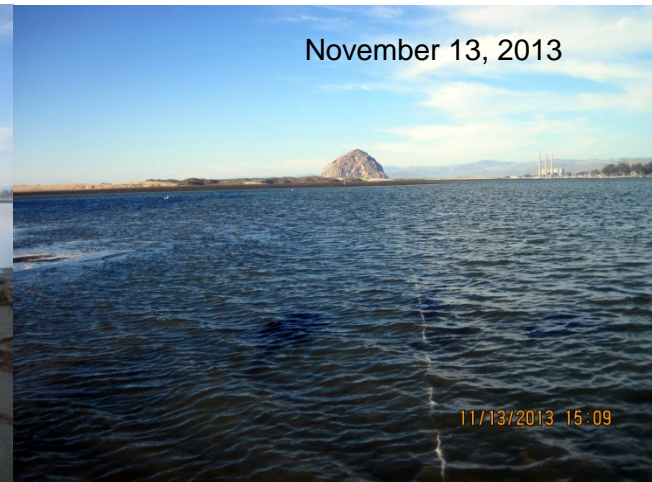
Chorro Transect:

No intertidal eelgrass was present. The site has had no to low eelgrass coverage since 2010. In the 2006 to 2009 time period, intertidal eelgrass coverage was dense. No eelgrass, either intertidal or subtidal, was observed in the area immediately outside of the transect area.

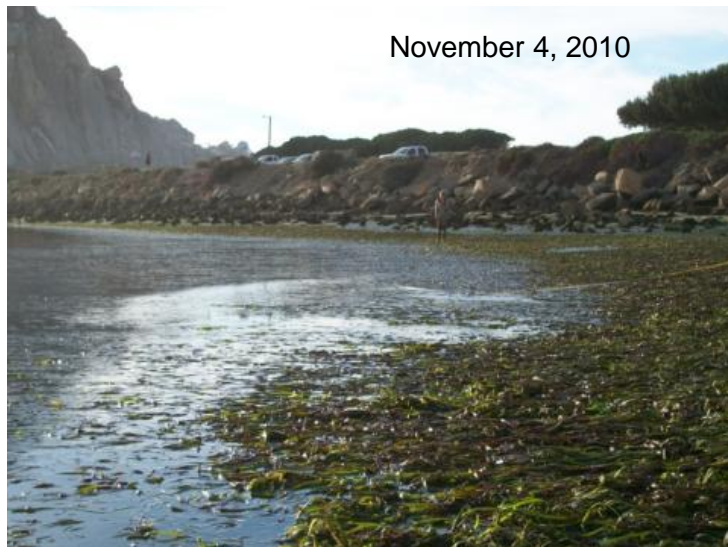
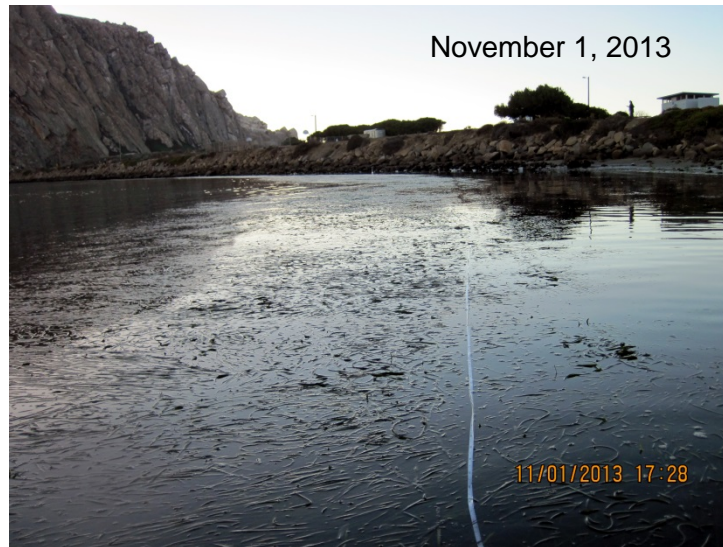
Coleman Transect:

Slightly lower intertidal eelgrass cover was observed than in the previous two years (2010 and 2012). A great deal of trash was present in the area. The eelgrass appeared to be wilted and not as robust as in past surveys. There was no large change in shoot densities from previous years.

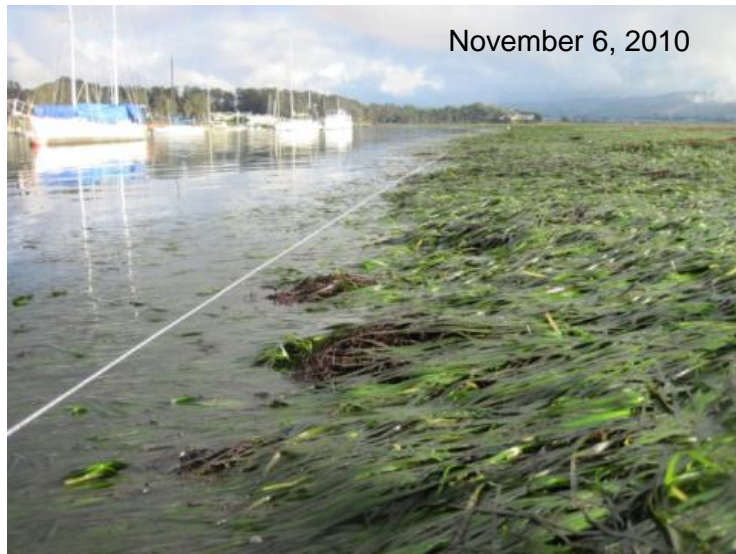
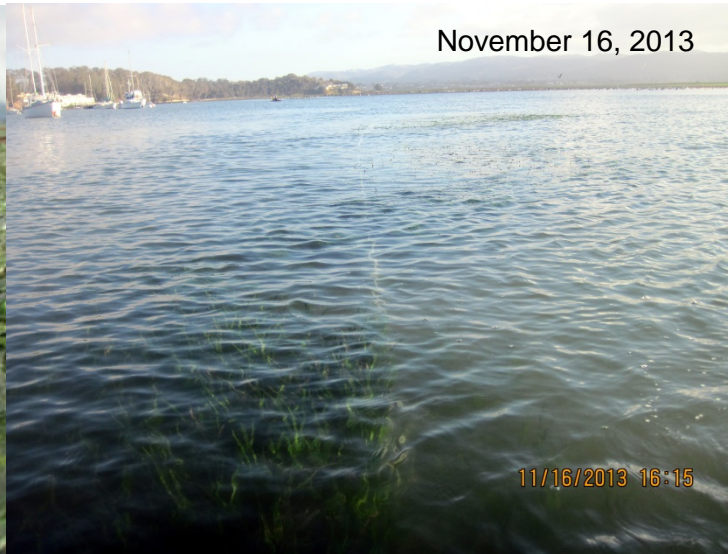
Tidelands Transect:

Intertidal eelgrass is present and healthy. Due to the shape of the bed, the transect went through a bare area, which decreased the percent coverage values. Eelgrass density was high throughout the bed.

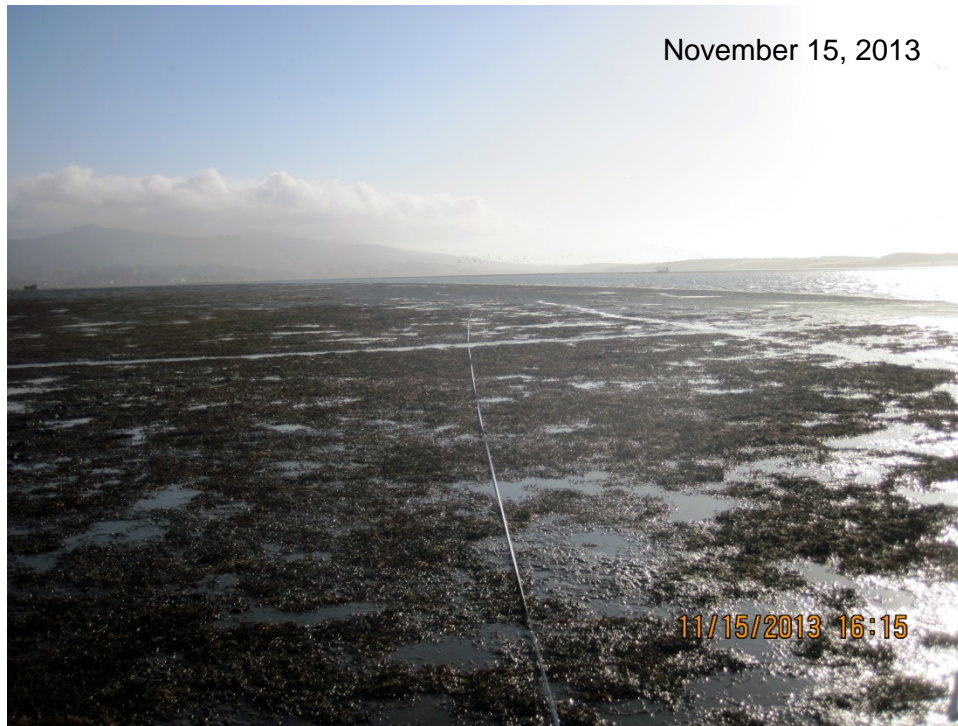
Marina Transect:

This transect had low coverage numbers in 2012 and 2013. Near the transect area, subtidal eelgrass was present in the deeper channel.

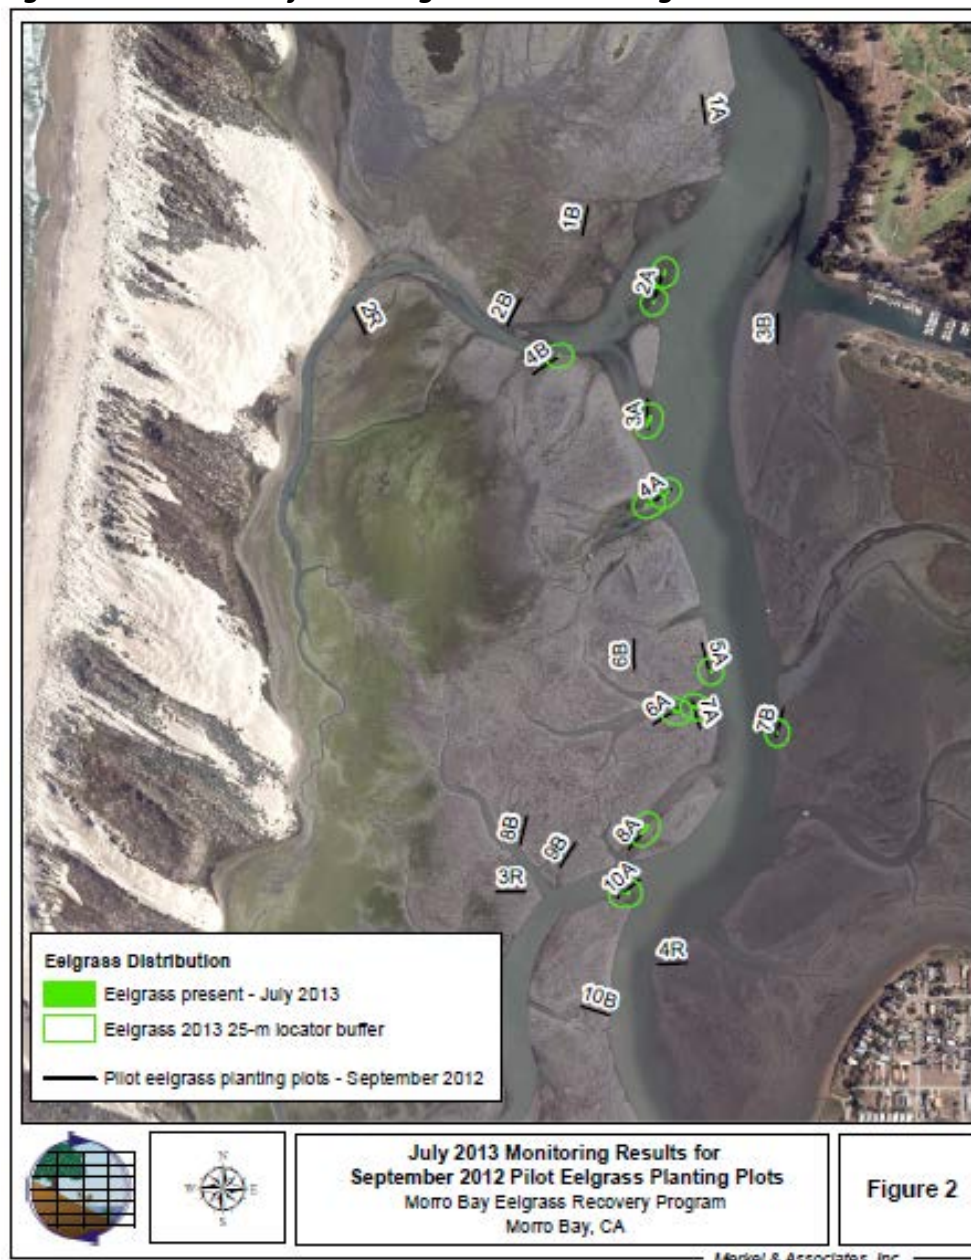
Figure 19: Locations of 2012 Eelgrass Pilot Planting Locations

Figure 19 contains a map of the pilot planting areas. Locations where eelgrass was detected in the July 2013 monitoring effort are shown in green.

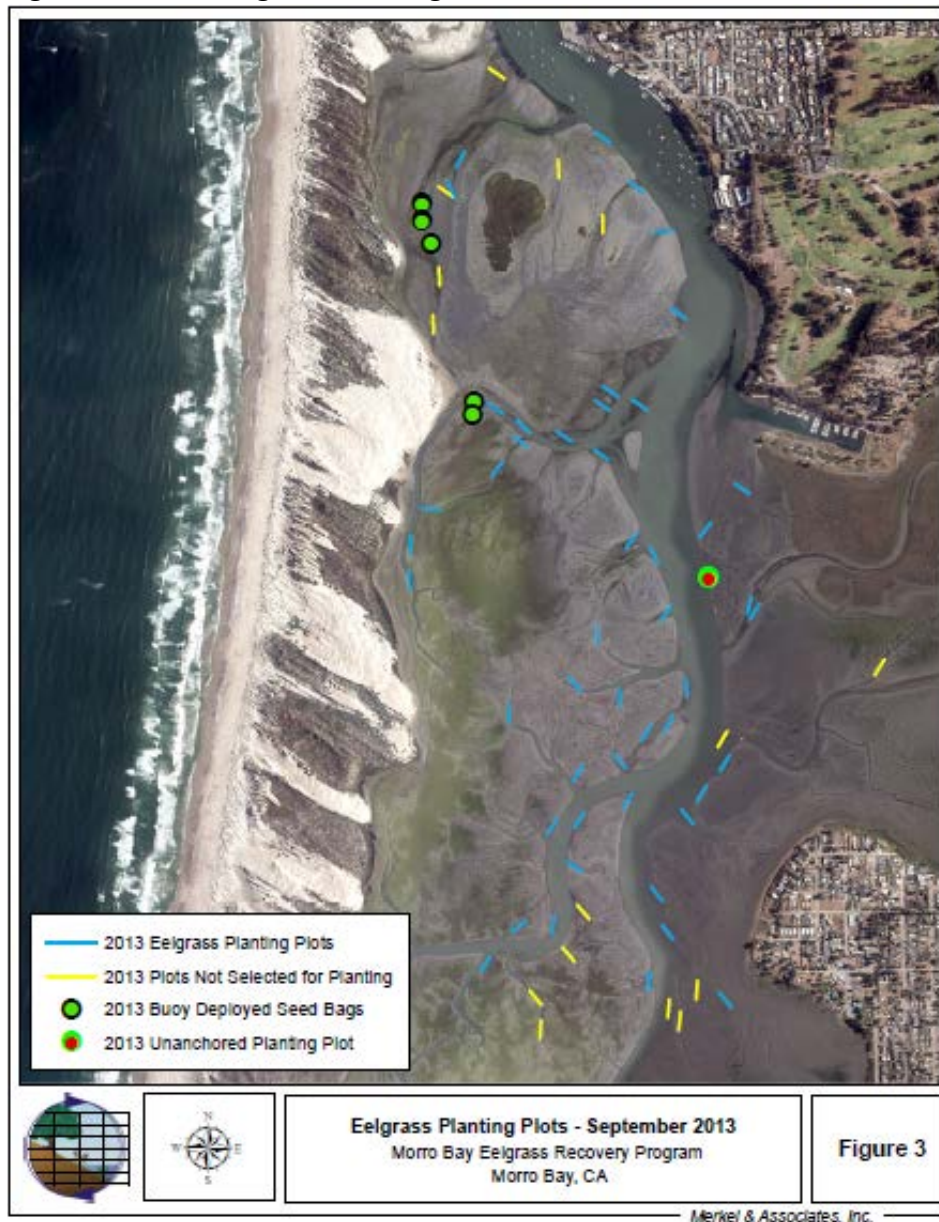
Figure 20: 2013 Eelgrass Planting Locations

Based on information from the 2012 pilot effort, a second more extensive planting effort was staged in an eight-day period in August 2013. Over 100 volunteers and partners, including non-profits and agencies, provided the funding and people power to prepare 9,775 eelgrass planting units which were installed in 49 plots, totaling approximately 2.4 acres. During harvesting, some eelgrass was flowering. This material was set aside and placed into mesh bags which were attached to buoys for seed dispersal. The locations of planting plots and buoy-deployed seed bags are illustrated in Figure 20.
