Morro Bay National Estuary Program

Morro Bay Eelgrass Report 2013

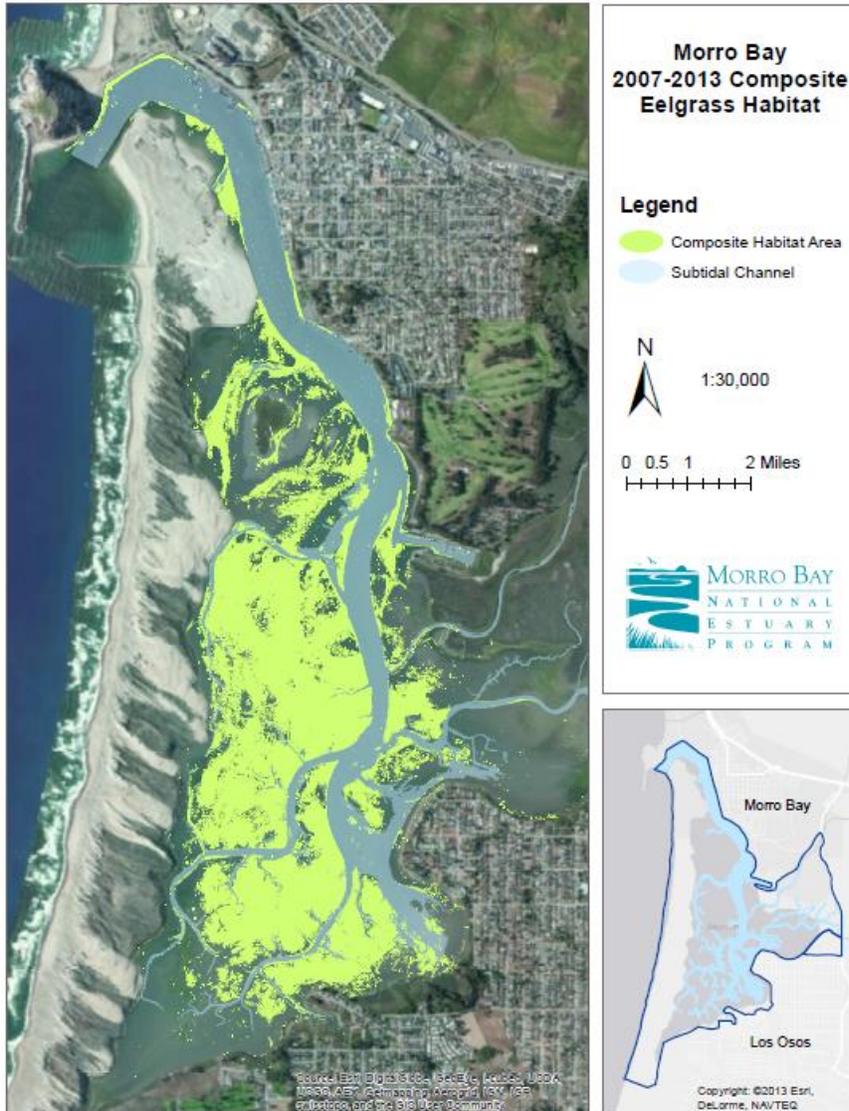
Figure 12: 2007-2013 Composite Intertidal Eelgrass Habitat

Once aggregation was complete, the 2007, 2009, 2010 and 2013 eelgrass datasets were merged to create one dataset. This merged dataset generated a composite of all eelgrass habitat detected between the years of 2007 and 2013. The composite dataset delineated approximately 902 acres as potential eelgrass habitat in the Morro Bay study area, shown in Figure 12.

Once each year of raw data had been aggregated, the datasets were merged to create a single file. The four unique datasets were merged via the Data Merge toolset in the ArcMap 10.1 suite. The resulting file contained a composite of all areas where eelgrass was observed during 2007, 2009, 2010 and 2013. This area was used to represent the composite or potential habitat area where eelgrass has been documented, and may occur in future surveys. The composite area of intertidal eelgrass habitat was determined to be 918.39 acres, as indicated in Table 7.

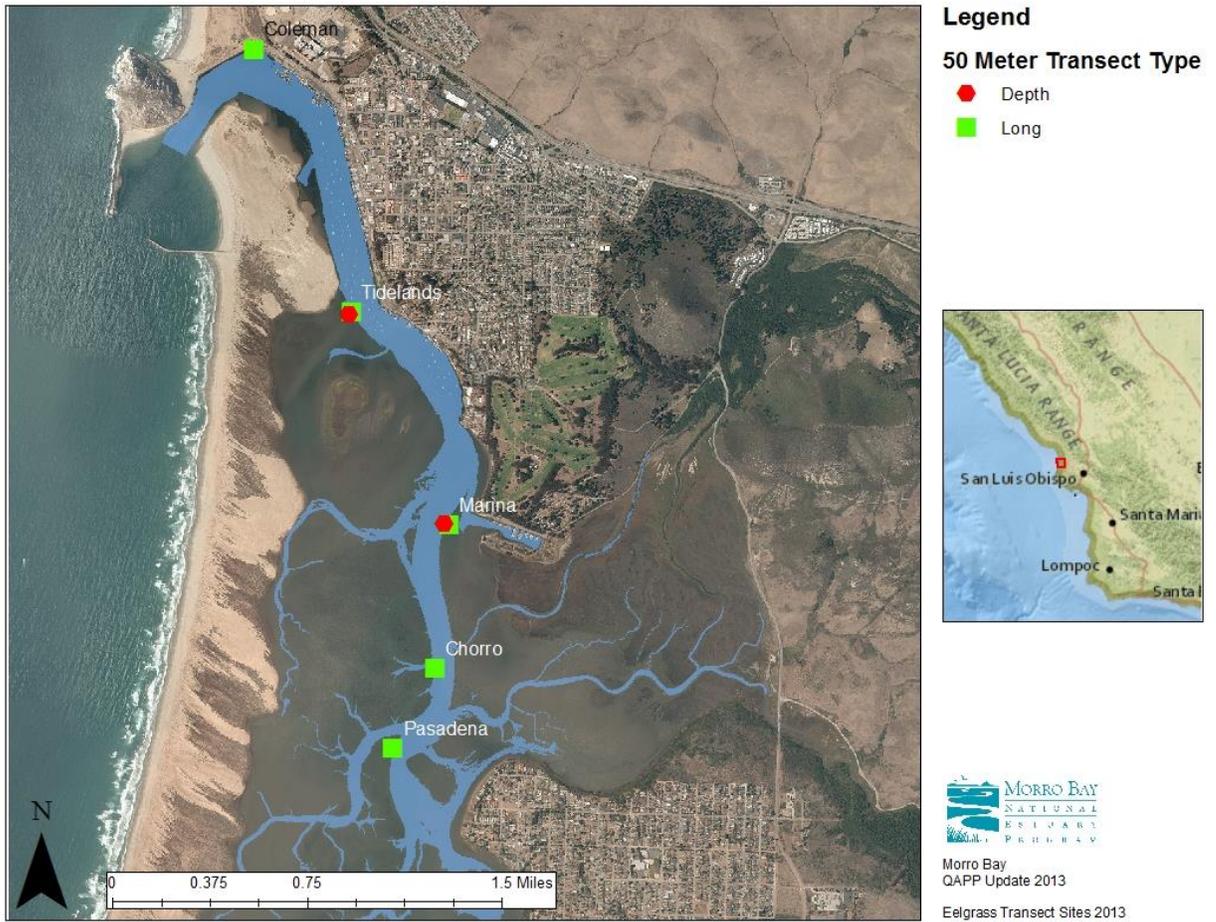
Figure 15: Transect Monitoring Locations

Transect fieldwork was conducted during extreme low tides during the late fall, as this period provides the best tidal windows for accessing sites. The timing of transect monitoring typically coincides with the imagery flight and can provide a useful qualitative assessment of conditions on the intertidal mudflats. Transect monitoring did not occur in 2011. Monitoring took place at five locations in 2012 and 2013. In 2013, the five transects were monitored over four days, November 1 and November 13 through 16. Staff accessed the sites by boat and conducted monitoring on foot. Figure 15 indicates the location of the five transects.

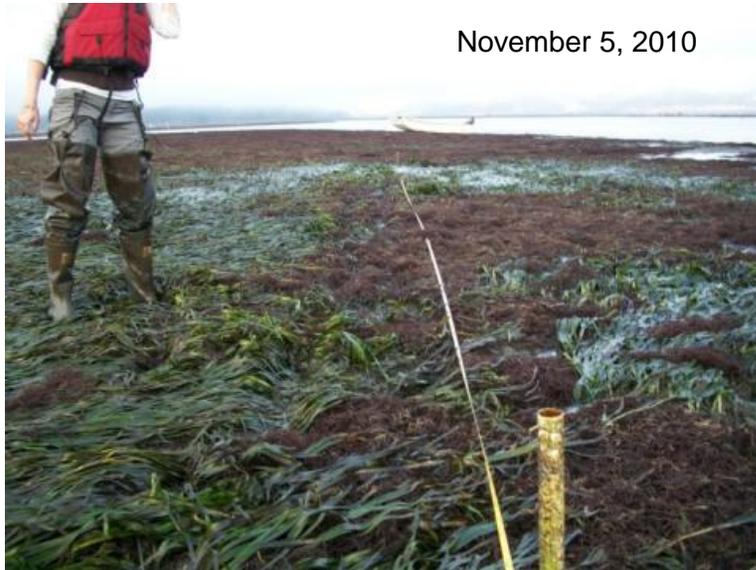
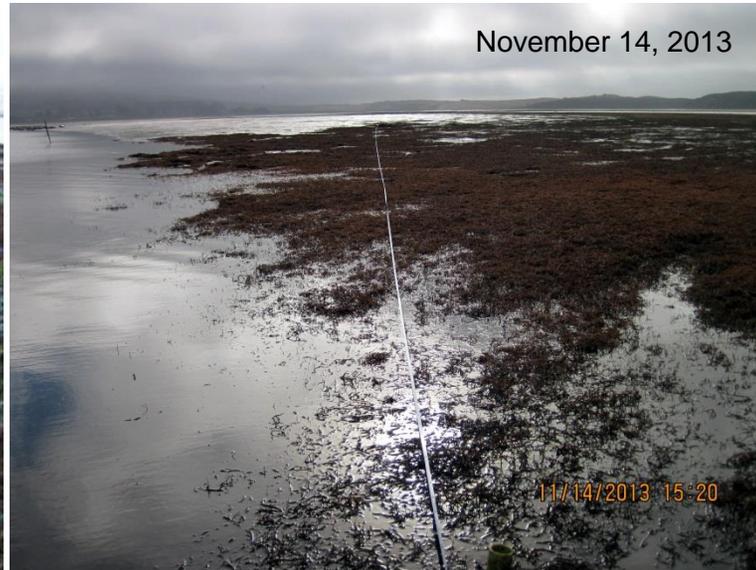
Pasadena Transect:

No intertidal eelgrass was observed along the transect in 2012 or 2013. Some eelgrass was present in 2010 and earlier. In deeper water near the transect, mature healthy subtidal eelgrass was present.

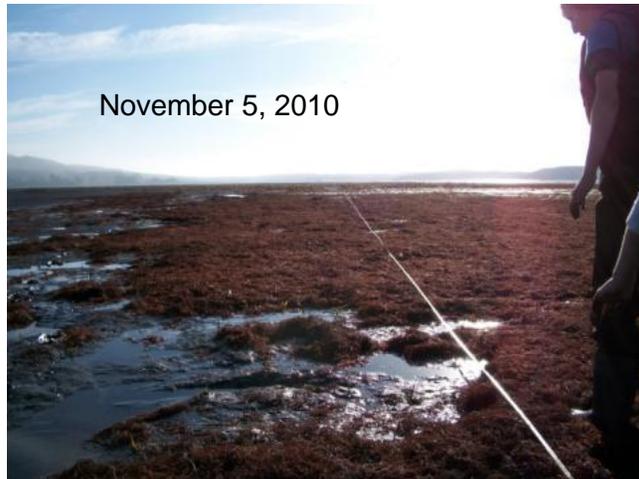
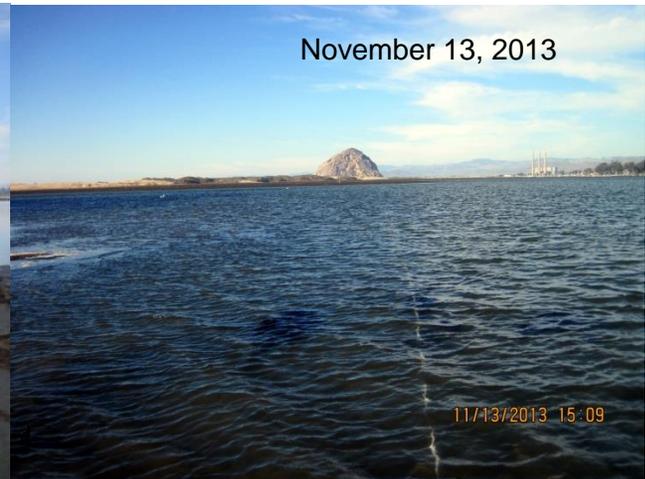
Chorro Transect:

No intertidal eelgrass was present. The site has had no to low eelgrass coverage since 2010. In the 2006 to 2009 time period, intertidal eelgrass coverage was dense. No eelgrass, either intertidal or subtidal, was observed in the area immediately outside of the transect area.

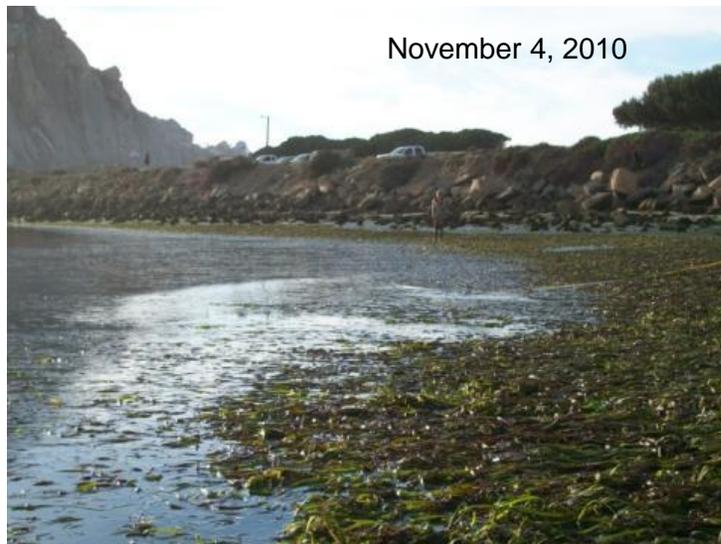
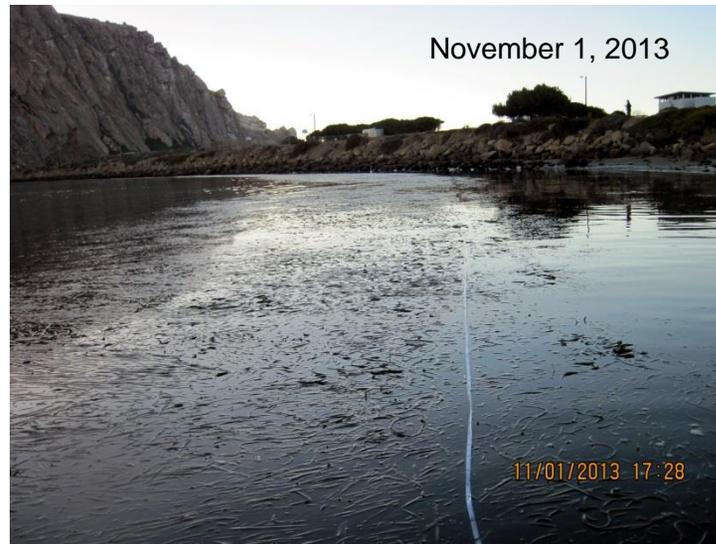
Coleman Transect:

Slightly lower intertidal eelgrass cover was observed than in the previous two years (2010 and 2012). A great deal of trash was present in the area. The eelgrass appeared to be wilted and not as robust as in past surveys. There was no large change in shoot densities from previous years.

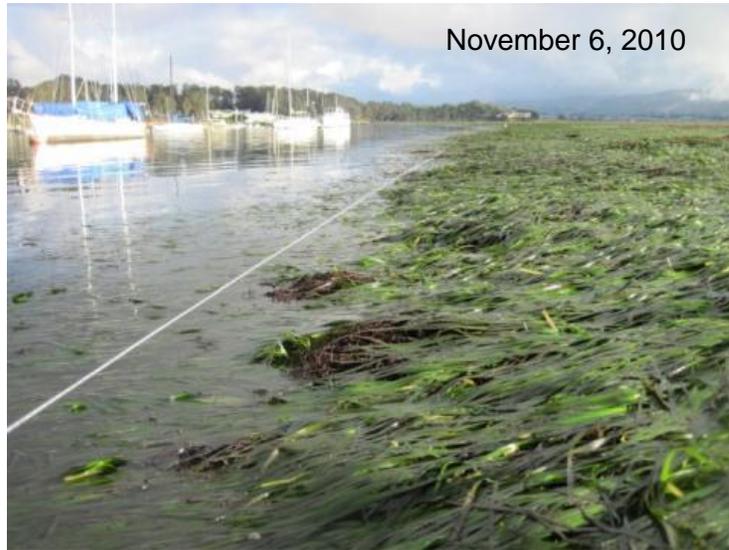
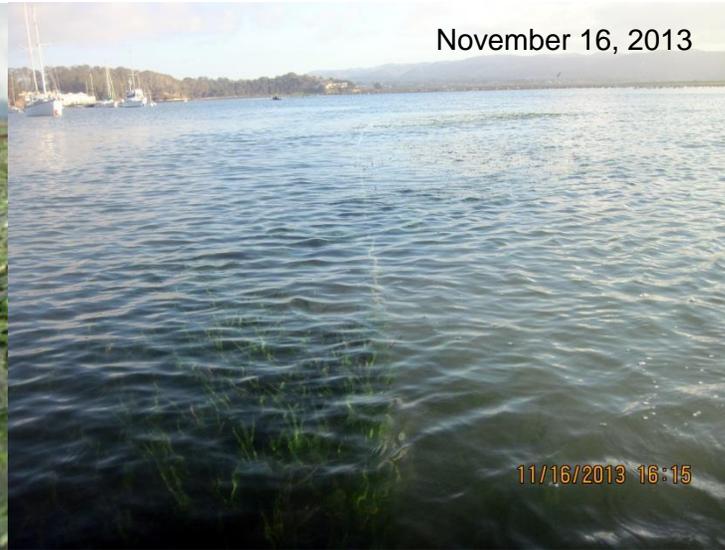
Tidelands Transect:

Intertidal eelgrass is present and healthy. Due to the shape of the bed, the transect went through a bare area, which decreased the percent coverage values. Eelgrass density was high throughout the bed.

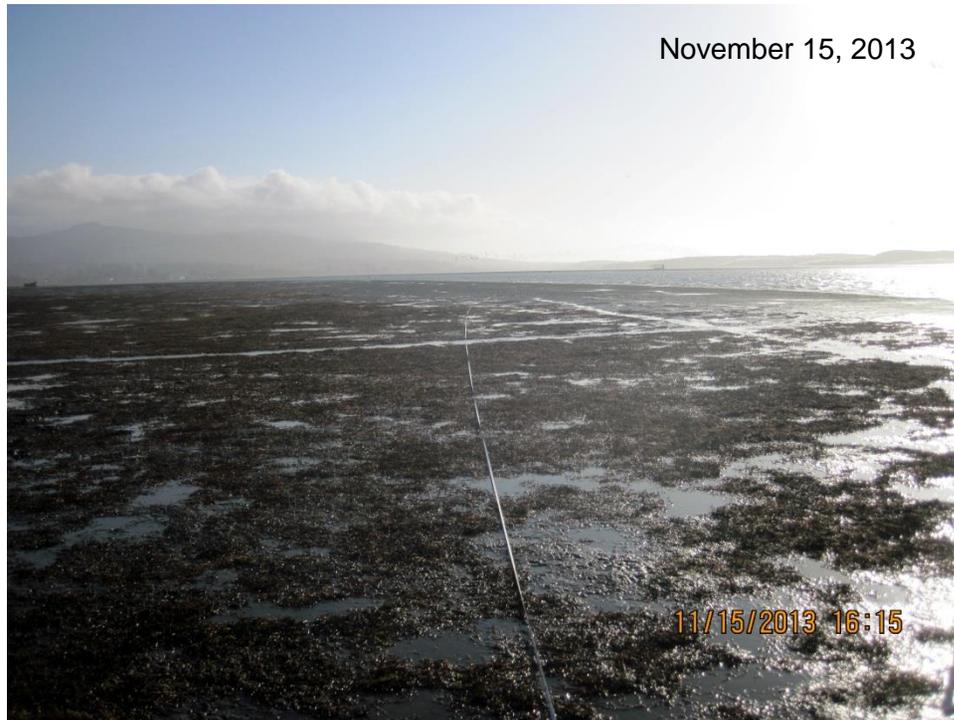
Marina Transect:

This transect had low coverage numbers in 2012 and 2013. Near the transect area, subtidal eelgrass was present in the deeper channel.

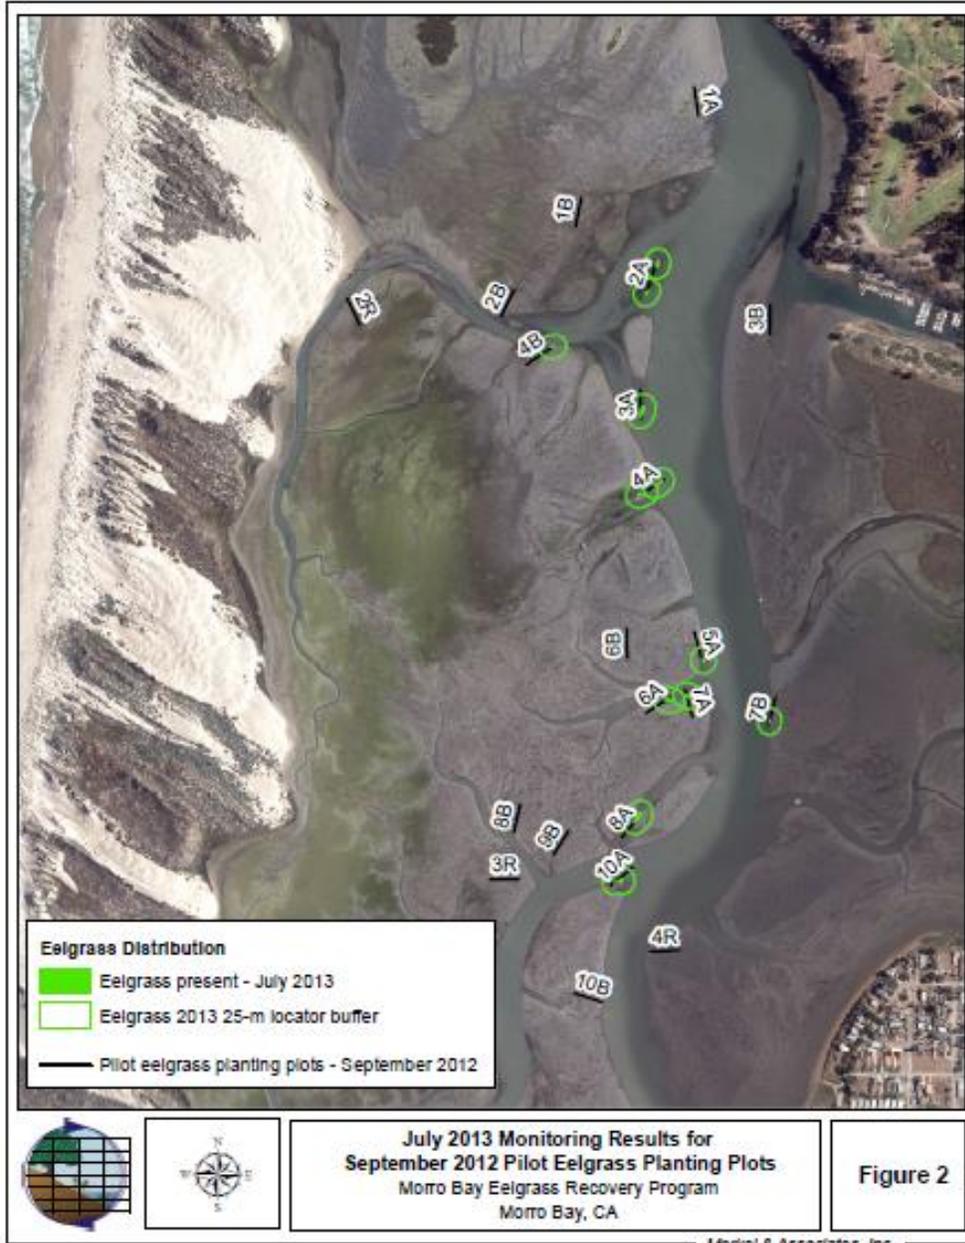
Figure 19: Locations of 2012 Eelgrass Pilot Planting Locations

Figure 19 contains a map of the pilot planting areas. Locations where eelgrass was detected in the July 2013 monitoring effort are shown in green.

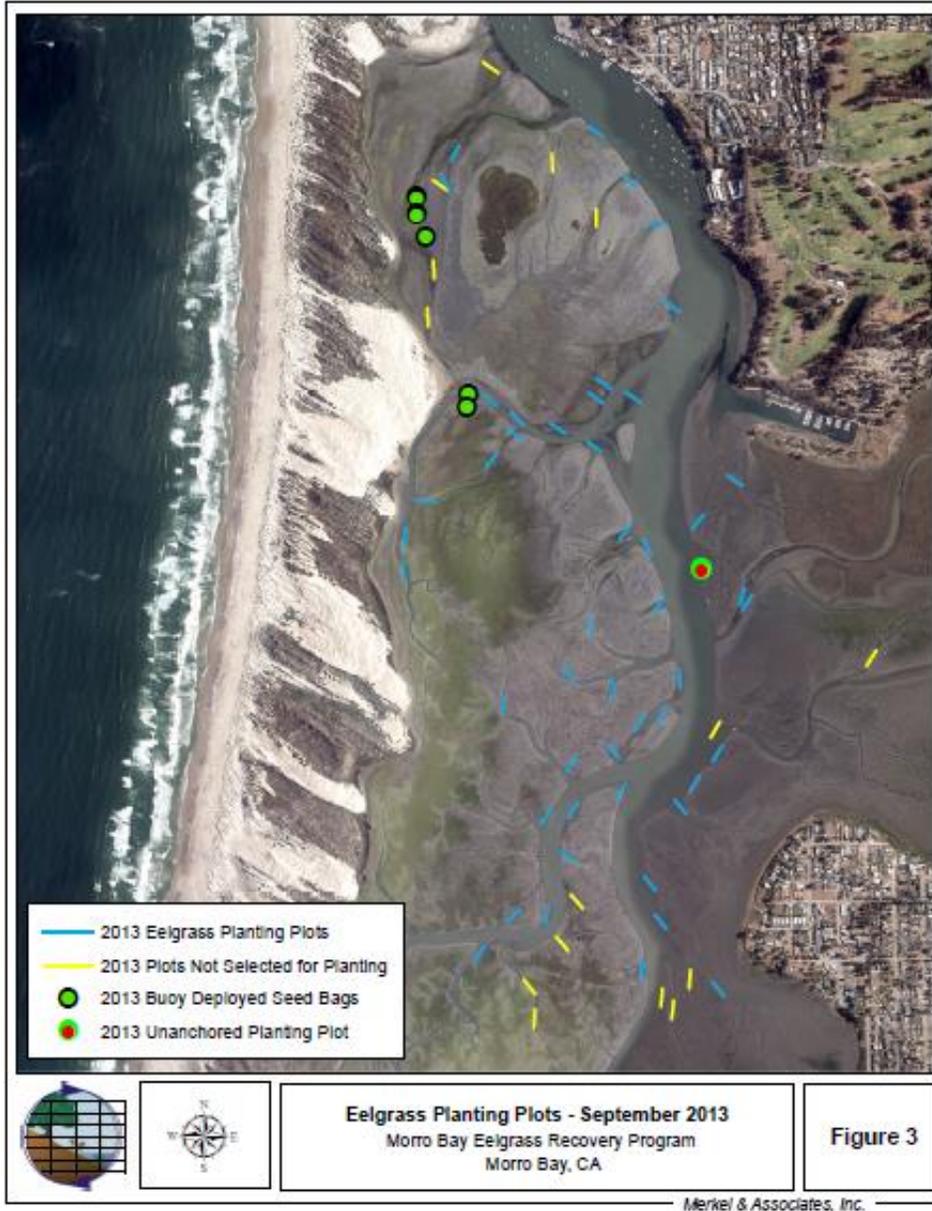
Figure 20: 2013 Eelgrass Planting Locations

Based on information from the 2012 pilot effort, a second more extensive planting effort was staged in an eight-day period in August 2013. Over 100 volunteers and partners, including non-profits and agencies, provided the funding and people power to prepare 9,775 eelgrass planting units which were installed in 49 plots, totaling approximately 2.4 acres. During harvesting, some eelgrass was flowering. This material was set aside and placed into mesh bags which were attached to buoys for seed dispersal. The locations of planting plots and buoy-deployed seed bags are illustrated in Figure 20.
