MORRO BAY SEDIMENT LOADING UPDATE

COMPILED BY THE MORRO BAY NATIONAL ESTUARY PROGRAM
DECEMBER, 2011

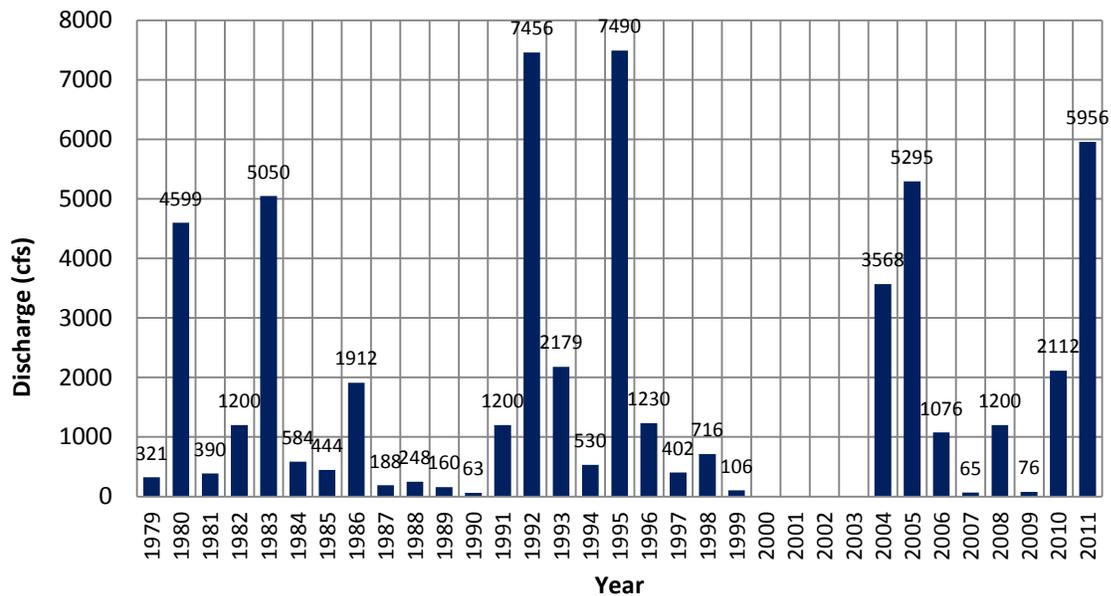
FIGURE 1: CHORRO CREEK, CANET ROAD, PEAK FLOW RECORDS†

Examination of peak flow records from the Canet Road gauge on Chorro Creek indicates that significant resolution may be lost by averaging annual sediment loads across several years. Review of approximately 29 years of peak flow data (Figure 1) indicates tremendous inter-annual variability in peak flows at the gauging station, with a range of approximately 7,427 cubic feet/second (cfs). As models indicate that flow volume and suspended sediment concentration are strongly correlated, it can be inferred that sediment loading is similarly variable from year to year.

†Data not available from 2000 through 2003 due to reconstruction of the crossing and gauge.

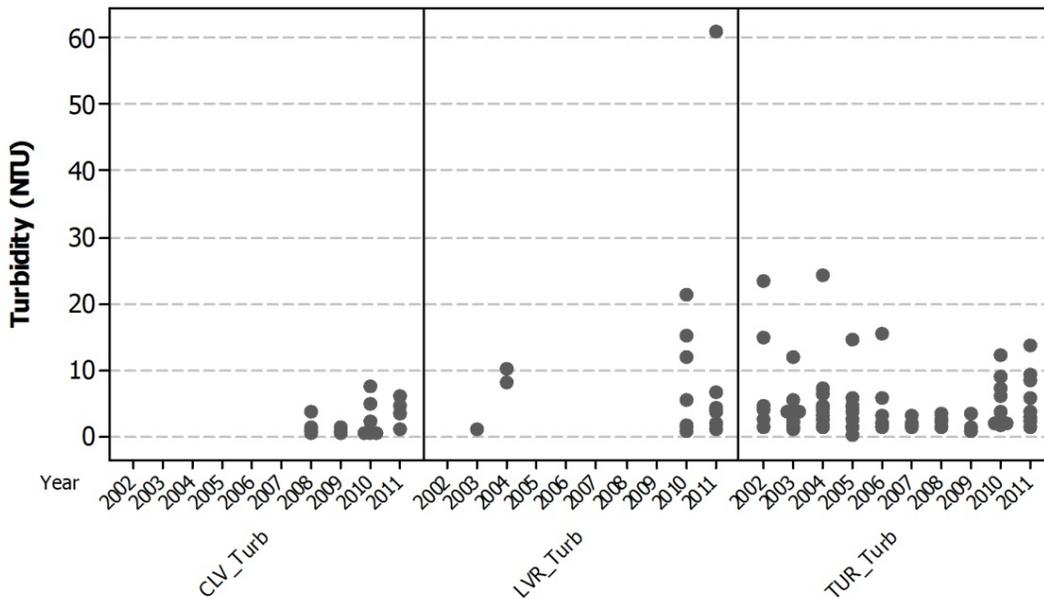
FIGURE 5: LOS OSOS AND WARDEN CREEK AMBIENT TURBIDITY DATA

Nephelometric turbidity data for the three sites in the Los Osos subwatershed are summarized in the individual values plot shown in Figure 5 below. Generally, nephelometric turbidity remains below 10 NTU, with a few exceptions usually occurring during winter storms.

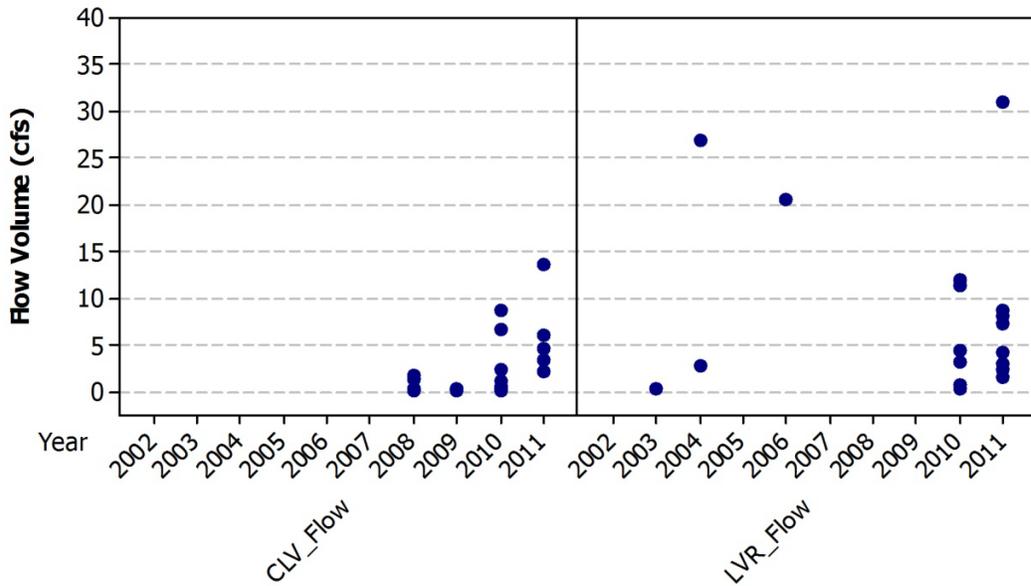
FIGURE 6: FLOW VOLUME MEASUREMENTS, LOS OSOS CREEK

Flow volume data has been collected periodically at two sites on Los Osos Creek. Both sites have semi-perennial flow regimes and dry up during the summer months most years. The LVR station is part of the San Luis Obispo County Flood Control and Water Conservation District's (the District) monitoring network. The site is equipped with a stage height recorder that logs data on a 15-minute interval. Individual values for flow measurements for sites CLV and LVR are shown in Figure 6.

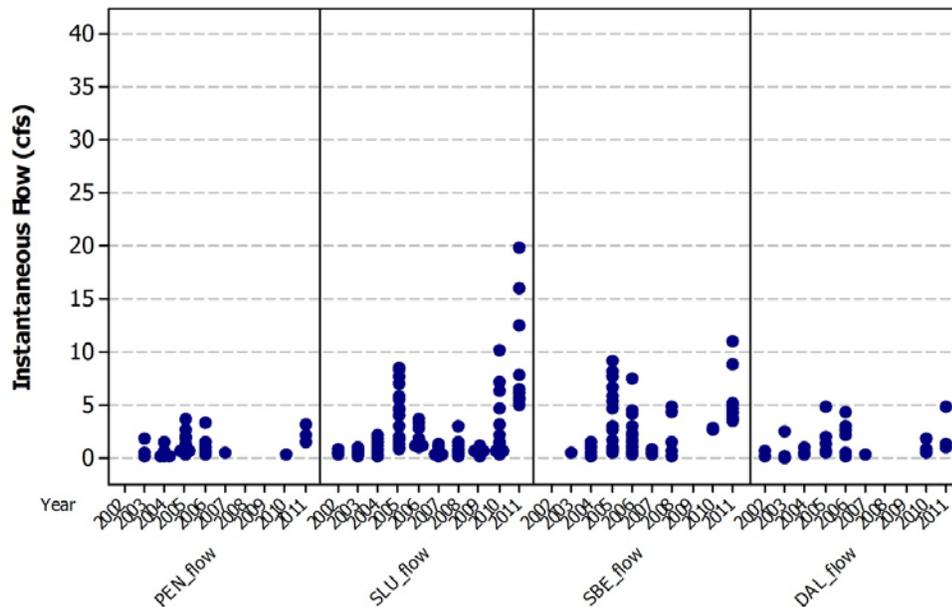
FIGURE 9: FLOW VOLUME MEASUREMENTS, CHORRO TRIBUTARIES

The data shown in Figure 9 summarize flow values collected from tributaries to Chorro Creek. Many of these tributaries are semi-perennial, which prevents data collection during the summer months of most years.

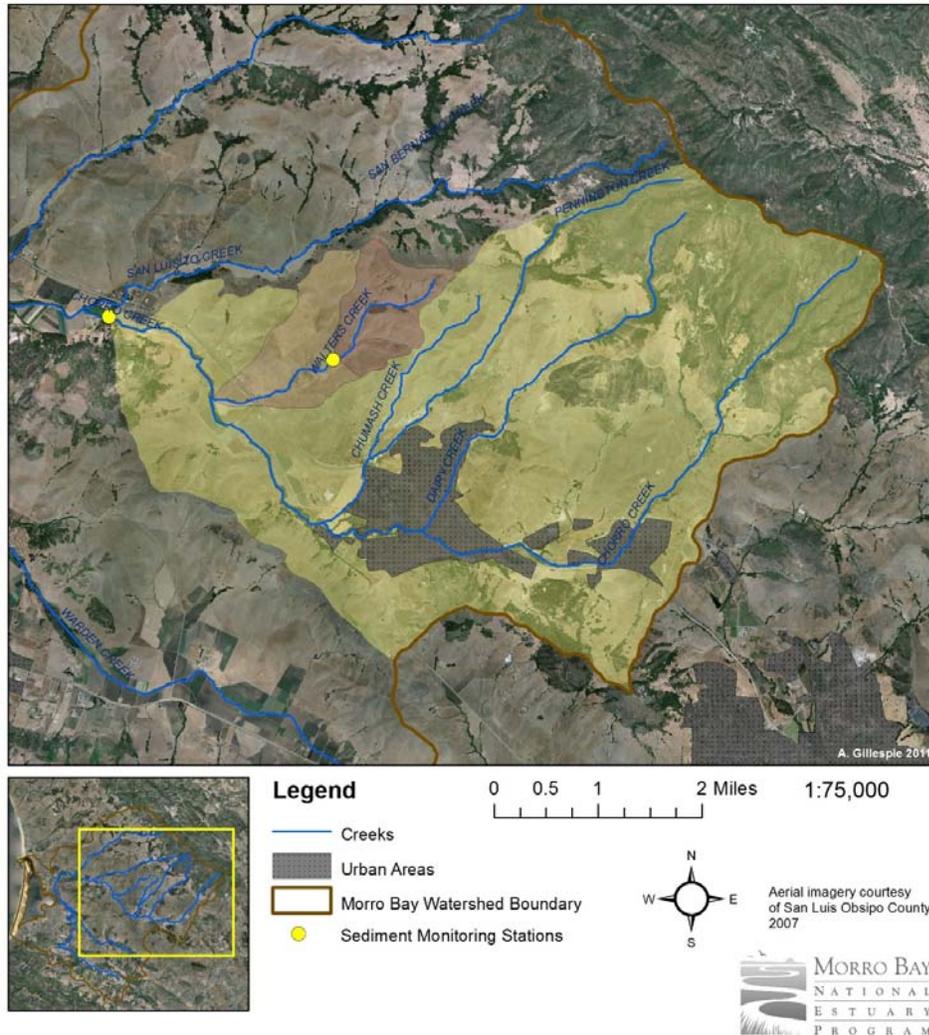
FIGURE 10: SUSPENDED SEDIMENT MONITORING STATIONS

The Walters Creek subwatershed encompasses drainage from approximately 1.90 square miles. The watershed is used as rangeland for beef cattle operations with a rotational grazing scheme. The flume monitoring station includes drainage from approximately 0.86 square miles of the subwatershed. The Walters Creek confluence with Chorro Creek is upstream of the Canet Road monitoring site. Figure 10 demonstrates drainage areas and monitoring station locations.

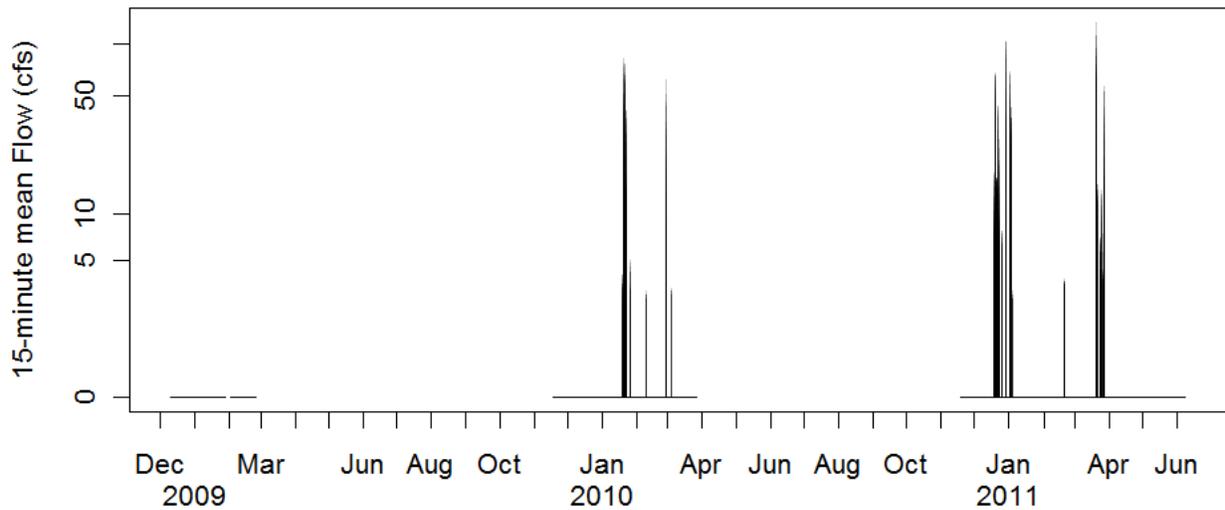
FIGURE 11: 15 MINUTE MEAN FLOWS AT WALTERS CREEK

Figure 11 indicates the frequency and magnitude of measureable flow volumes at the Walters Creek flume. The flow regime at Walters Creek is characterized by long periods of shallow base flow and short duration elevated flows associated with storm events.

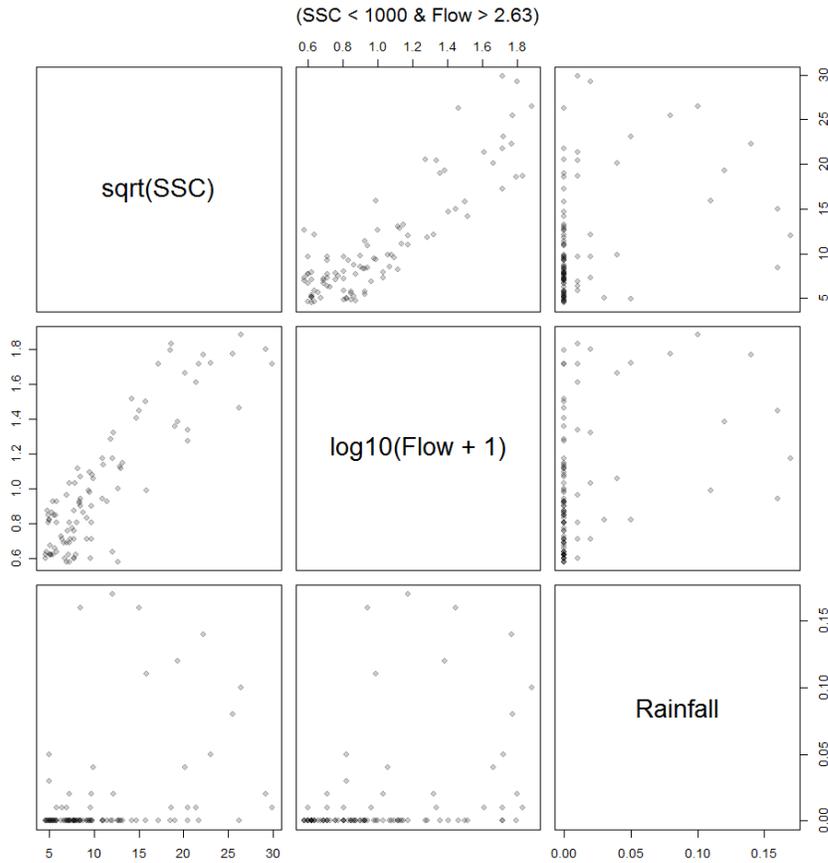
FIGURE 12: DATA TRANSFORMATIONS APPLIED FOR NORMALIZATION OF WALTERS DATA

The data was analyzed to identify a reasonable set of transformations for modeling the variables. Transformations were applied to stabilize the variance, achieve linearity (so linear models could be fit), induce normality in the residuals, and balance leverage across the data points so that outlying x-values wouldn't have undue influence on the regression coefficients. Transformations were applied to the SSC data (SqrtSSC), and the flow volume data ($\text{Log}_{10}(\text{Flow} + 1)$). Rainfall data from the Canet station at Chorro Creek was considered as a possible variable but was not included in the final models. The final model analysis considers only data when flow is greater than 2.63 cfs and $\text{SSC} < 1000 \text{ mg/L}$. Transformed values and relationships are shown in Figure 12, below.

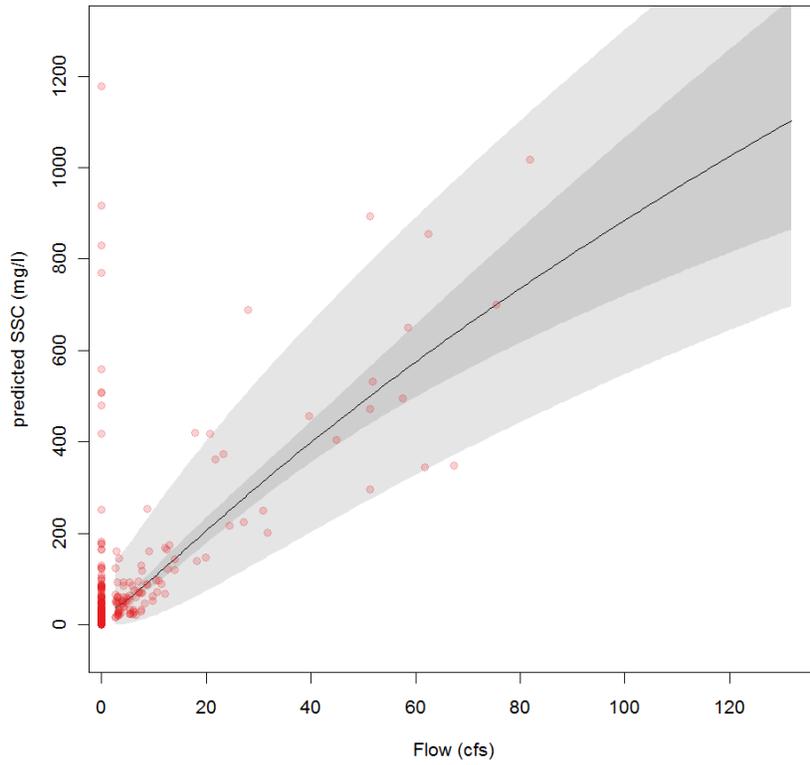
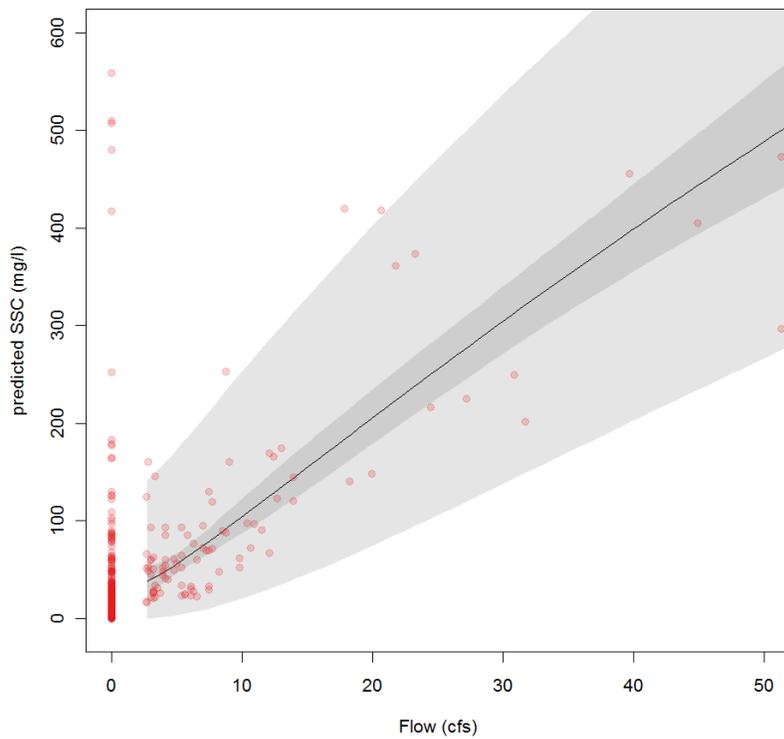
Figures 13 and 14 display the fitted model with 95% confidence and prediction bands as well as the data used to generate the model. Note that all data is plotted for reference, but the model only includes Flows greater than 2.63 cfs.

FIGURE 13: WALTERS CREEK POST-PROJECT PREDICTIVE MODEL (FULL RANGE)

FIGURE 14: WALTERS CREEK POST-PROJECT PREDICTIVE MODEL (LOW RANGE)

The final model adopted for predicting sediment loading and establishing the relationship between the variables included a higher order flow term and dropped the rainfall predictor variable, which was shown to be non-significant (). Residual diagnostics appeared to satisfy modeling requirements. The model adopted for determining sediment concentration based on flow volume achieves a very high R-sq (adj) = 79%, indicating that a substantial fraction of the variability in SSC can be explained by Flow alone. The higher range of the model has a wider confidence interval and prediction bands owing to a lack of data. Additional data collection efforts could reduce the width of these intervals.

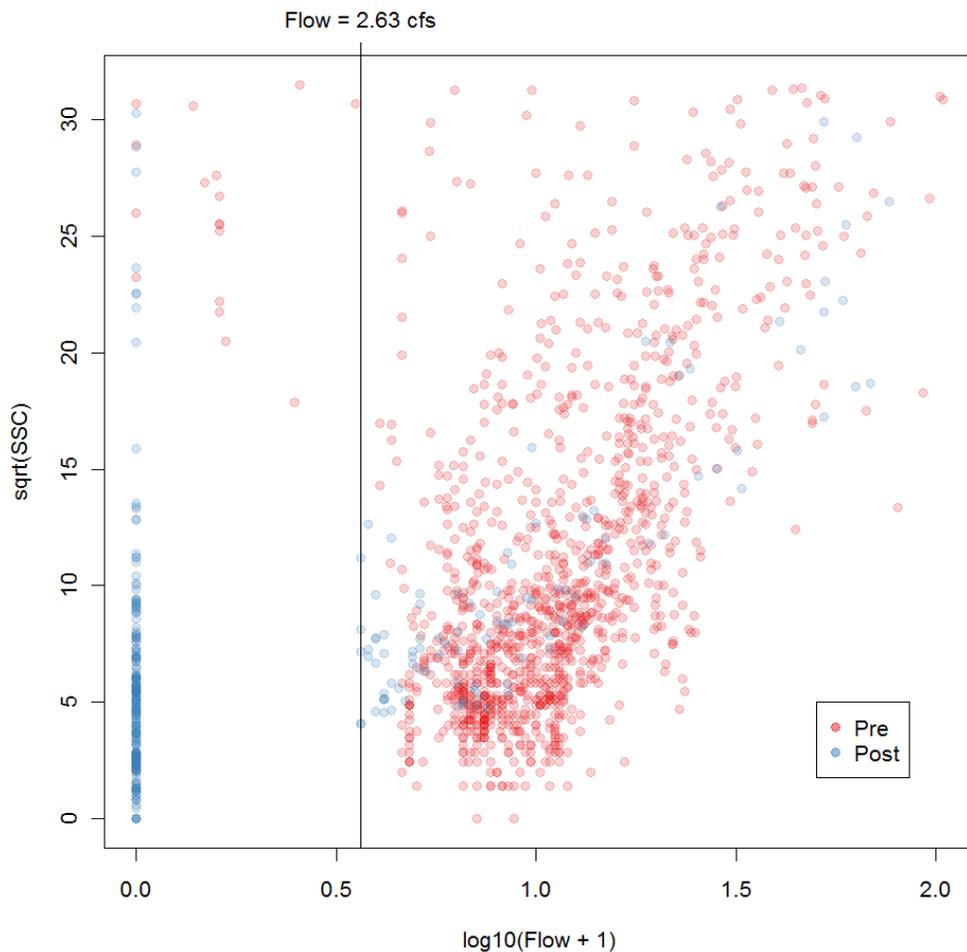
FIGURE 15: WALTERS CREEK PRE- AND POST-PROJECT SEDIMENT DATA

The following graphic displays the pre-Project TSS and post-Project SSC data on the same plot. Due to the different time periods of pre- and post-Project analysis, there is a greater number of pre-Project (red) data points and also greater variability among the pre-Project data. Data shown to the left of the reference line at 2.63 cfs was not included in model analysis as it did not meet the minimum flow criteria.

The pre-project data was incorporated into the final model that was used for determining the relationship for the post-Project data, assuming that the functional relationship between the two parameters would remain the same. However, the parameters in the pre-Project period were allowed to differ from the post-Project period. The residual behavior of the pre-Project data was checked using the functional form of the post-Project data and did not indicate a need for higher order terms in the model.

There was substantially more variability in the pre-Project TSS data as noted by the residual standard error (pre-project data = 5.33 mg/l, post-project data = 2.836 mg/l), and thus a lower adjusted R-sq = 41% for pre-Project data versus 79% with the post-Project data.

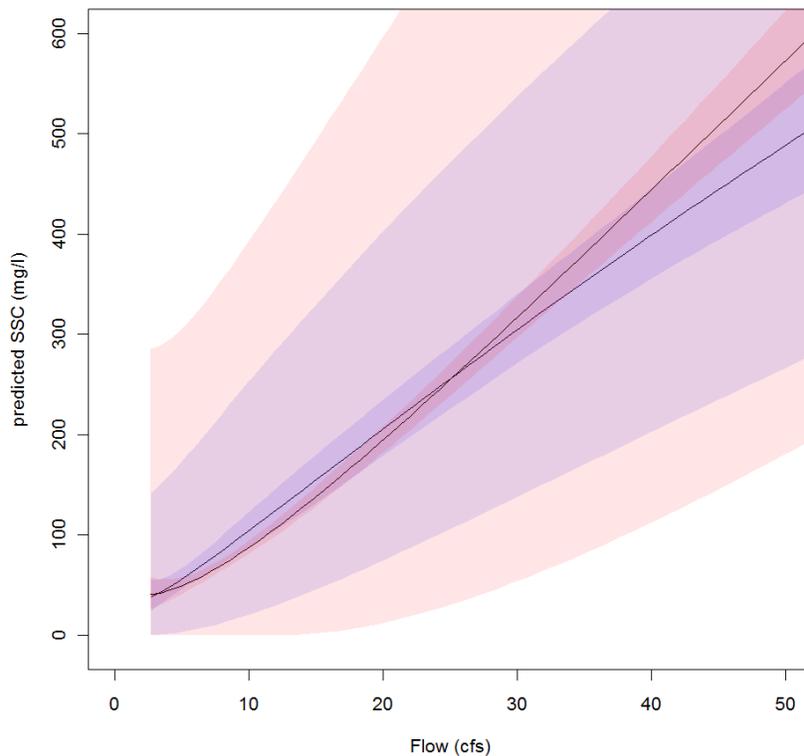
FIGURE 16: WALTERS CREEK PRE- AND POST-PROJECT SUSPENDED SEDIMENT MODELS

Figure 16 displays the pre- and post-Project model results. 95% confidence intervals are indicated by darker bands of red and blue, with lighter shades indicate corresponding prediction intervals for both conditions. The pre-Project data (red) has a very narrow confidence band due to the large sample size but a wide prediction band due to highly variable predicted SSC values. The post-Project data (blue) has a wider confidence band due to smaller sample size and narrower prediction band due to less variability within the post-Project dataset.

The 95% confidence interval bands essentially overlap for the pre- and post-Project datasets. A formal test to compare the model results (considering data for which flow is greater than 2.63 cfs) indicates there is only weak evidence for a difference between pre- and post-Project conditions ().

While there is not a significant difference between the pre- and post-Project conditions, there is some indication of a change in condition at different ranges of flow. At flows between approximately 5 to 25 cfs, the models indicate that SSC concentrations are higher in post-Project conditions. While this may indicate a change of conditions in the watershed, changes in lab methodology (greater recovery of suspended particles) may also be influencing this apparent trend. The appearance of reduced SSC in the post-Project condition at higher flows (greater 30 cfs) may become significant by narrowing of the 95% confidence interval through the addition of more data.

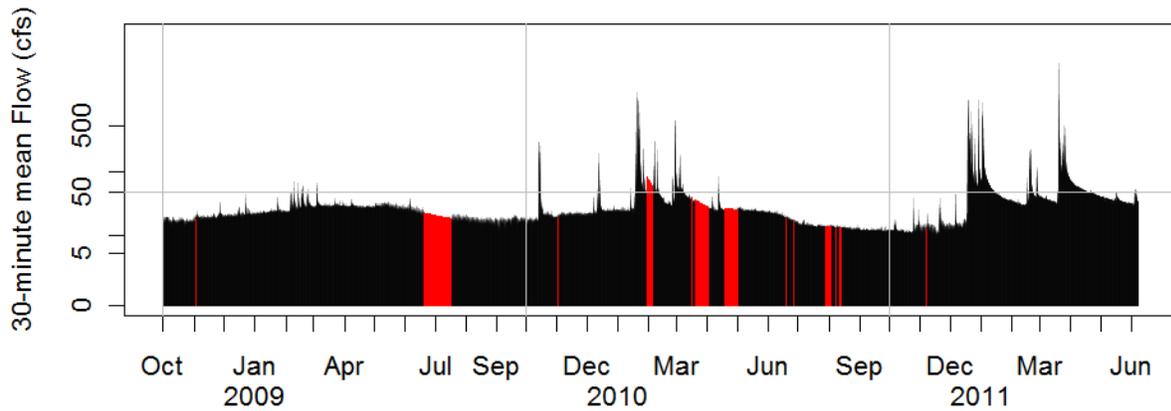
FIGURE 18: CHORRO CREEK, CANET ROAD, DISCHARGE RECORD WITH INTERPOLATION

There were a few instances of equipment failure in the stage height record during the period of analysis. These data gaps were interpolated through a statistical model. The flow record for the analysis period is shown in Figure 18, with interpolated data periods shown in red. This data period includes two complete water years: the 2008-2009 water year (October 1, 2008 - September 30, 2009), and the 2009-2010 water year (October 1, 2009-September 30, 2010). The 2010-2011 water year is shown as incomplete and spans October 1, 2010 through June 8, 2011.

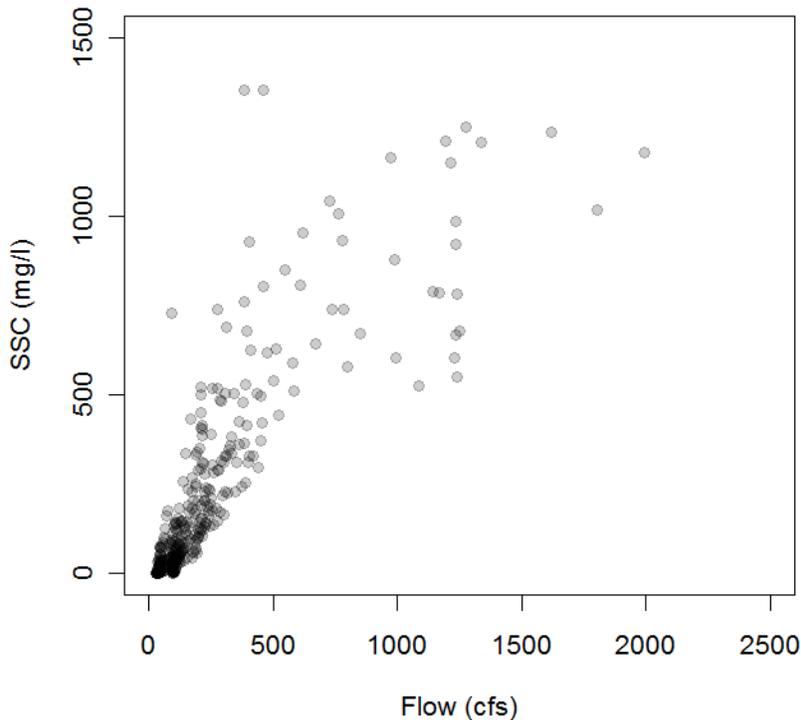
FIGURE 19: CANET ROAD SSC DATASET

The three year data collection effort generated 523 individual records of SSC for the Canet station. Samples were collected on 30 or 60-minute intervals during storm events. The dynamic channel bed morphology of the Canet site resulted in burial of the sampler intake during a few major storm events. To ensure accuracy and rule out samples contaminated by bed-load materials, only samples with SSC less than 1,000 mg/L were included in the following analysis. Of the 523 records collected, 503 met the criteria for inclusion in the model. Figure 19, below, demonstrates the raw data from CAN incorporated into the model.

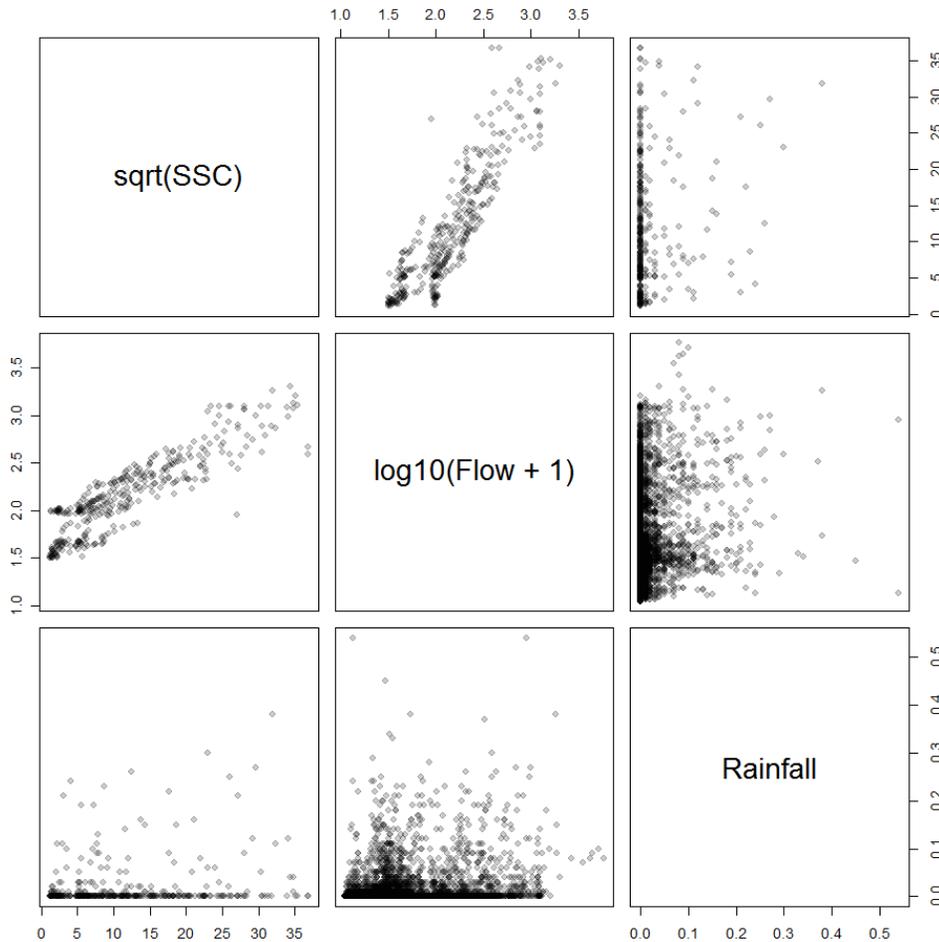
FIGURE 20: DATA TRANSFORMATIONS APPLIED FOR NORMALIZATION OF CANET ROAD DATA

The data was analyzed to identify a reasonable set of transformations for modeling the variables. Transformations were applied to stabilize the variance, achieve linearity (so linear models could be fit), induce normality in the residuals, and balance leverage across the data points so that outlying x-values wouldn't have undue influence on the regression coefficients. It was determined that transformations similar to those used for the Walters Creek dataset adequately normalized the datasets for the Canet station.

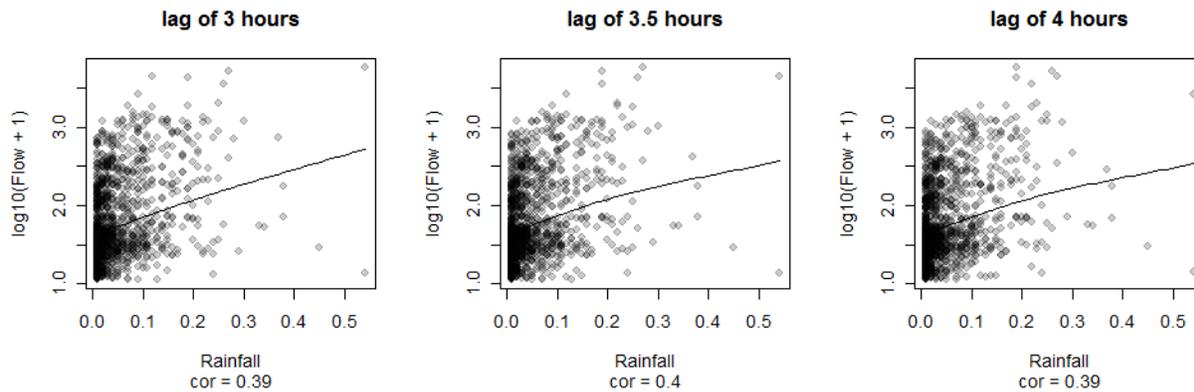
FIGURE 21: CANET RAINFALL AND FLOW VOLUME CORRELATION

The relationship between flow and rainfall was examined for the possibility of inclusion in the model. Surprisingly, there is little apparent relationship between rainfall and stage height recorded at the Canet gauge. The relationship was tested in time intervals of 30 minutes, from 0 minutes of lag time up to 8.5 hours of lag time. Lagged data (Figure 21, with loess smooth curve) suggests that flow may be most highly correlated with rainfall recorded three and a half hours earlier, indicating that it likely takes about three and a half hours for rainfall to maximally impact flow volumes at the Canet station. Ultimately, rainfall was not found to be a useful predictor of suspended sediment and was not included in the final model for suspended sediment load at Canet.

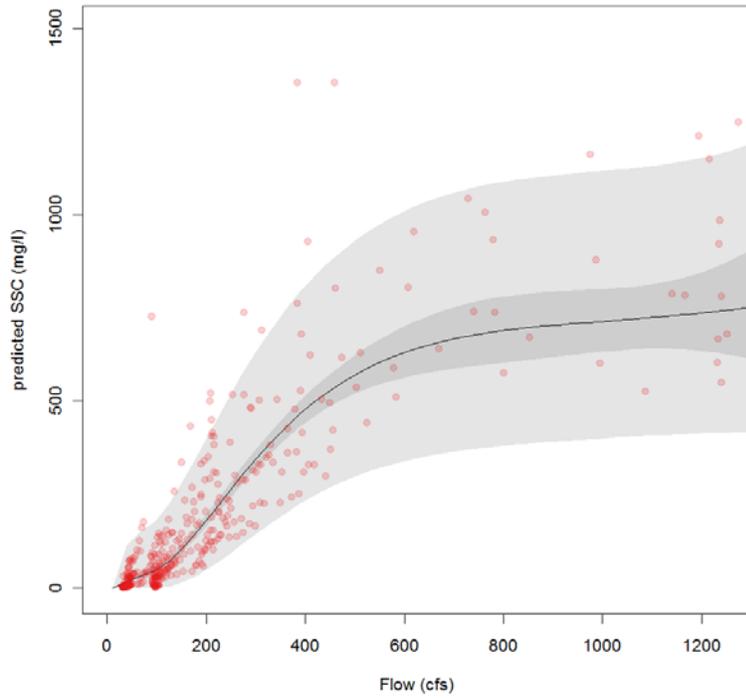
FIGURE 22: SUSPENDED SEDIMENT MODEL, CHORRO CREEK AT CANET ROAD

Initial modeling of the relationship between flow and SSC indicated that higher ordered flow terms were needed. A second-order model (similar to that applied to Walters Creek) was tested with the CAN data. The model indicated a tendency to underestimate SSC for flows in the 100 to 600 cfs range. Additionally, the residuals still showed some curvature indicating that higher ordered terms were needed.

Sequentially including higher ordered terms suggested the use of a 5th order model. A 6th order term was not found to be statistically significant (). While unconventional, the intent to use this as a predictive model suggests that the higher order model may be appropriate. Consideration was given to the concern that a 5th order model would ‘over-fit’ the data. However, graphs of model predictions reveal that this is likely not a concern. This model achieves an adjusted R-sq = 81%.

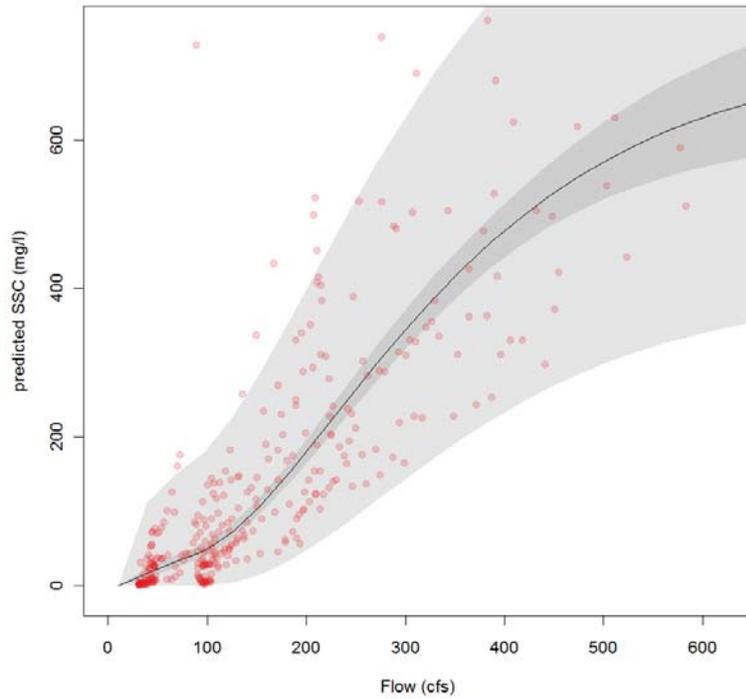
FIGURE 23: SUSPENDED SEDIMENT MODEL, CHORRO CREEK AT CANET ROAD, LOW RANGE

Figure 23 demonstrates the performance and correlation of the model at flows ranging from 0 to 600 cfs.

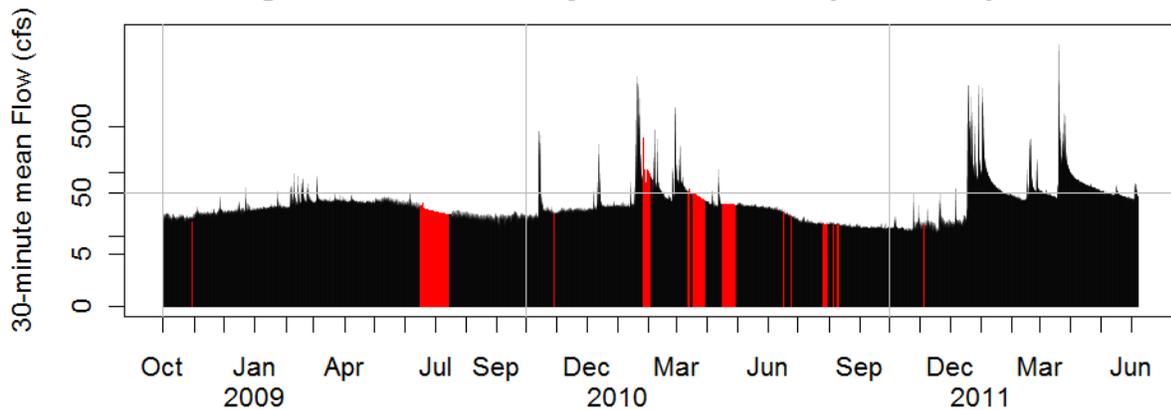
FIGURE 24: CHORRO CREEK DISCHARGE RECORD WITH INTERPOLATION

In the 2008-09 water year, only 6% of the sediment load was transported during conditions where flows were greater than 50 cfs. Due to drought conditions during this year, flows exceeded 50 cfs during only a few short periods. In contrast, during the 2010-2011 water year, 99.7% of the sediment load was transported during flow conditions greater than 50 cfs. There were prolonged periods of flow volumes greater than 50 cfs during the 2010-2011 water year, as indicated in Figure 24.

Data analysis indicated a significant outlier event that took place on March 20, 2011 from 3:00 a.m. to 3:30 a.m. The discharge in this bin was characterized by a peak flow estimate of 5,956 cfs, which exceeds most estimated criteria for a ten-year flood frequency event.

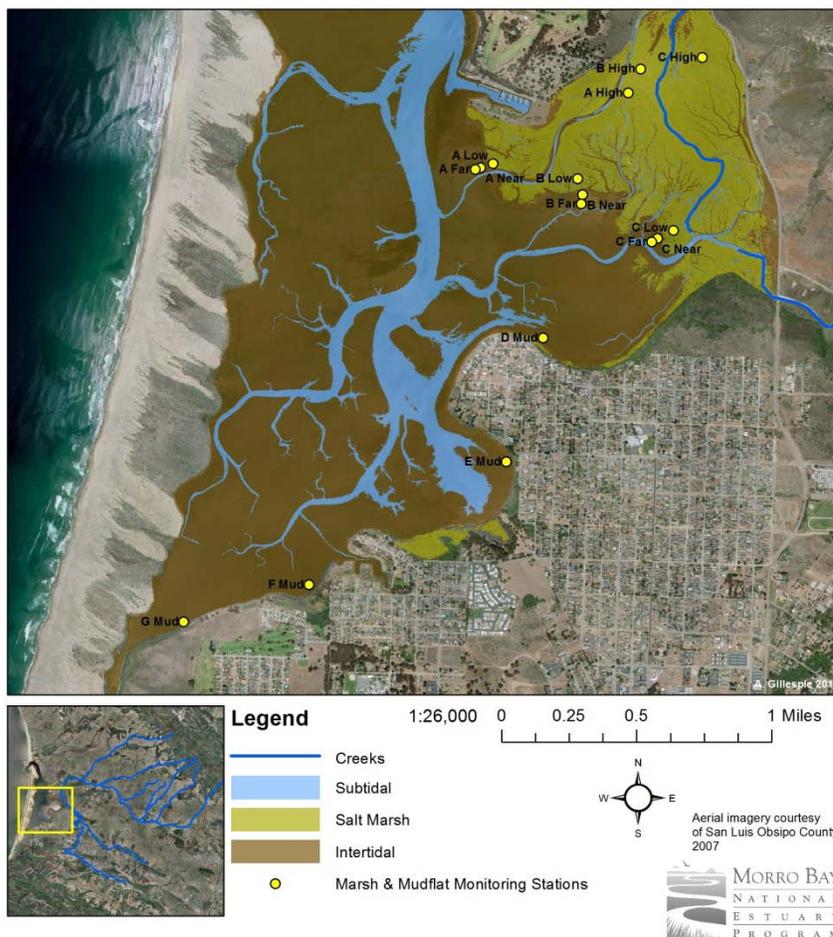
FIGURE 26: MAP OF ALL MORRO BAY SETS & HORIZON MARKERS, SALT MARSH AND MUDFLATS

Six surface elevation sampling stations were established in the salt marsh along three transects (A, B & C) in January of 2004. Additional sampling stations were constructed in the intertidal mudflats at elevations below each of the marsh sampling stations. Four additional mudflat stations were established around the shoreline of the bay in October of 2004. Stations are illustrated in Figure 26.

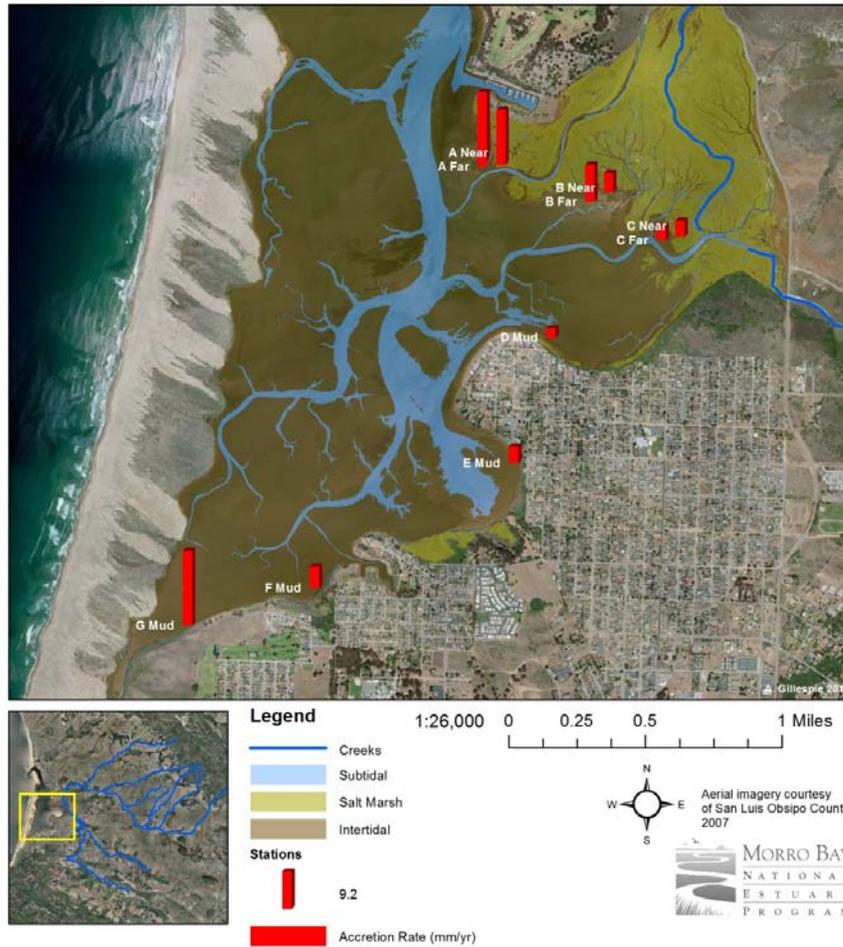
FIGURE 28: MAP OF MUDFLAT MARKER HORIZON ACCRETION RATES

Mudflat marker horizons were used to measure the accretion rate at ten locations. Accretion rates for mudflat stations are shown in Figure 28. Based on measurements of sediment depth relative to the fabric plots, Stations A Far and G showed the highest rates of sediment accumulation, with both stations accumulating over 80 mm of sediment since October 2005. Stations A Near and B Far accumulated over 50 mm of sediment, while all other stations accumulated 30 mm or less. In some cases, these average values are based on a smaller sampling size due to damaged plots.

Annual accretion rates based on these cumulative accumulation values ranged from 2 to 18 mm/yr, with the same trend evident across stations: the highest rates were at G and A Far, with both A Near and B Far also having relatively high rates. For these four stations, annual rates varied from 9 to 18 mm/yr. While these accretion rates are much greater than those measured in the salt marsh, they are not unusually high given the highly dynamic nature of mudflat ecosystems. In addition, the rates measured at the other locations are all in the range of 2 to 5 mm/yr, just slightly exceeding current rates of global sea-level rise and giving no indication of large-scale rapid filling of mudflats in the areas where these sampling stations are located.
