Morro Bay National Estuary Program

Morro Bay Eelgrass Report 2014 to 2016

July 2017

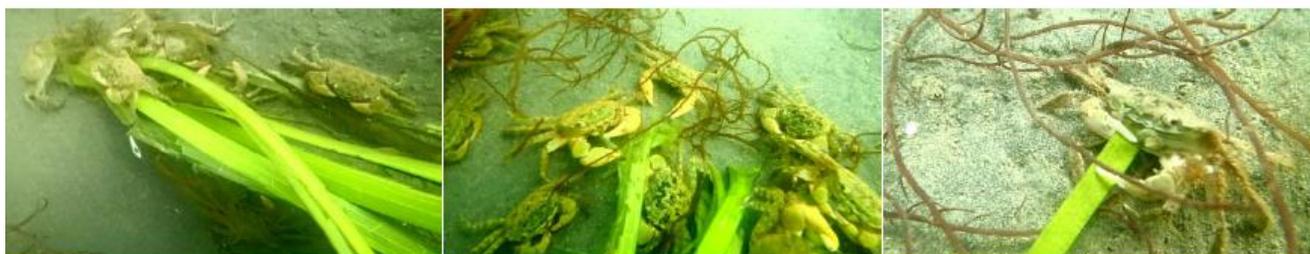
Figure 5. Yellow shore crabs (*Hemigrapsus oregonensis*) cutting and consuming eelgrass blade tissue. Photographs taken within minutes of planting during the 2014 planting effort (Merkel & Associates 2015a).

In August 2014, a third transplanting effort was completed over six days. A total of 8,949 eelgrass units were planted into 45 plots. As in the previous 2012 and 2013 transplants, the plots were laid out as linear arrays 66 meters in length and 3 meters wide, with 200 planting units in each plot. To try to eliminate genetic factors that could be limiting transplant success, rather than collecting from Coleman Beach, eelgrass was collected from the beds along the State Park Marina entrance channel and across from Tidelands Park on the west side of the bay. Although we now know there are no significant genetic differences between eelgrass beds within Morro Bay, per genetic research conducted by Dr. Jenn Yost of California Polytechnic State University San Luis Obispo (Cal Poly). Again, plots were planted in the low intertidal and subtidal zones. While planting in some areas, an interesting observation was made: yellow shore crabs (*Hemigrapsus oregonensis*), not previously identified as a consumer of eelgrass, exhibited aggressive herbivory on the new planting units (Fig. 5). See Appendix A for details on the planting method.

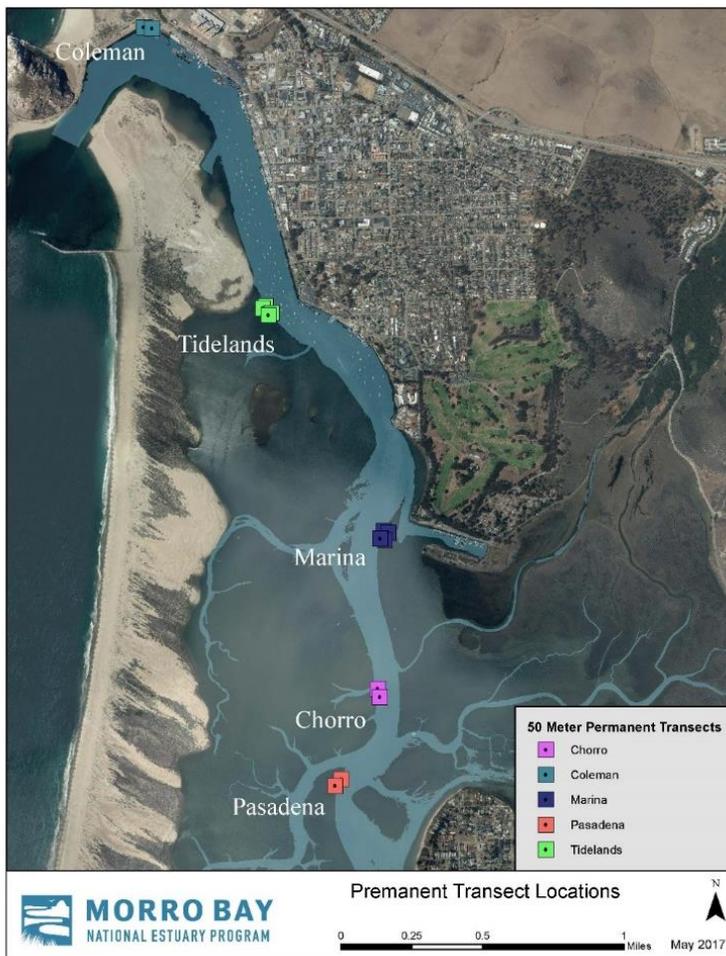
Figure 7. The five current permanent transect monitoring locations.

Permanent transects were established to track eelgrass shoot density annually throughout Morro Bay. There are currently five permanent transects, most having been established in 2005 (Fig. 7). In February 2005, the Estuary Program and Battelle Marine Sciences staff established two transects, across from Tidelands (also known as Reference Bed) and at Chorro Creek. In November 2005, two more transects were established, at Pasadena Point and near Mitchell Lane, and the Chorro Creek transect was moved for better accessibility. In November 2006, a transect at Coleman Beach was established. In 2007, the Mitchell Lane transect was discontinued due to safety concerns. Thus, four transects were monitored annually from 2006 to 2010. No data was collected in 2011 due to staffing logistics. In November 2012, a transect was established near the State Park Marina. Some sites were not surveyed due to poor weather or tide conditions in 2012 through 2016.

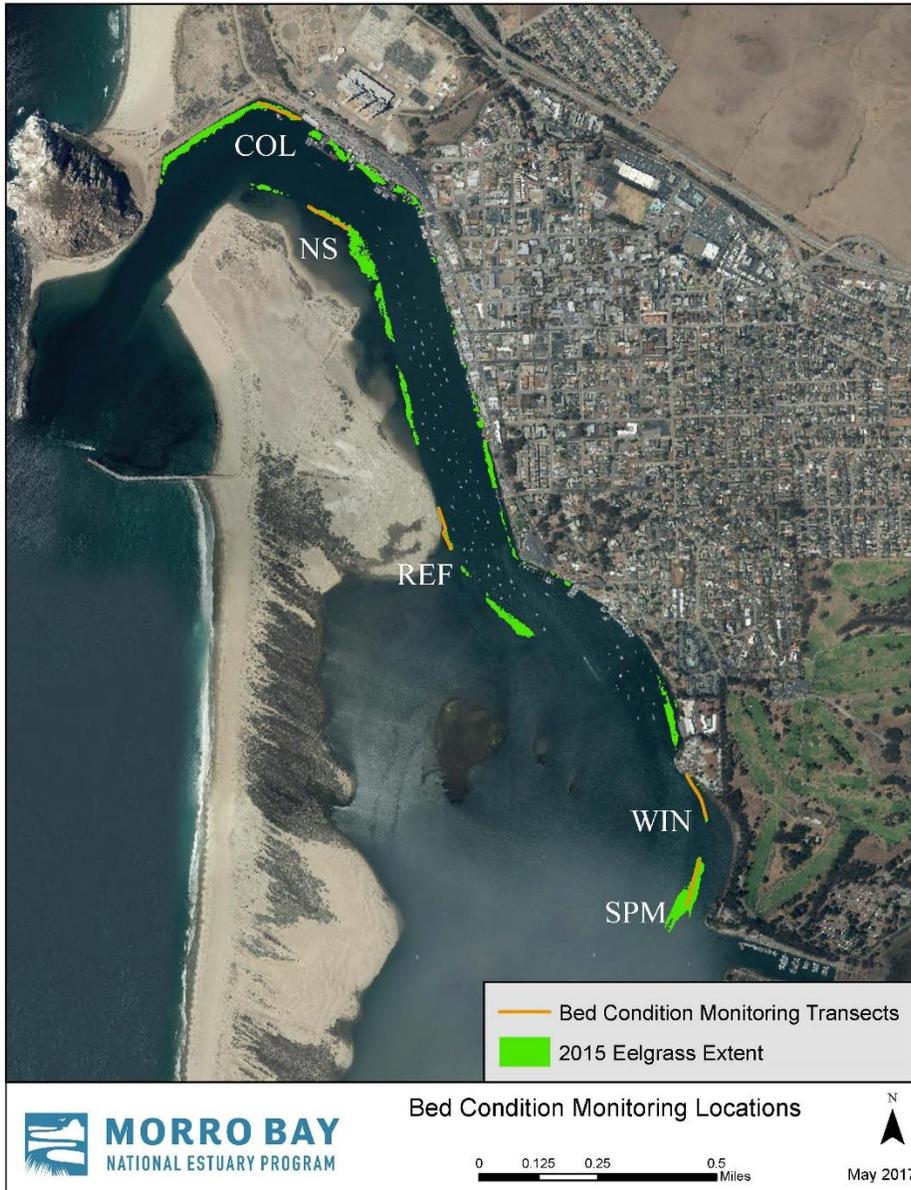
Figure 10. Bed condition monitoring sites.

Intertidal monitoring occurs at four significant eelgrass beds in Morro Bay: Coleman Beach, North Sandspit, Reference Bed, and Windy Cove (Fig. 10). Measurements are taken along a 150 meter, 7 quadrat survey through the bed (if the bed length allows). Ideal tides for intertidal monitoring are below -0.5 feet. A 1 mx1 m quadrat is placed every 25 m to measure eelgrass. Data collected includes eelgrass density, macroalgae and other organism presence, eelgrass blade lengths, diseased spots on eelgrass blades, and overall patchiness of the bed.

Subtidal monitoring occurs at five significant beds in Morro Bay: Coleman Beach, North Sandspit, Reference Bed, Windy Cove, and the State Park Marina (Fig. 10). Measurements are taken in a 150 meter, 7 quadrat survey through the bed (if the bed length allows). Often due to lack of visibility, a less robust data set is measured during subtidal surveys. Data collected includes shoot density and patchiness of the bed.

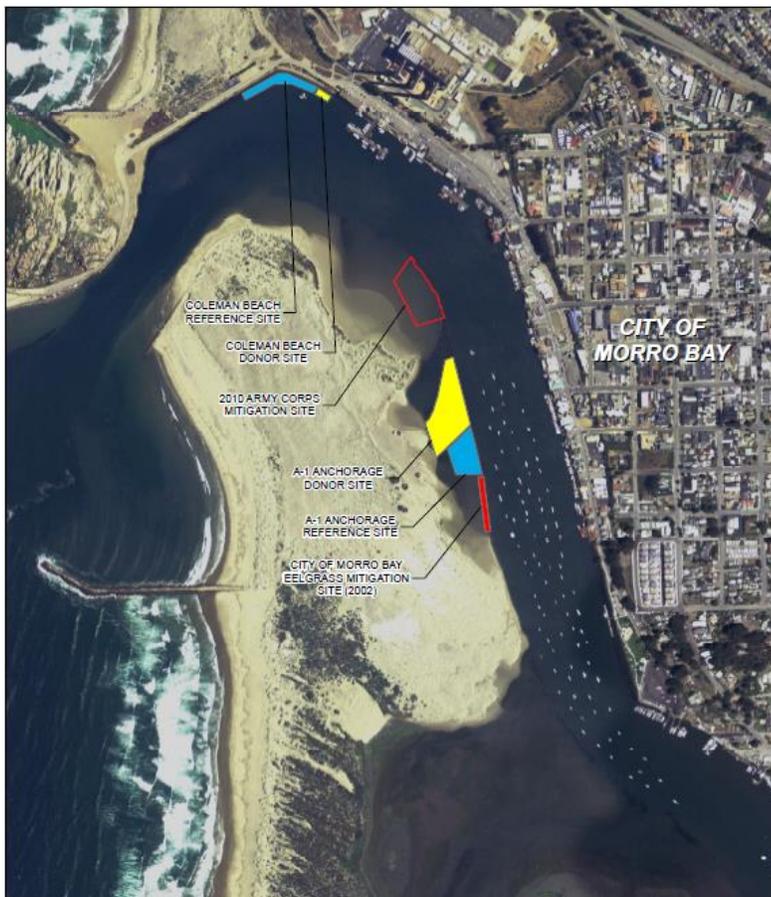
Figure 11. Eelgrass mitigation, donor, and reference sites (Merkel & Associates 2015b).

The 2009-2010 dredge operation resulted in damage to eelgrass, and a mitigation agreement was established between the ACOE and the National Marine Fisheries Service (NMFS) to plant an eelgrass area of approximately 1.74 acres. The final 60-month monitoring report was completed in September 2015 (Merkel & Associates 2015b).

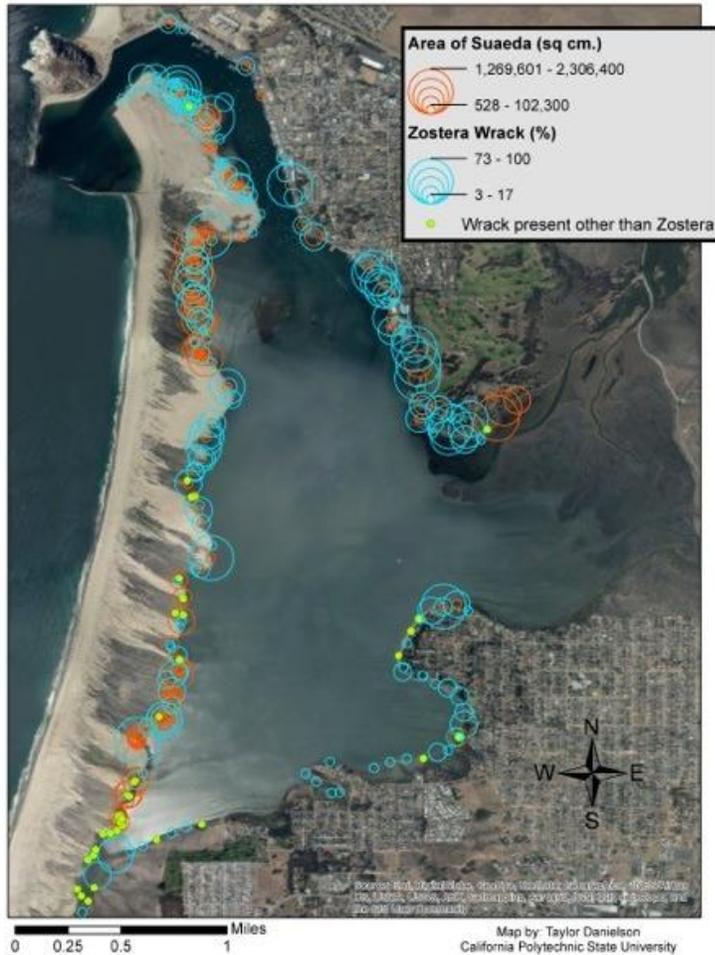
Figure 12. Distributions of *Suaeda* and eelgrass wrack (McKechnie 2017).

In 2016, a team from Cal Poly mapped the distributions of eelgrass wrack and *Suaeda* around Morro Bay (Fig. 12). This map may be used to compare future *Suaeda* distributions as eelgrass populations fluctuate. The experimental component of the study aimed to compare how wrack inclusion vs. exclusion impacted *Suaeda* seedling growth, but it was inconclusive. However, several new *Suaeda* plants were successfully transplanted on the eastern side of the Bay, near Pasadena Park in Los Osos. Matt McKechnie compiled the report of the study for his Cal Poly senior thesis and was assisted by Jennifer O'Leary, Jenn Yost, Kathy Boyer, and students Frances Glaser, Erin Aiello, Kyle Nessen, Taylor Danielson, and Sean Whitlock (McKechnie 2017).

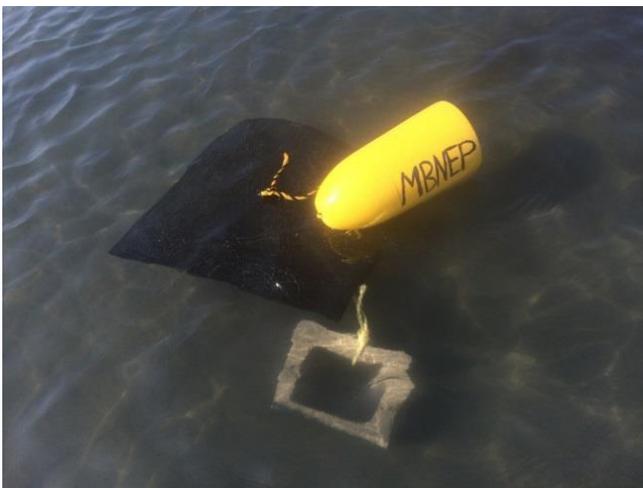
Figure 16. The test seed-bag design: cinder block, attached to oyster bag, attached to a buoy.

The test seed bag design was an oyster bag attached by rope to a buoy on one side and a cinder block on the other. Oyster bags were cut in half and secured by zip ties. Six of these designs were set out around the bay and, after three weeks, four remained intact. One bag was not re-located and one bag lost its buoy. Of the intact bags, many had moved significantly from the original deployment location and *Gracilaria* build up was substantial.

For the future, if this method is used, ample rope should be tied to the bag, buoys should not be Styrofoam, heavier cinder blocks/anchor should be used, and *Gracilaria* build-up on the rope should be regularly removed. Bags should be deployed while sediment is exposed so the anchor can be buried.

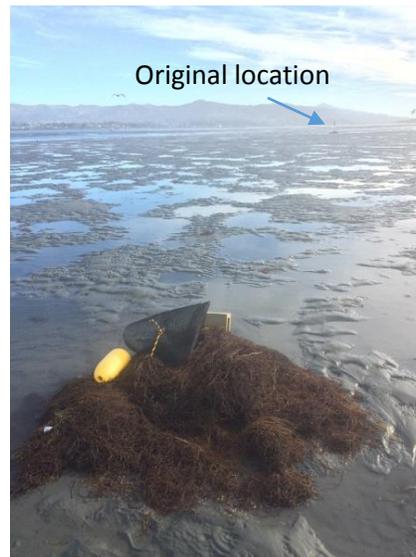
Figure 15. Seed bag unit one week after deployment. Note how far it moved from its original location and the *Gracilaria* build-up.

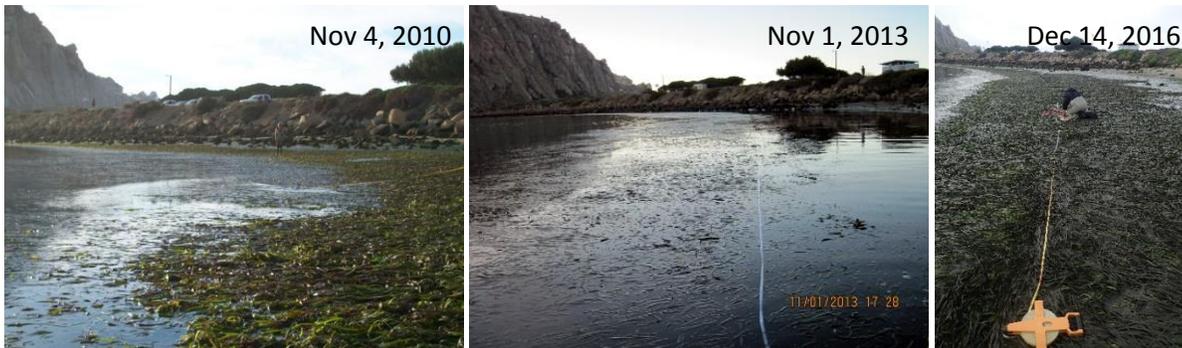
Coleman Transect:

In 2013, it was noted that the eelgrass appeared to be wilted and not as robust as in past surveys. The 2016 density counts show a significant density increase, the highest density observed since 2012.

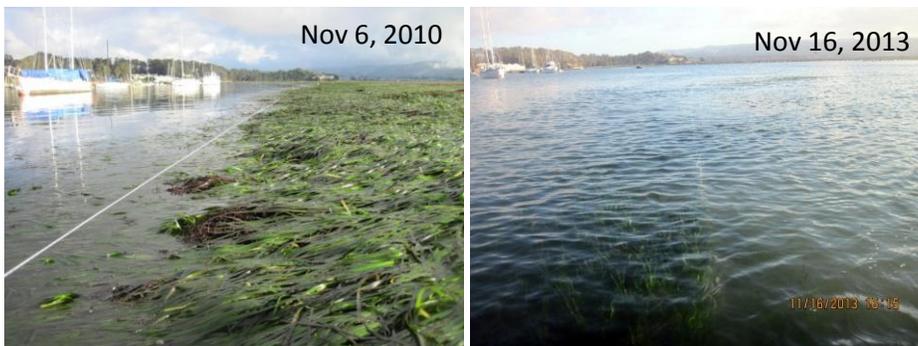
Tidelands Transect:

In 2013, it was noted that due to the shape of the bed, the transect went through a bare area, which decreased the average density counts. However, density was high throughout the bed. In 2016, it was noted that the visibility was poor, but density counts were roughly equal to those from 2013.

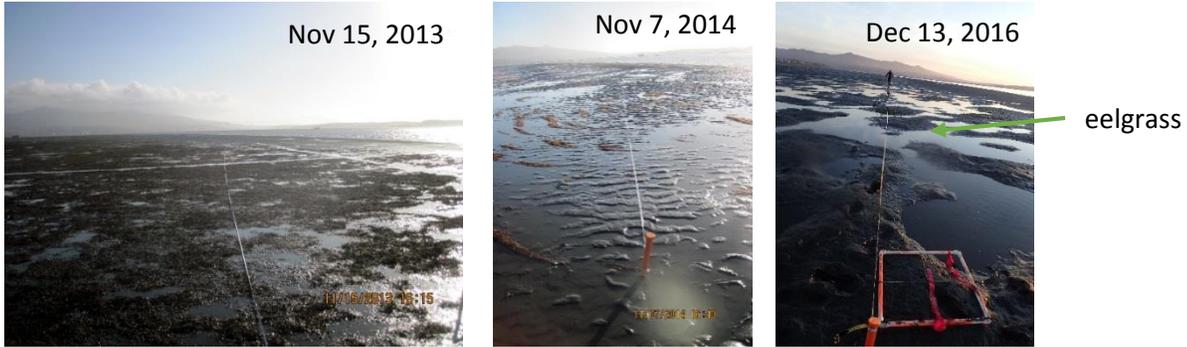
Marina Transect:

Since being established in 2012, there has been minimal eelgrass observed. In 2016, none of the quadrats measured along the transect held eelgrass, but there were two patches of eelgrass on/near the transect (at 8 m and near 47 m). In the general area, there were 31 patches of eelgrass that ranged in size from 0.25 m x 0.25 m to 1 m x 1 m. The survey area had numerous depressions in the mud, likely from bat rays.

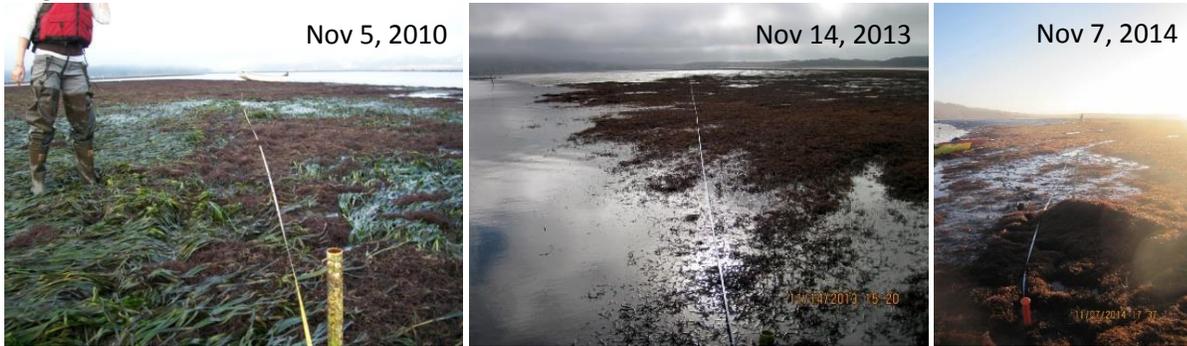
Pasadena Transect:

Eelgrass was present in 2010, but no eelgrass was found in 2012 to 2014. In 2013, mature healthy subtidal eelgrass was noticed near the transect. No data for 2015 to 2016

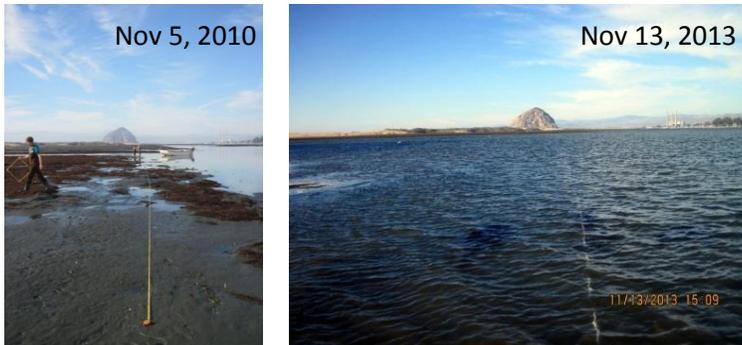
Chorro Transect:

In 2010, eelgrass densities saw a drastic decline from the previous few years. No eelgrass, intertidal or subtidal, was observed in the area from 2013 to 2014. No data for 2015 to 2016.
