Morro Bay National Estuary Program

Morro Bay Eelgrass Report 2017

October 2018

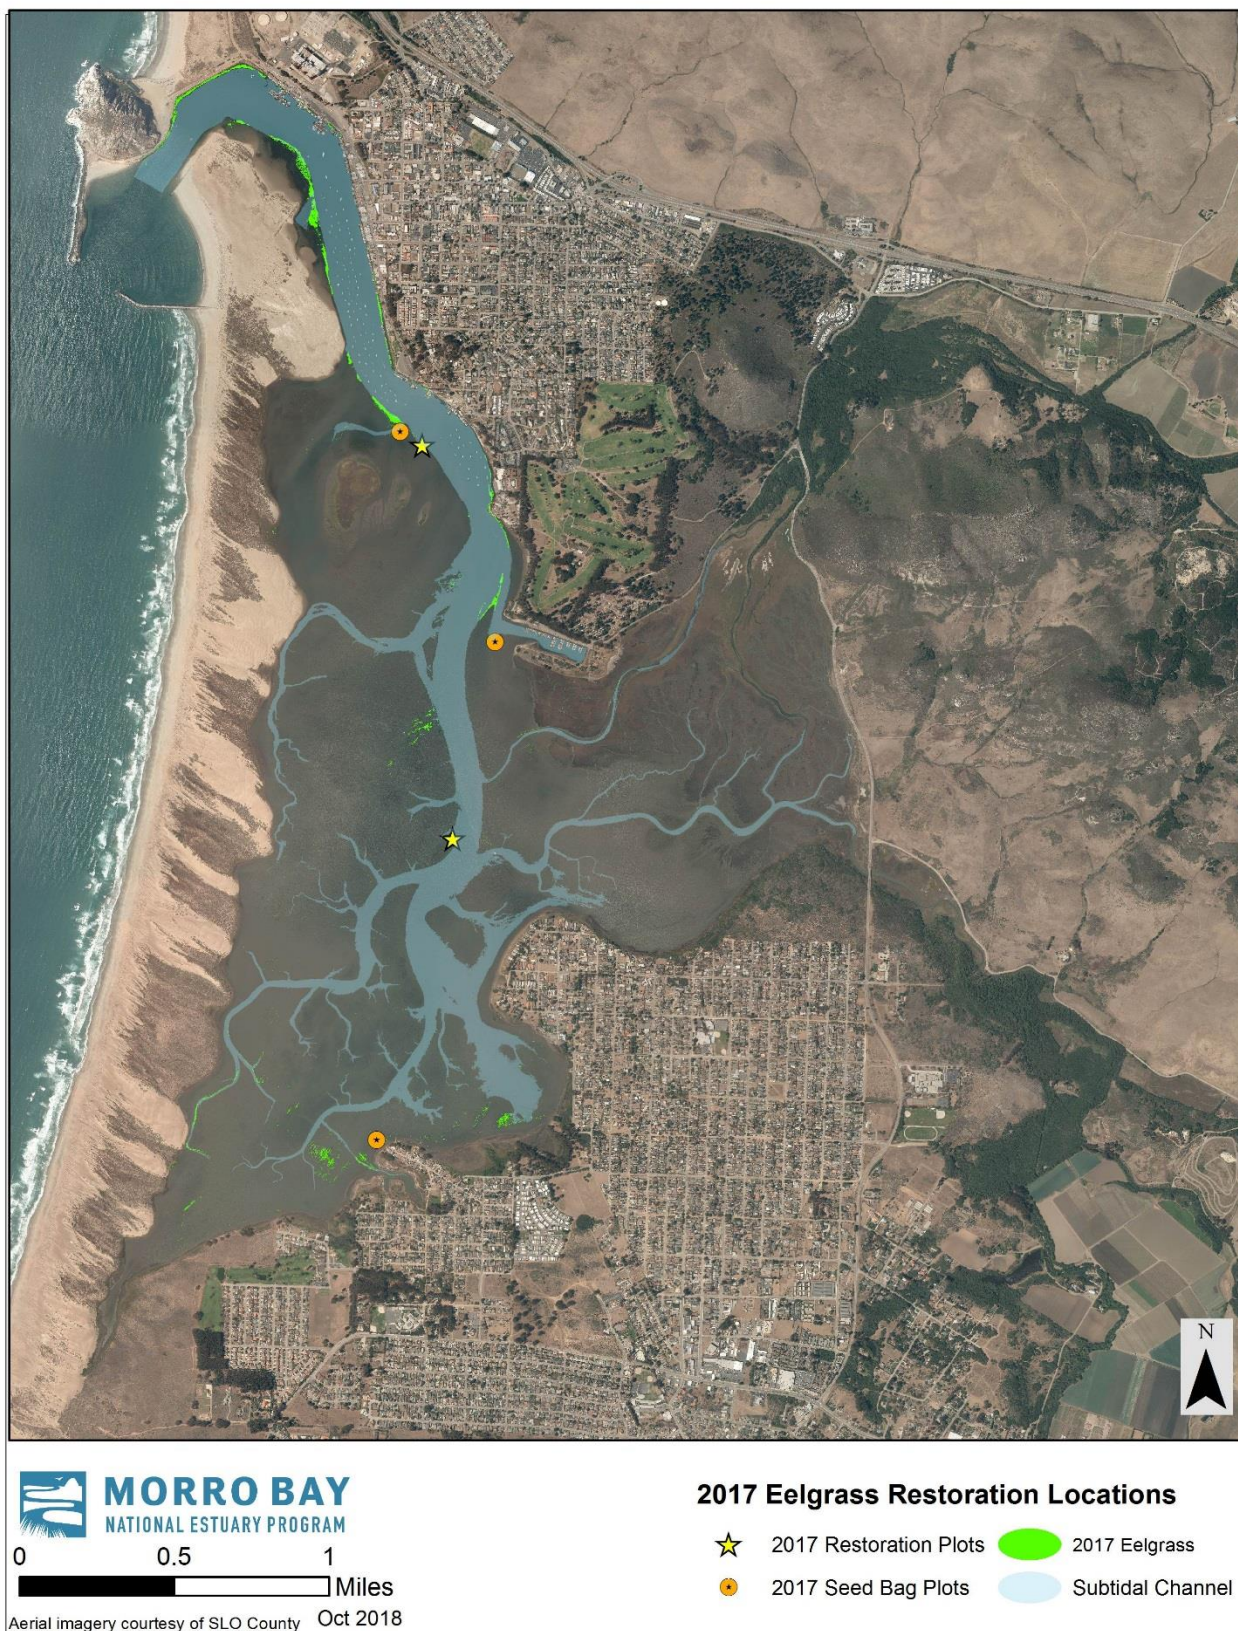
Figure 7. Map with Eelgrass Restoration Locations for 2017.

Transplant: Two transplanting sites were chosen to test eelgrass growth in different environmental conditions where eelgrass has historically been found. At each site, four 1 m x 1 m plots were planted. Each plot had 72 plants, totaling approximately 576 transplanted eelgrass plants for this spring effort. At each site, the plots were within the intertidal or low intertidal zones, and placed at least 4 m apart at a similar elevation profile. See Figure 7 for the transplant locations.

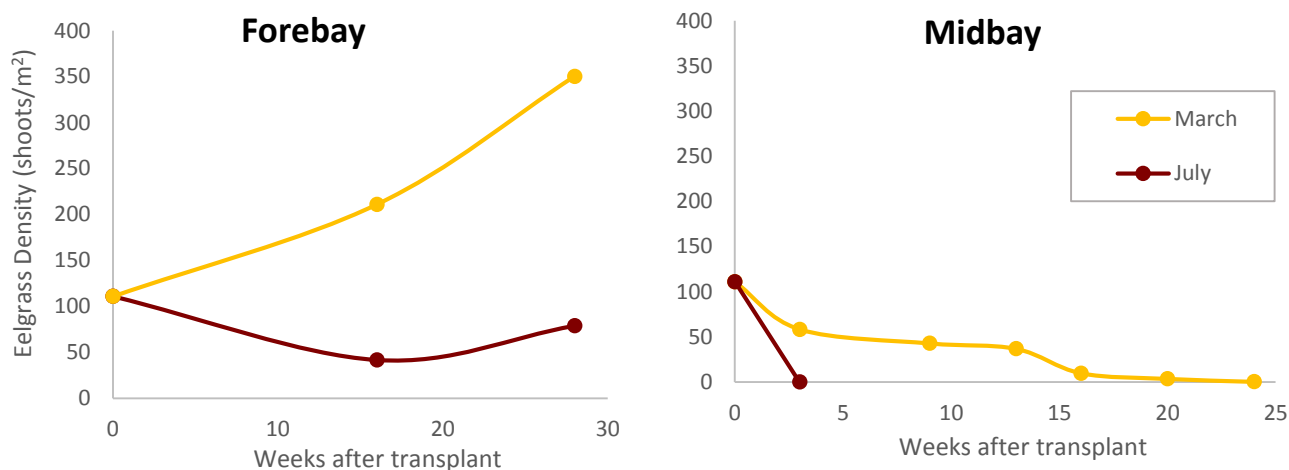
Figure 8. Eelgrass shoot densities (shoots/m²) for the March and July transplants in the forebay and midbay (Aiello, in preparation).

The spring and summer transplant plots were monitored every month by Cal Poly graduate student, Erin Aiello, to measure blade length and shoot density and to take photographs. When comparing locations, the forebay site was much more successful than the midbay site (Figure 8). When comparing seasonality, there was overall more success in March compared to July.

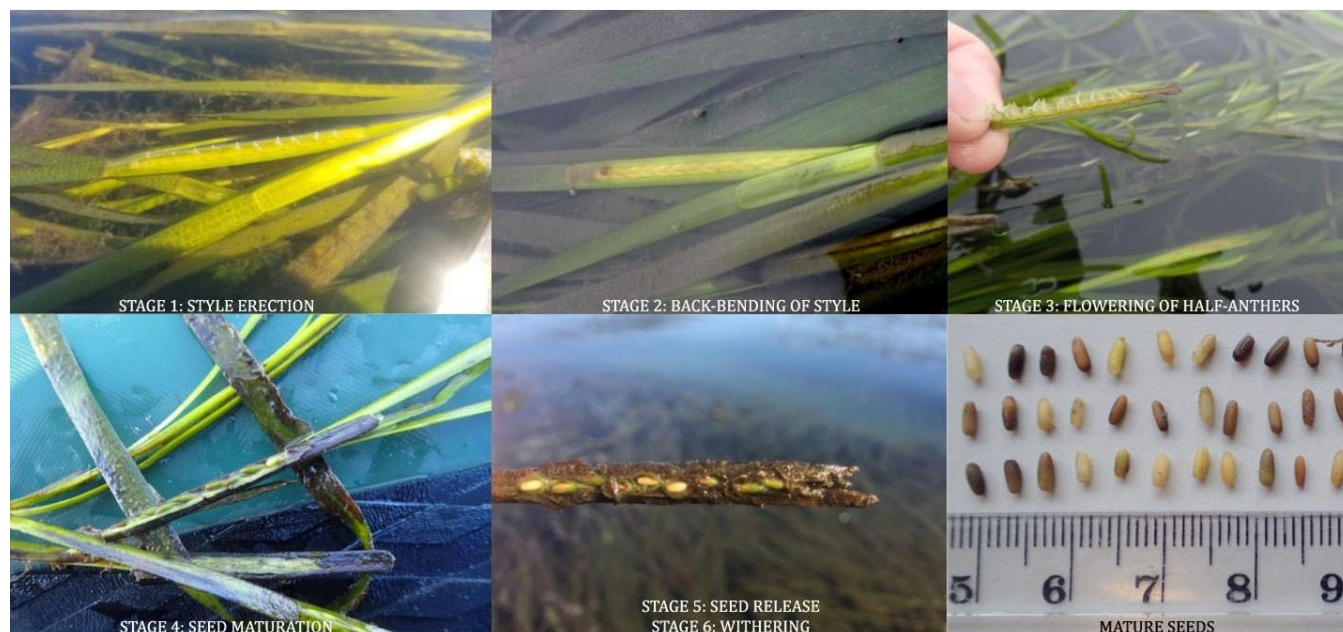
Figure 9. Stages of eelgrass flowers and seed production in Morro Bay (Adapted from materials by M&A).

In June 2017, the Estuary Program began monitoring eelgrass beds for flowers every other week. Standup paddleboards were used to access the majority of the forebay beds during mid to high tide windows. Total flowering shoot counts were recorded in a 1 m x 1 m quadrat and the various stages of each flowering shoot were recorded (Figure 9). Anecdotal evidence from Erin Aiello suggests that some beds began flowering as early as May, but densities of flowering shoots were approximately 1 to 5% of the beds monitored. Beds began flowering in higher densities in early July and into August and, of those flowering shoots, most contained seeds in stages 2 or 3. Each flowering shoot often had multiple blades containing seeds, and though they occurred on the same shoot, many blades were in various stages of seeding.

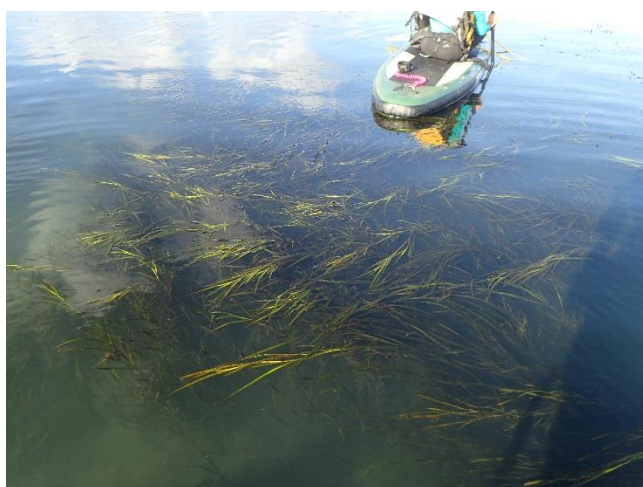
Flowering shoots floating at water's surface

Eelgrass beds were checked periodically for seed development and availability in 2015 and 2016. While it was once thought that Morro Bay eelgrass beds flowered in July and August because this is the case in other estuaries, some beds were found to have flowering shoots with a range of developmental stages in September and October. More observations were necessary to understand the exact flowering timeframe.

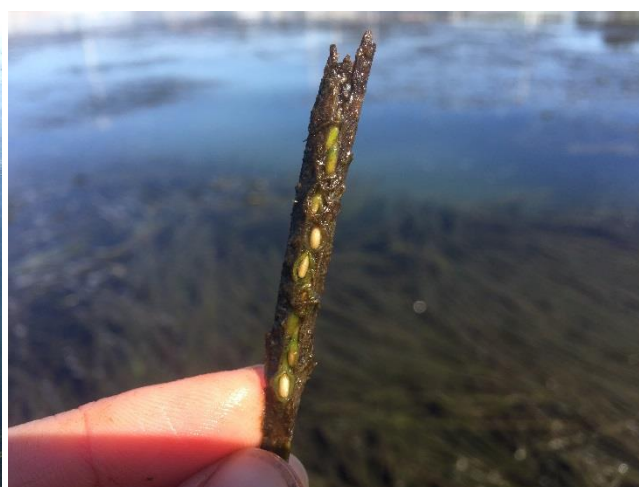
Seeds in a collected blade

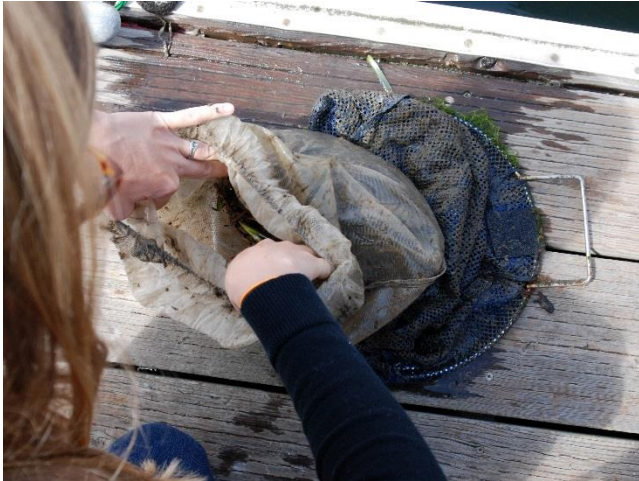
The flowering shoots held in mesh bags

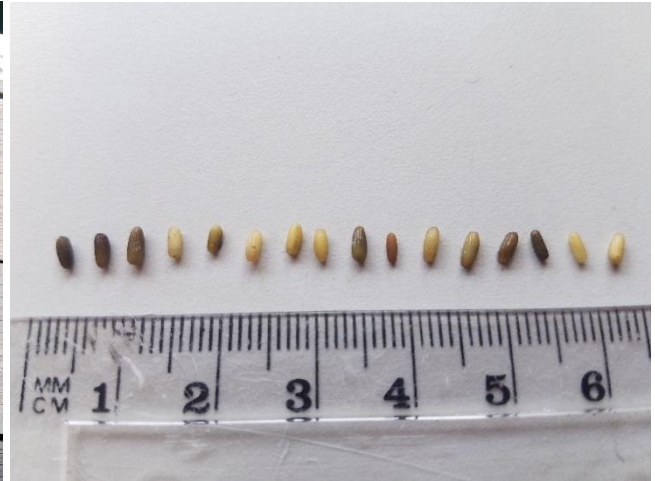
Eelgrass seeds

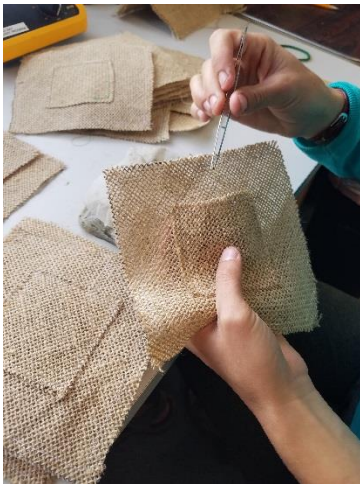
Seeds put into burlap packets

Small 2" burlap packets were created with a 1" border to be used for staking the packet to the sediment with garden staples. Using tweezers, ten seeds were inserted into each burlap packet and then the bag was stapled shut. Seed bags were planted at each of the following locations: the forebay north of the 2017 restoration plots, State Park Marina, and the backbay off Mitchell Drive. See Figure 7 for locations. At the three planting locations, fifteen burlap packets were staked into the sediment evenly spaced within a 1 m x 2 m plot. Plots were marked with small PVC poles at all four corners. Additionally, some extra seeds were scattered directly into the sediment (2 to 3 cm deep) by hand in a plot in the backbay.

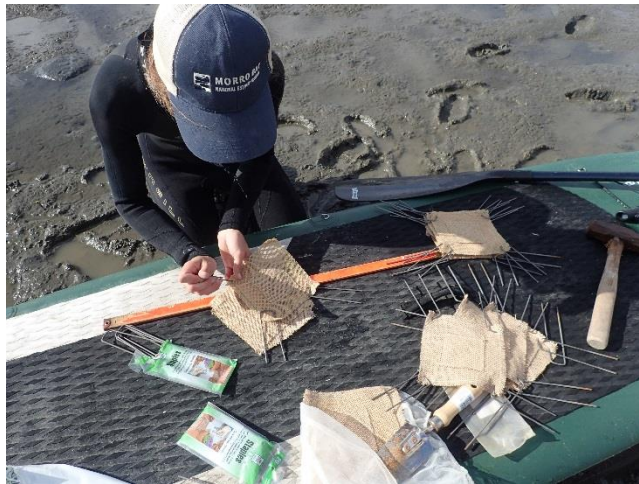
Burlap packets prepared for deployment

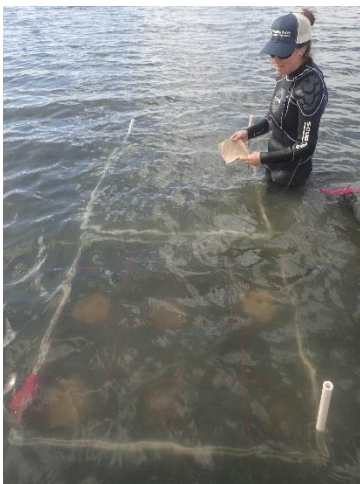
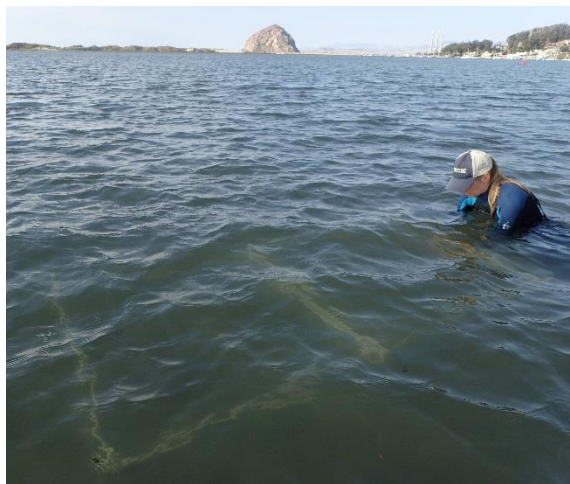
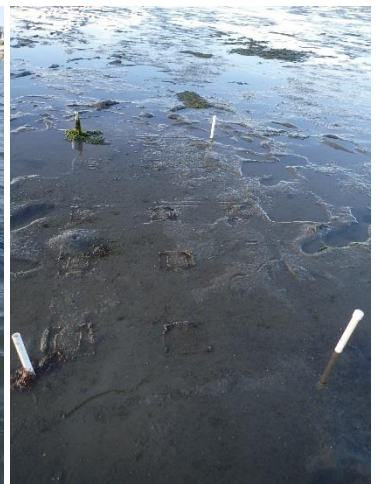
Bags deployed at forebay (left), State Park Marina (center), and backbay near Mitchell Drive (right).

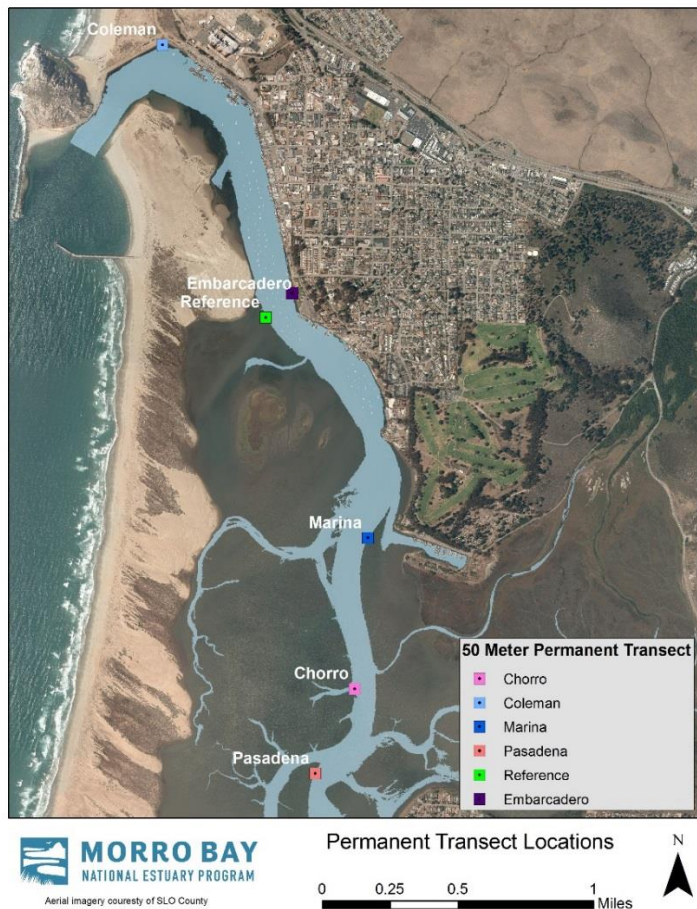
Figure 10. The six current permanent transect monitoring locations.

Permanent transects were established to track changes in eelgrass shoot density throughout Morro Bay. There are currently six permanent transects, some having been established as far back as 2005. Four transects (Coleman, Reference, Chorro, Pasadena) were monitored annually from 2006 to 2010. No data were collected in 2011 due to staffing logistics. In November 2012, a fifth transect was established near the State Park Marina. Some sites were not surveyed due to poor weather or tide conditions from 2012 to 2016. In December 2017, a new transect was established on the eastern side of the channel at Tidelands Park ("Embarcadero"). Note the transect now called "Reference" was originally named "Tidelands" and has been changed to avoid confusion.

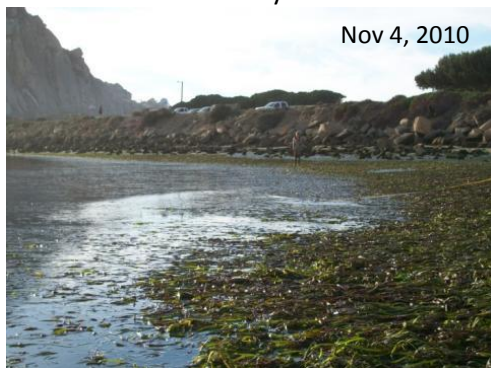
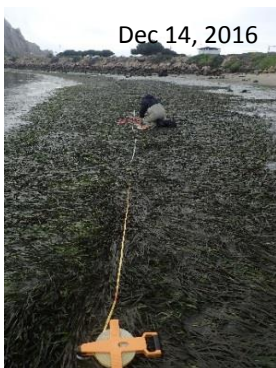
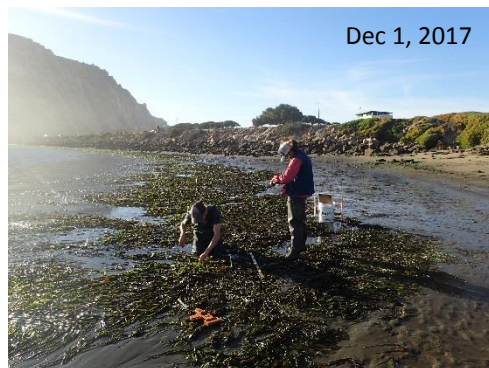
Coleman Transect

The 2017 shoot density counts were almost identical to the 2016 counts.

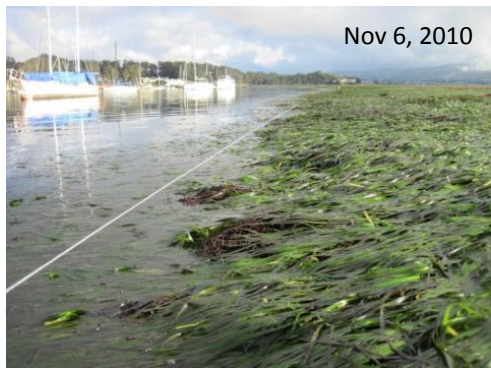
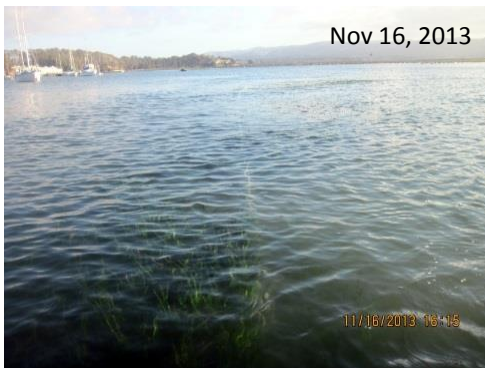
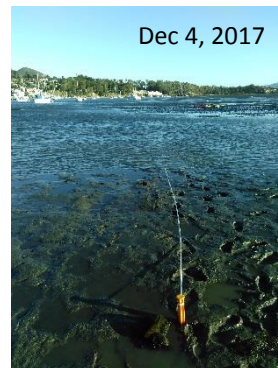
Reference Transect

Previously known as "Tidelands." While there was no eelgrass on the completed transect, a large eelgrass bed was located within several meters. A PVC stake in the bed, presumably marking the main transect, was very deep and likely measuring subtidal eelgrass instead of intertidal. Due to site conditions, this deeper transect was not monitored.

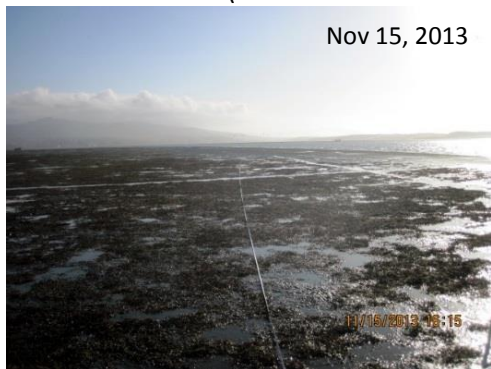
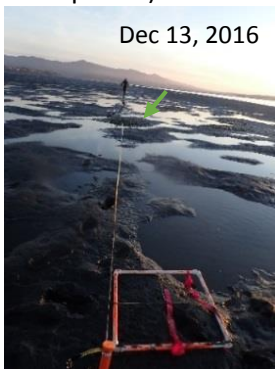
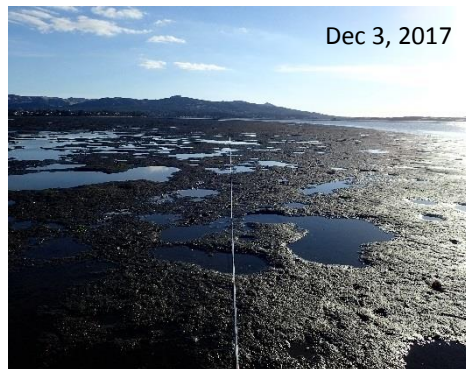
Marina Transect

While there were numerous eelgrass patches observed in the area in 2016, no eelgrass was found in the 26 m x 50 m area in 2017 (all three transects were completed).

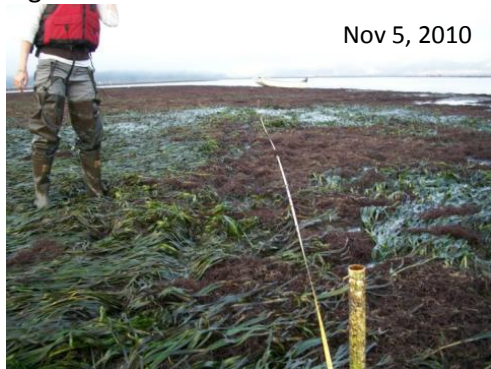
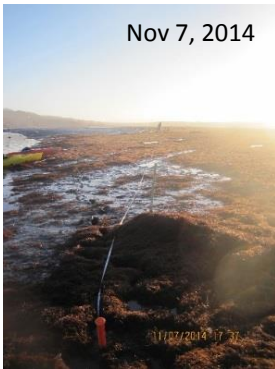
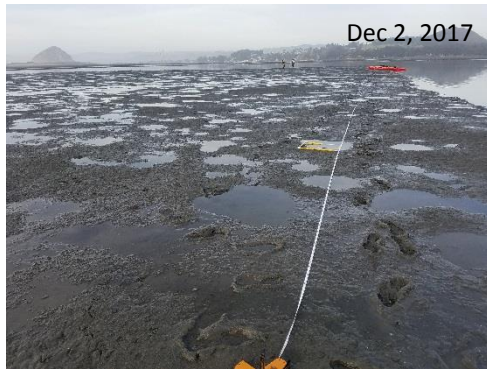
Pasadena Transect

There was some confusion over the location of the transect as the area had not been surveyed since 2014. One transect was monitored based on the markers in the field, and two were identified using maps from 2014. None of the transects had eelgrass, but some small patches ranging in size from 0.0625 m² to 0.25 m² were found higher on the mudflat.

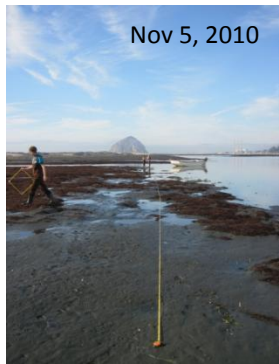
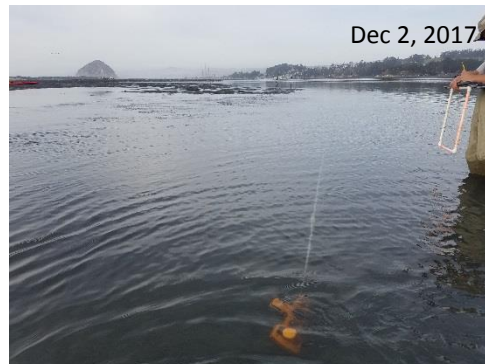
Chorro Transect

The area was last surveyed in 2014 and no eelgrass, either intertidal or subtidal, was found. In 2017, no eelgrass was found on the transect, but two small patches were found in the area.

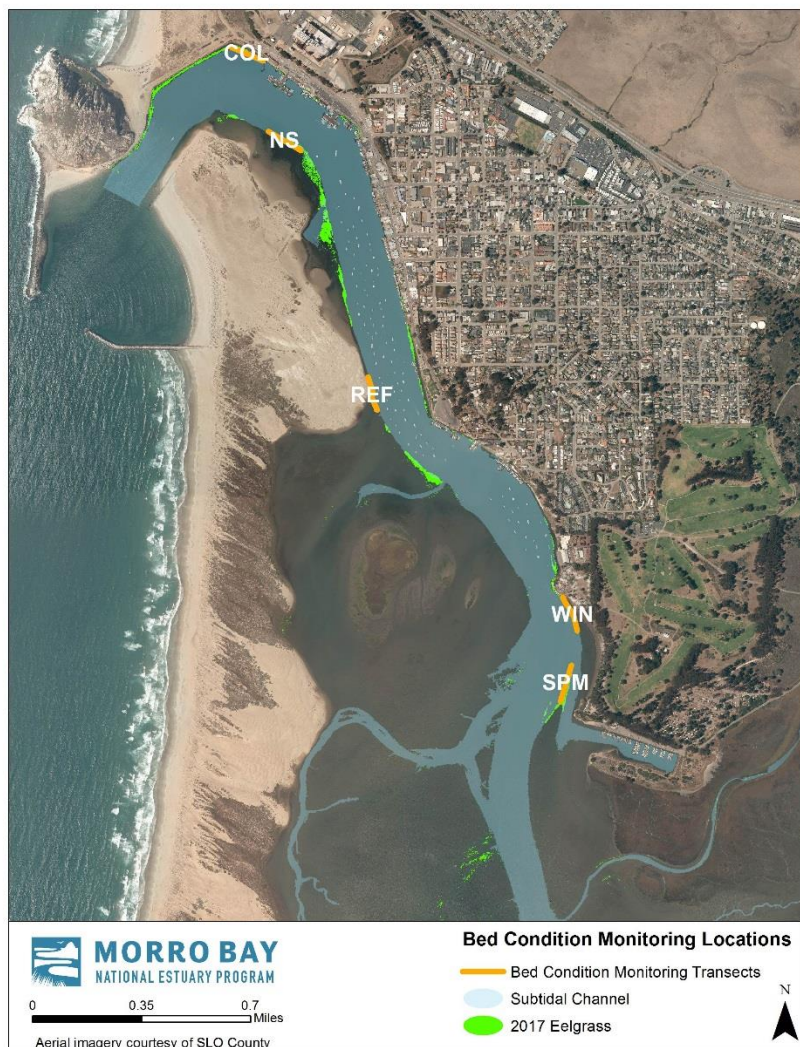
Figure 12. Bed condition monitoring sites: Coleman Beach, North Sandspit, Reference Bed, Windy Cove, and State Park Marina.

As eelgrass declined, a new method of monitoring the remaining eelgrass beds was needed to supplement the permanent transects. Bed condition monitoring was established as a joint effort between Dr. Jennifer O'Leary and the Estuary Program in late 2015. This method measures eelgrass condition in terms of density, blade length, evidence of necrotic tissue, and competition with other algae and organisms. Monitoring occurs at five significant beds in Morro Bay along a 150-meter, 7-quadrat survey. Both intertidal and subtidal eelgrass are surveyed, as so much of the intertidal eelgrass is gone. Monitoring has occurred twice per year since 2015, once in late fall and again in the spring. The plan is to continue this monitoring in future years. This work is being supported by California Sea Grant and by a grant from the Pacific States Marine Fisheries Commission (PSMFC).
