Sediment Monitoring Report for 2017 and 2018 Water Years

Morro Bay National Estuary Program
601 Embarcadero
Morro Bay, CA 93442

March 16, 2020

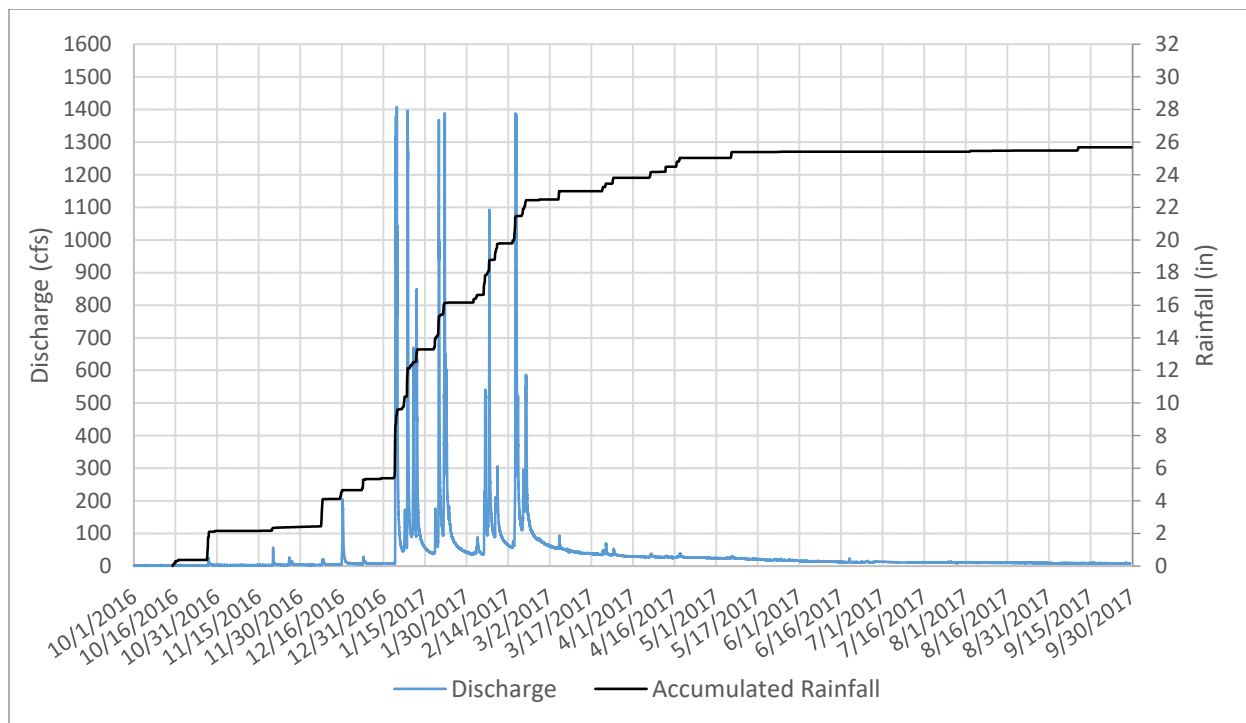
Figure 12: Hydrograph and precipitation accumulation at CAN for WY 2017

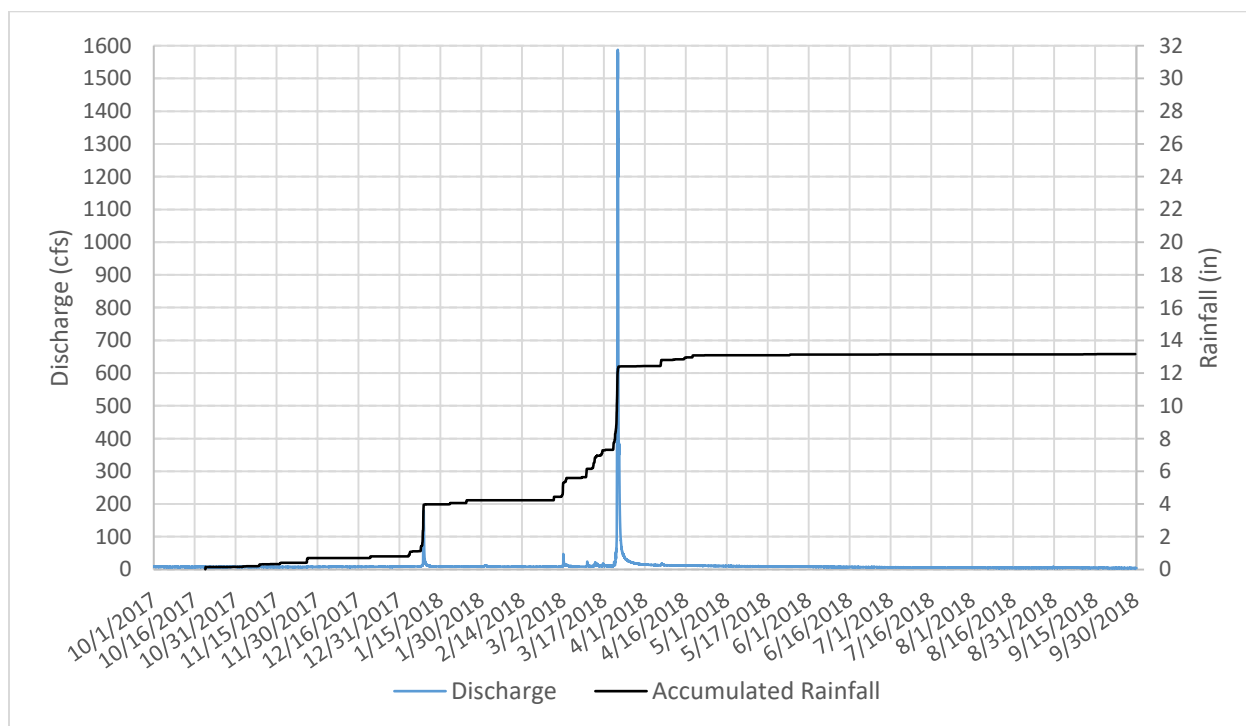
Figure 13: Hydrograph and precipitation accumulation at CAN for WY 2018

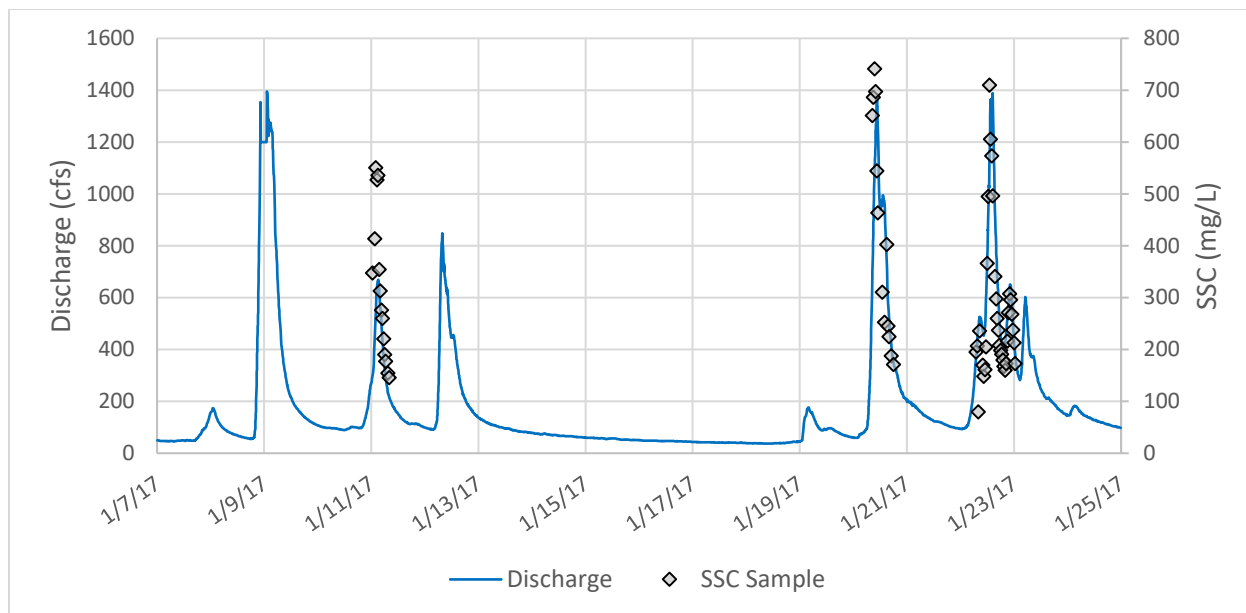
Figure 14: All processed WY 2017 sediment samples and the corresponding hydrograph for Canet Road

In total, there were 60 suspended sediment samples analyzed for WY 2017, all from January 2017 (Figure 14).

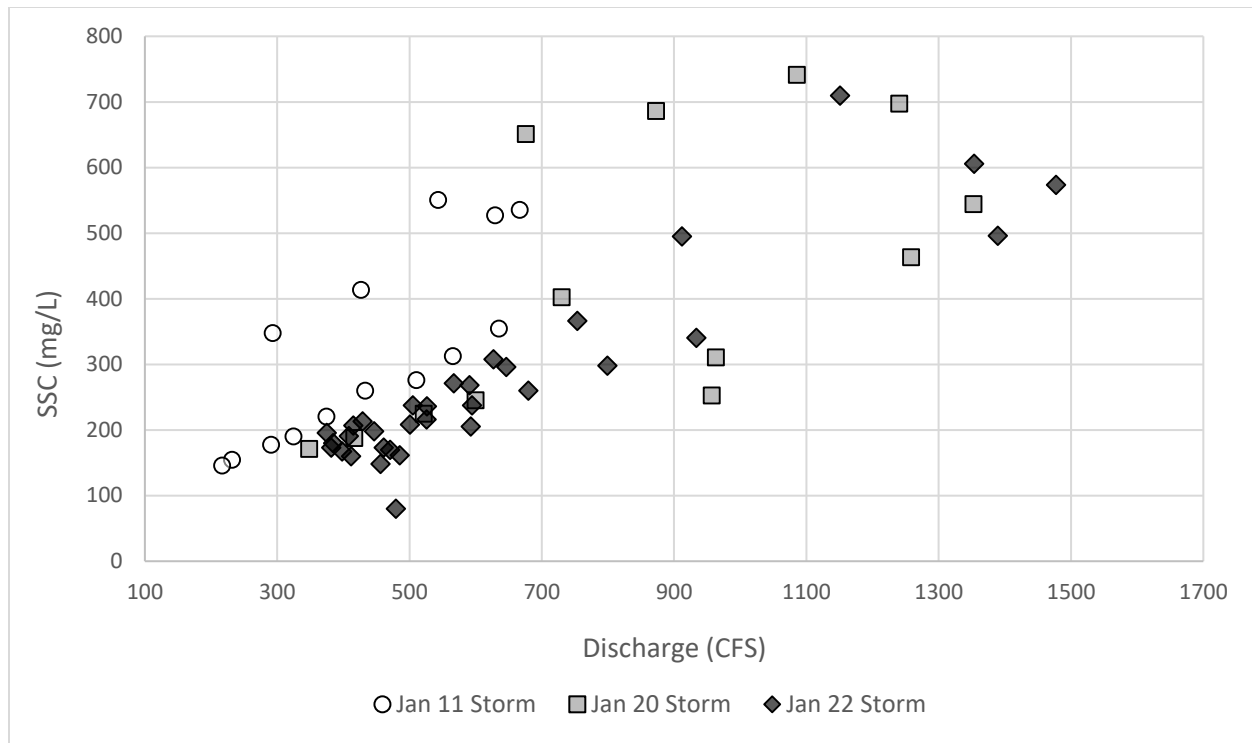
Figure 15: Plot of all WY 2017 SSC measurements and corresponding discharges at Canet Road

The correspondence of SSC with discharge was variable between these storms. The wide distribution of SSC-Q relationships made a single water year regression a poor predictor of sediment load (Figure 15).

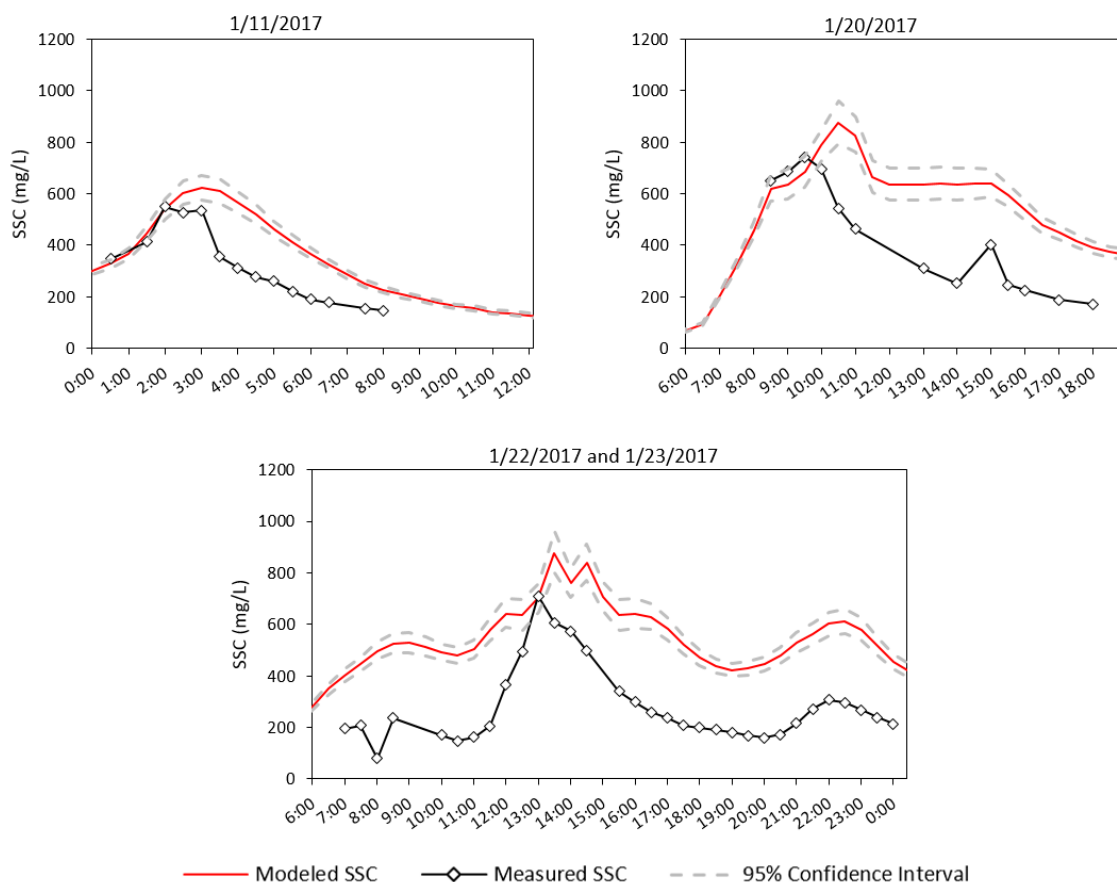
Figure 16: Comparison of measured SSC values with SSC values predicted by the model at Canet Road

The sediment samples taken during these storms can be compared to the calculated sediment load generated by the predictive model (Figure 16).

The actual results and modeled results resembled each other in the shape and slopes of their graphs, but the totals were quite different. The model is not capable of predicting effects such as sediment hysteresis, which may explain fluctuations in sediment load that do not correlate with discharge. Sediment hysteresis is the nonlinear relationship between discharge and SSC that results when different sediment fluxes occur at the same discharge. It can be caused by a delay or advancement of sediments into the water column at a rate that is different than the simultaneous increase or decrease in streamflow. Sediment hysteresis is strongly affected by the soil water content of the catchment area for the sampling site, which also varies significantly from year to year in Mediterranean climates (Seeger et al., 2004). Furthermore, the predictive model is based on several years of data, whereas the measured data from 2017 represents only one water year. This could be interpreted to mean that these January storms in 2017 had a lower-than-average suspended sediment load and that the sediment supply was less than in other years that have been studied by the Estuary Program. The numerical totals for the predictive model's estimates are compared to the Estuary Program's measured values in Table 5.

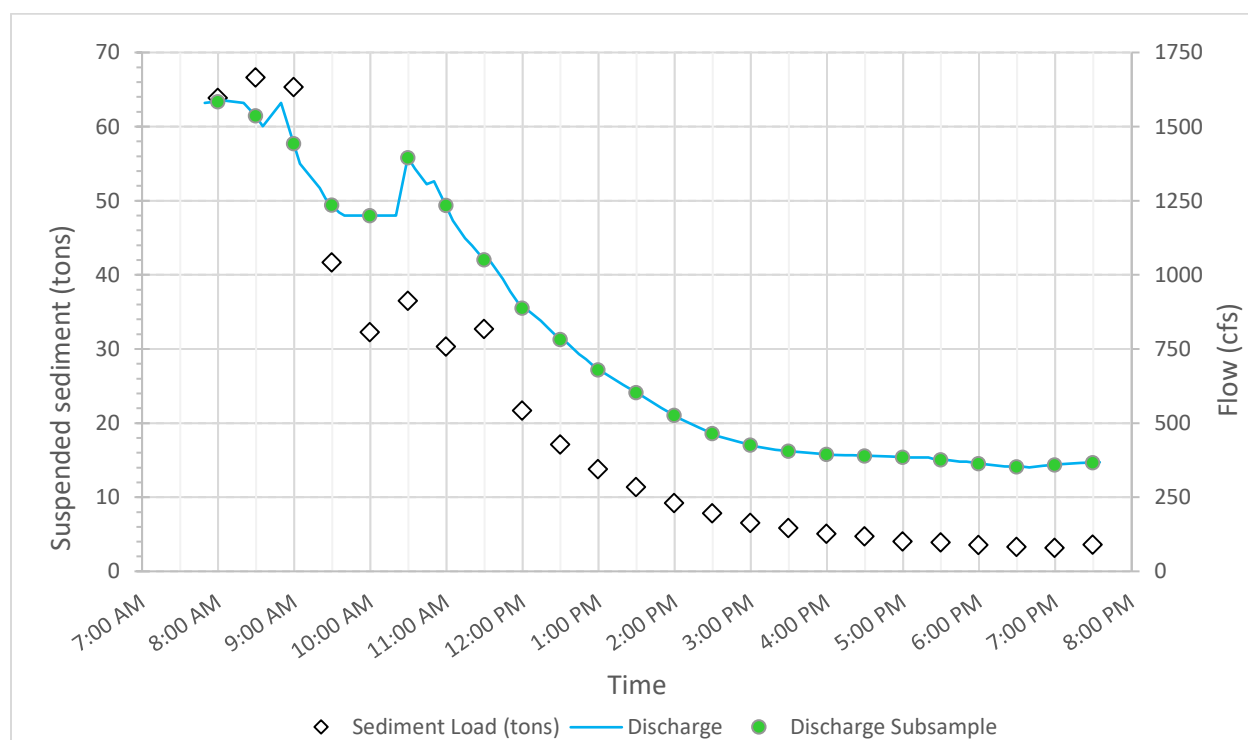
Figure 17: Sediment loading graph during March 22, 2018 storm at Canet Road

Note that the sampling rates of the ISCO sediment sampler and the water level gauge are not identical, so water level was interpolated to match the intervals of the ISCO sampler. Interpolation

The SSC results of the storm monitored on March 22, 2018 were extrapolated to the entire stream discharge during the monitoring event, as shown in Figure 17. Discharge subsamples (green) are the instantaneous discharge values that were used to calculate the mass of sediment and extrapolated to the half hour interval until the next sample was collected. The peak flow rate was 1,587 CFS, and the maximum sediment concentration was 806.3 mg/L during this sampling event. Each point plotted on the sediment load series represents the total mass of sediment estimated for a half-hour block of time.

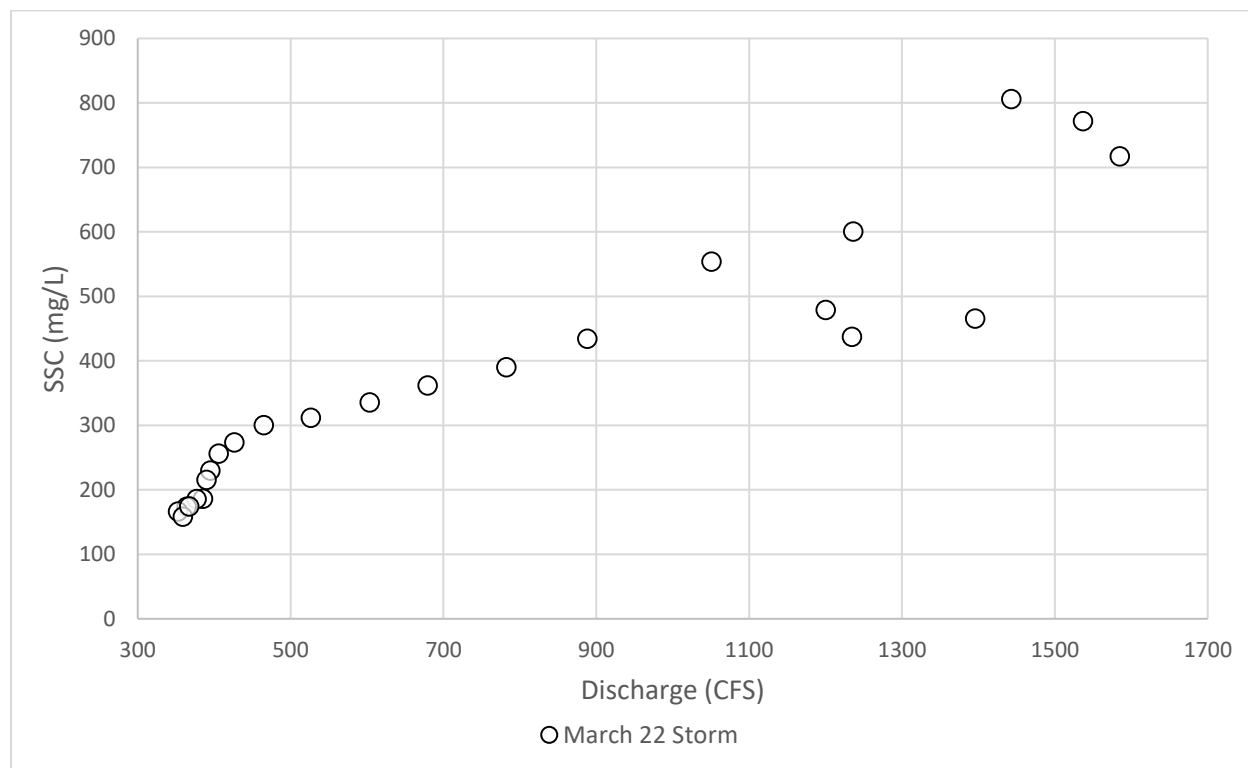
Figure 18: Plot of SSC-Q for WY 2018 storm at Canet Road

was necessary due to the irregularity of sampling by the water level gauge during storms, which varies in response to how rapidly the stage rises or falls. The ISCO sampler does not operate in this manner and is instead restricted to regular half-hour intervals. This is illustrated by the green dots along the hydrograph in Figure 17, which align exactly with sediment sampling events on the sediment loading curve. The sum total suspended sediment load of the above storm event is estimated to be 494 tons, or 448 thousand kilograms. The relationship between SSC and discharge for this storm is shown in Figure 18.

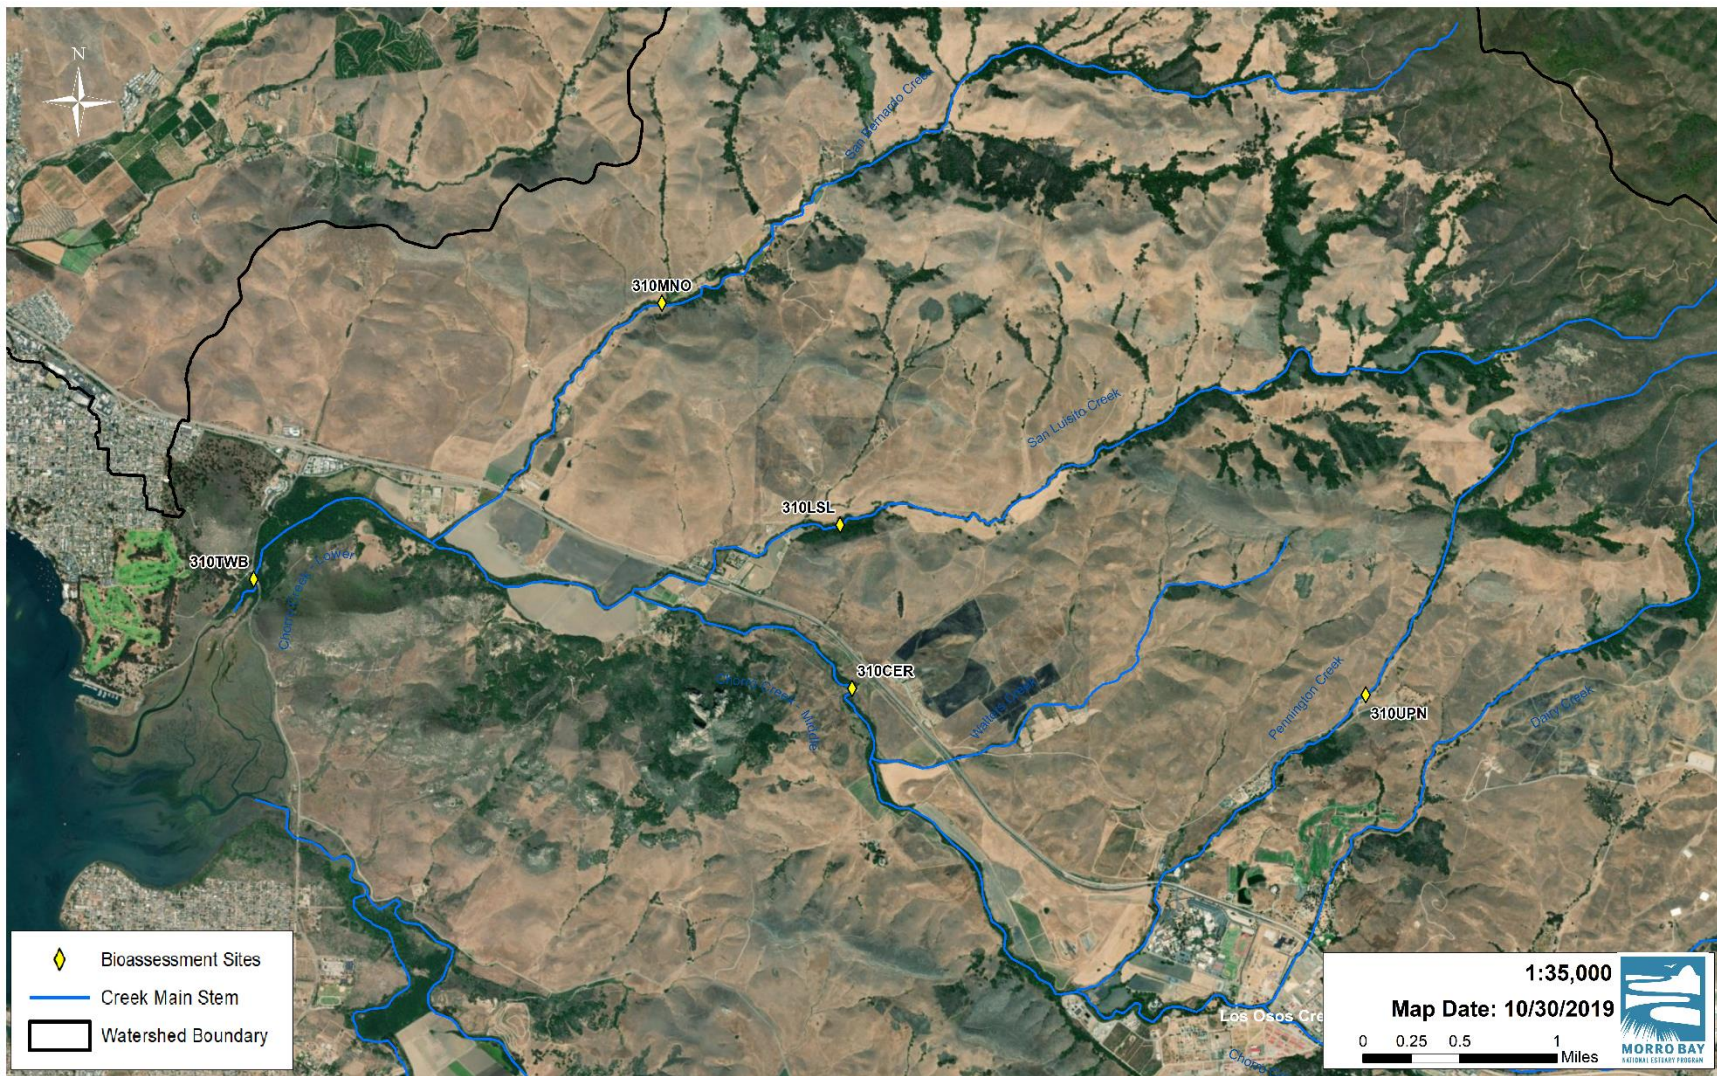
Figure 19: Representative bioassessment sites in 2017 and 2018

Five bioassessment monitoring sites were selected to be included in this analysis. These monitoring sites are located on Pennington Creek (310UPN), San Bernardo Creek (310MNO), San Luisito Creek (310LSL), Lower Chorro Creek (310TWB), and Middle Chorro Creek (310CER). See Figure 19 for a map of the monitoring locations. The selective scores between 2008 and 2018 were averaged for all sites in Table 10. This is a representative subset of the larger number of bioassessment sites that are monitored in each year.
