Chorro Creek Ecological Reserve

Floodplain Restoration Project Implementation

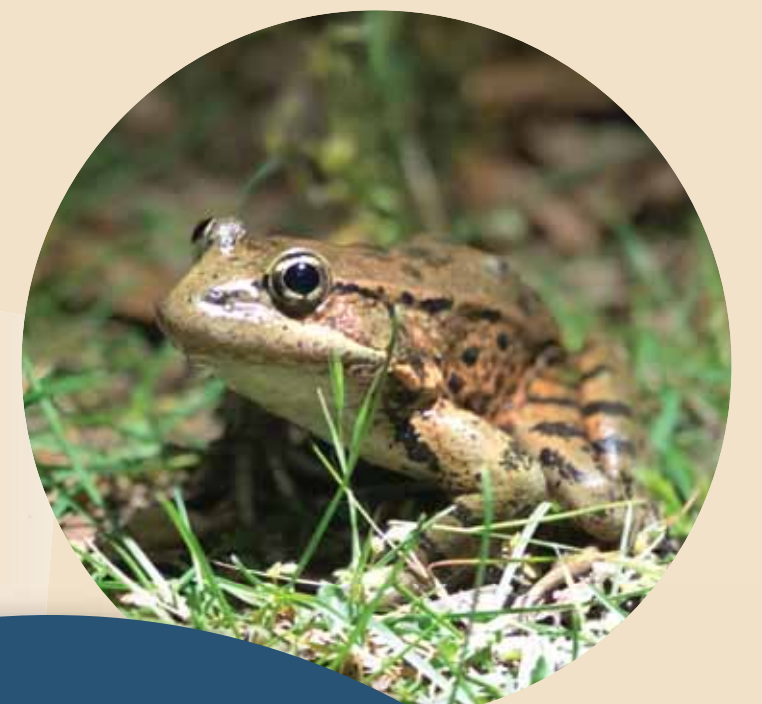
How floodplain restoration helps the watershed

- 1 Better sediment capture
- 2 Better groundwater recharge
- 3 Improved water quality
- 4 Provides vital habitat for wildlife

Through the construction of two side channels and an expanded floodplain, the site is now reconnected to nearly five acres of floodplain habitat, allowing for sediment capture, better groundwater recharge, and improved water quality. The improved channel conditions and native vegetation provides vital habitat for wildlife including steelhead trout and red-legged frogs, which utilize the floodplain side channels for refuge.

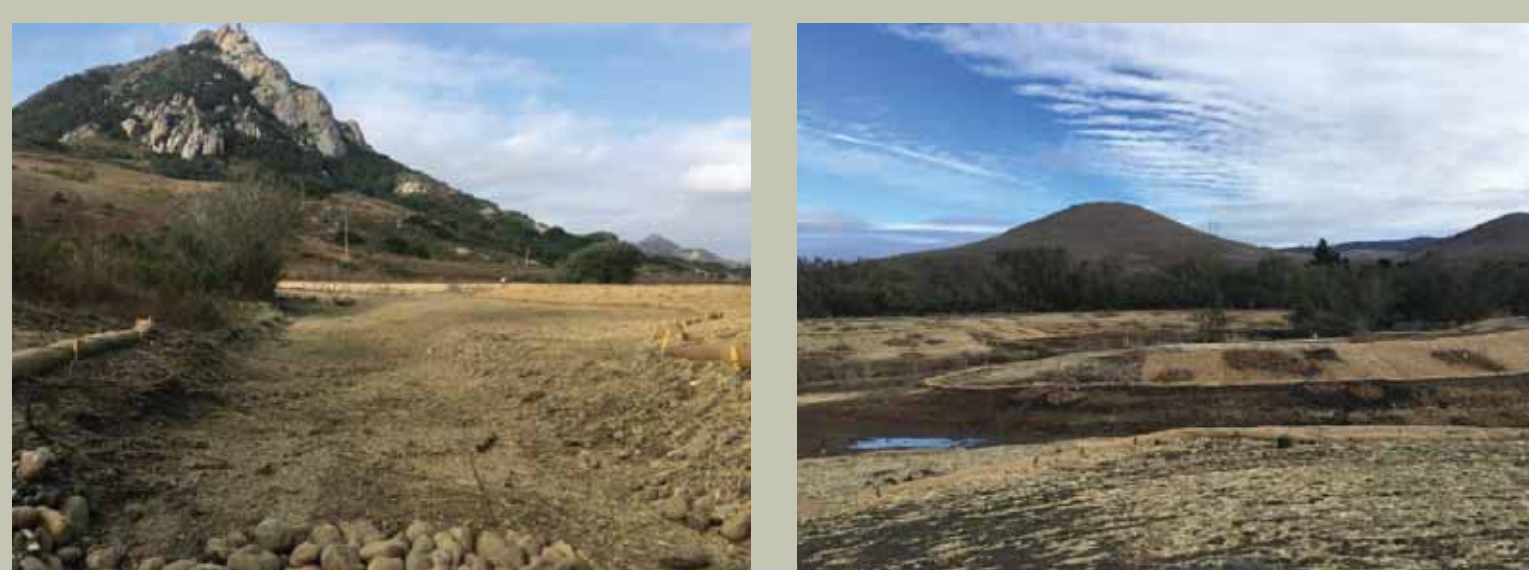
GRADING SIDE CHANNELS AND EXPANDING THE FLOODPLAIN

Workers excavated a new channel and created additional floodplain space along two side channels (2,400ft). Sediment was removed from the area to a three-acre fill site at the base of Hollister Peak. Concrete riprap was also removed from the site and recycled.

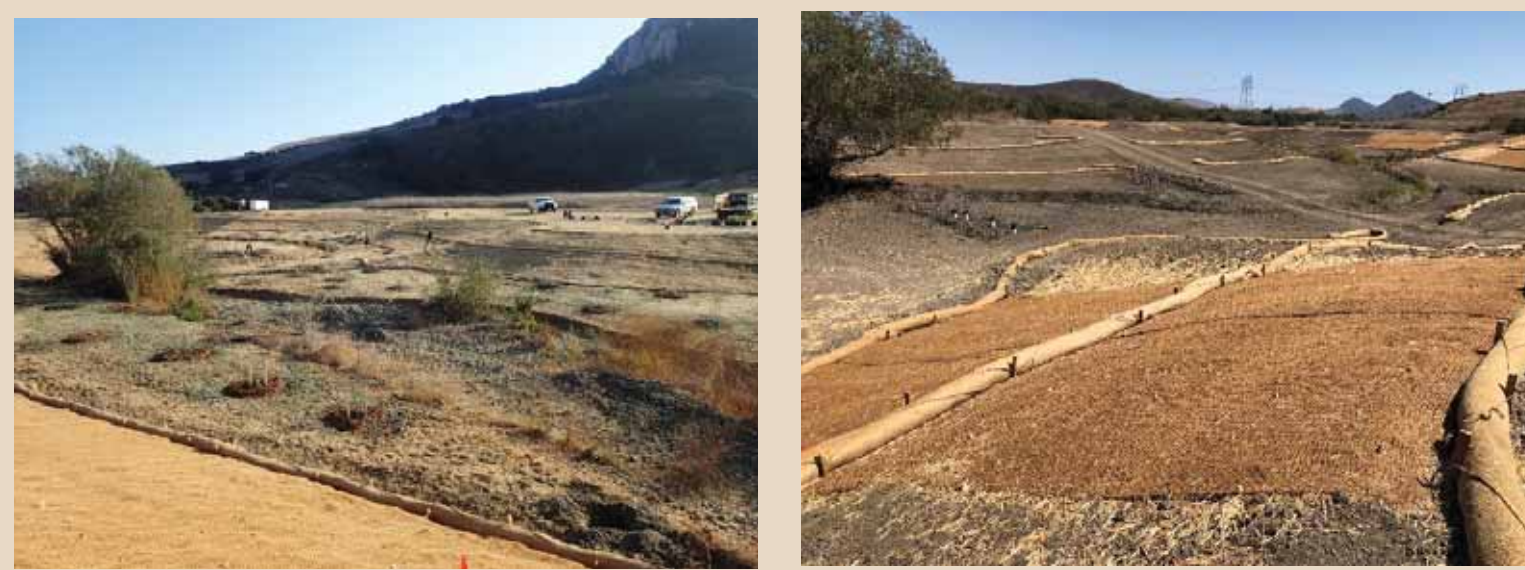
CREATING HABITAT AND SLOWING THE FLOW OF THE CREEK

To create more suitable habitat for fish and aquatic species, pieces of large wood were then anchored through the channel. Large wood in creeks provides refuge for fish during high flow conditions, as well as adds complexity to the stream. Willow baffles were placed along the creek corridor for channel stabilization and to slow down flowing water for sediment to settle out. For sediment stabilization and erosion control, coir fabric and straw wattles were secured upslope of the channel. Native seed was then scattered using a hydro-seeder and drill-seeder throughout the project area.

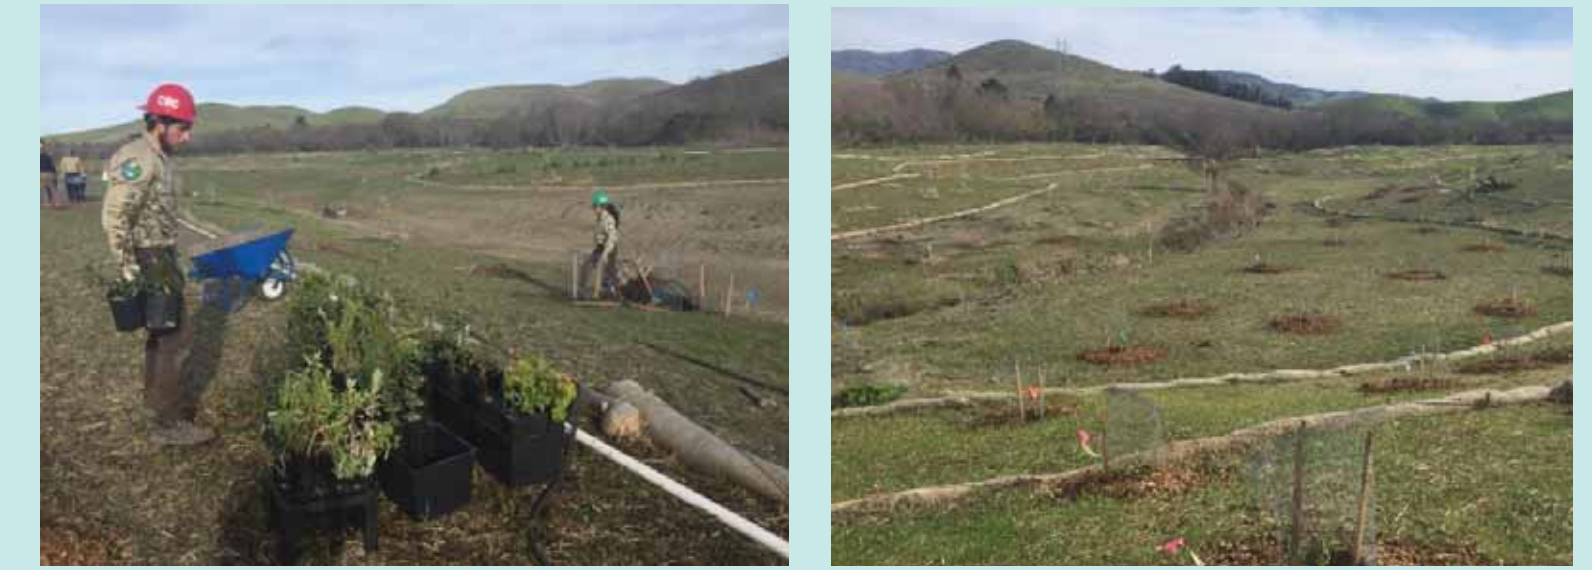
BRINGING NATIVE PLANTS BACK TO CHORRO CREEK'S FLOODPLAIN

The final effort was establishing nearly 1,500 native plants throughout the site. These plants were grown locally by the California Conservation Corps, and the planting effort was largely possible through their support. Species included Coastal Live Oak, Coyote Brush, Box Elder, California Sycamore, Black Sage, Blue Elderberry, Mugwort, Coffeeberry, California Sagebrush, and California Rose.
