STATE OF THE BAY | 2026

A report on the health of the Morro Bay Estuary

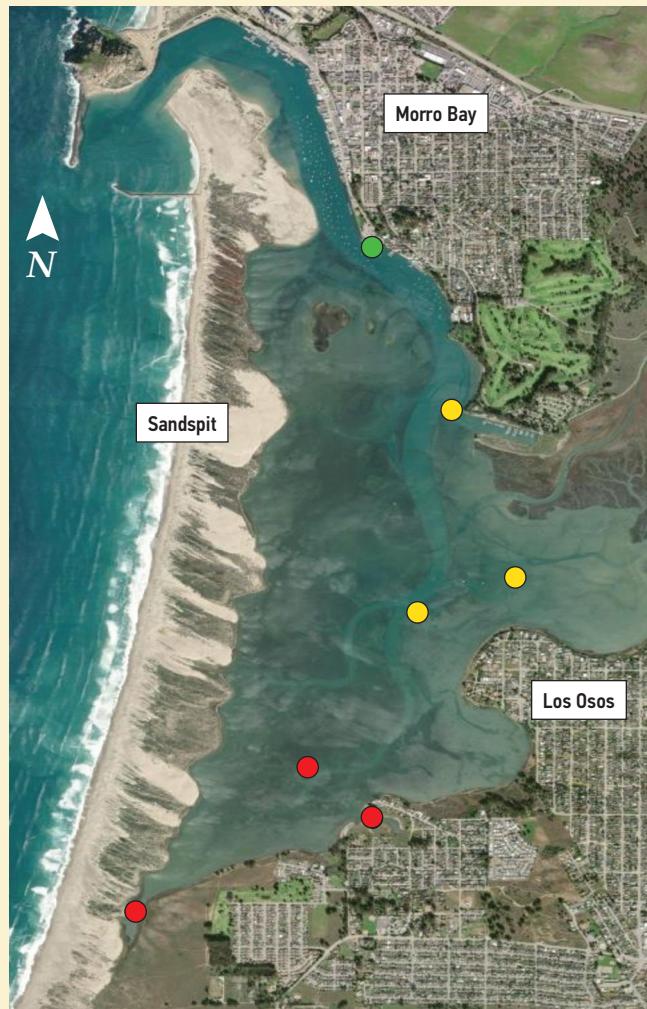
Bay Oxygen Status

The waters of the Morro Bay estuary are home to fish, invertebrates, and other types of aquatic life, many of which require oxygen to thrive. To better understand the health of the bay, Estuary Program volunteers kayak out in the early morning hours to measure the lowest oxygen levels of the day at seven bay sites. This monitoring effort has been conducted for over 20 years, and the data consistently shows a trend of decreasing oxygen as you move from the front bay to the back bay. The deeper waters of the front bay easily mix with the cold, well-oxygenated water pushed in from the ocean by incoming tides. Conversely in the back bay, the shallow waters limit tidal mixing, leading to lower oxygen levels. Although lower than ideal, baywide oxygen levels have remained relatively stable over time. While conditions remain Very Poor at the furthest back bay sites, data indicate significant improvements in oxygen levels at the Sharks Inlet and Cuesta Inlet sites.

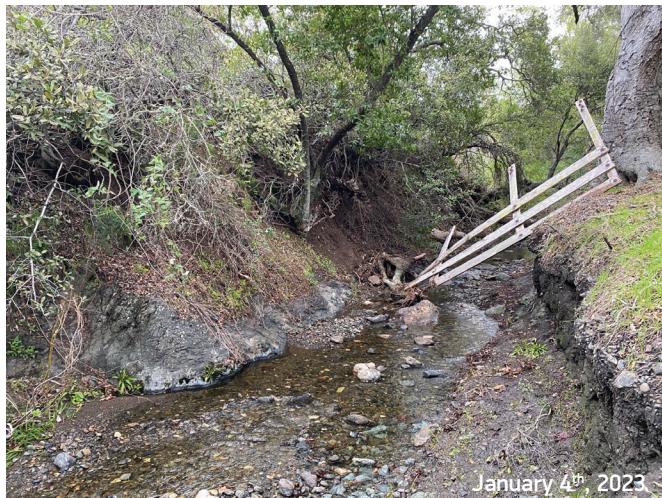
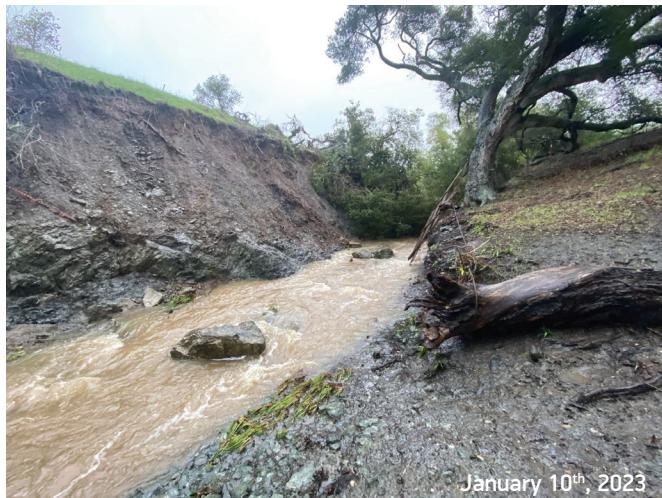
below illustrates how the storms of January 2023 affected Pennington Creek. The high flows caused severe bank erosion and stripped away vegetation. By 2024, many of these sites were on the rebound, with Pennington, San Bernardo, and Dairy Creek scores improving by 50% or more. These improvements indicate a relatively quick recovery of sensitive macroinvertebrate species in these tributaries, despite the severe impacts of the 2023 storms.

These photos show the same site on Pennington Creek before and after the large storms of early January 2023.

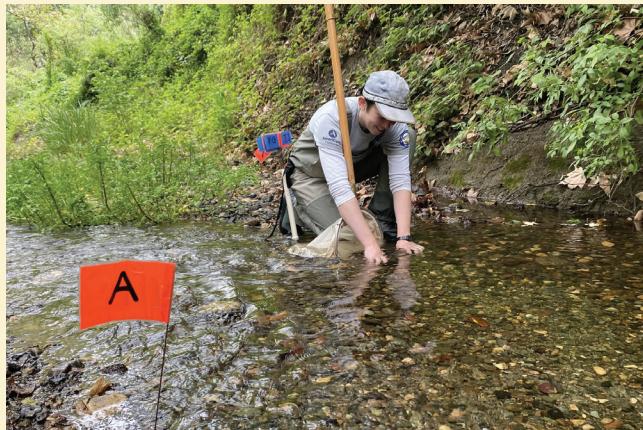
To collect macroinvertebrate samples, we scrub the rocks and stir up the sediment on the creek bottom. This releases the macroinvertebrate larvae which drift with the current into our net.

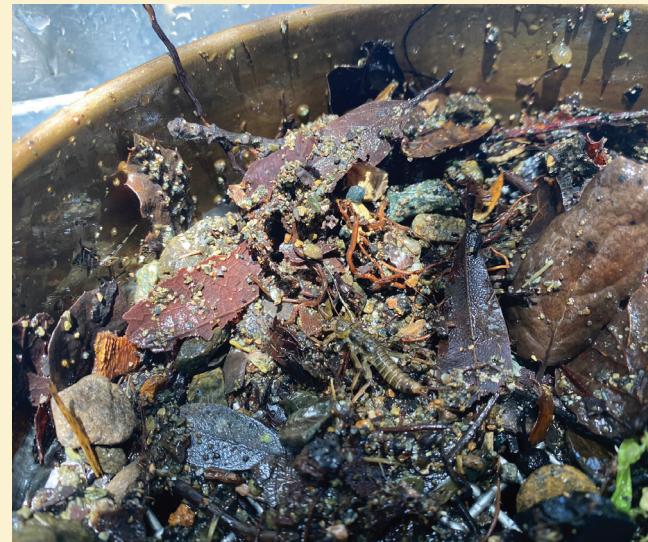
After collecting our sample, we empty the contents of the net into a sieve to sort out the sticks, rocks, and leaves. The macroinvertebrates are then preserved and sent to a taxonomy lab for identification and counting. This sample from Dairy Creek contains a large stonefly larva, a species that typically indicates good water quality for sensitive aquatic life.

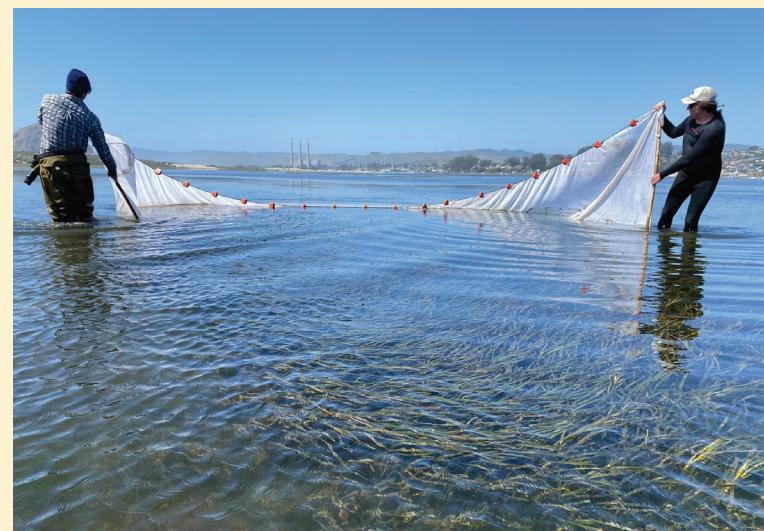
During 2023 and 2024, fish were sampled from Morro Bay's shoreline, intertidal flats, and open channels. For shoreline locations, like the one pictured above, nets called beach seines were used to collect fish. All fish collected during the study were identified, measured, and then safely released.

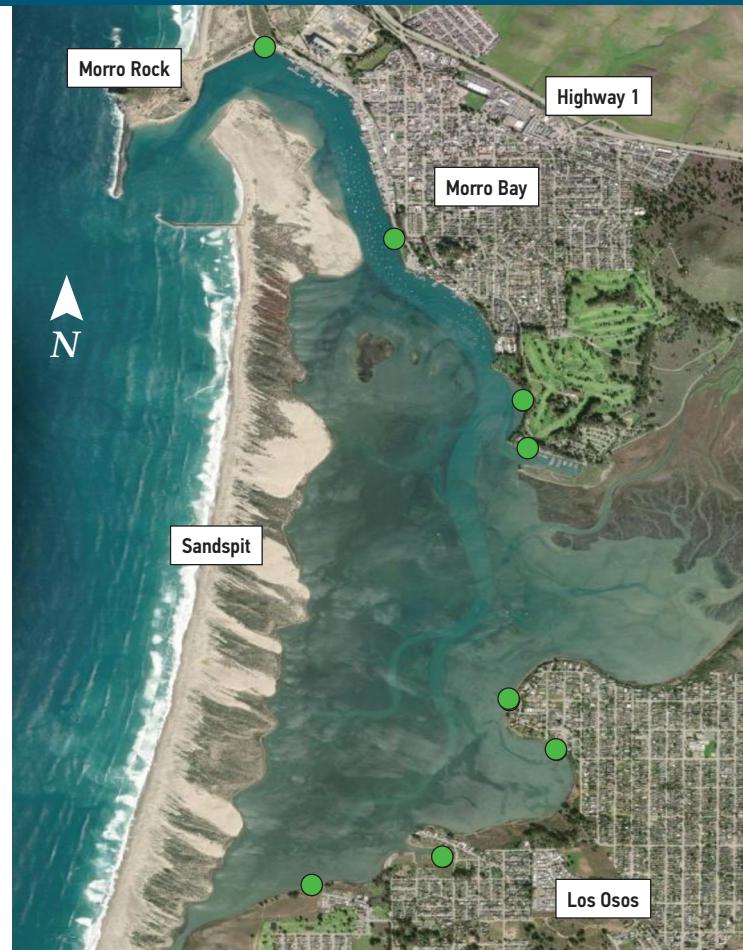
Bay Bacteria Status

This map shows the eight sites where the Estuary Program has monitored water quality monthly from 2005 through 2024. The green color of the circles indicates that bacteria levels are low and that these sites are typically safe for swimming. However, runoff from a storm can carry pollutants including bacteria into the bay, so public health officials recommend staying out of the water for 72 hours following a storm.

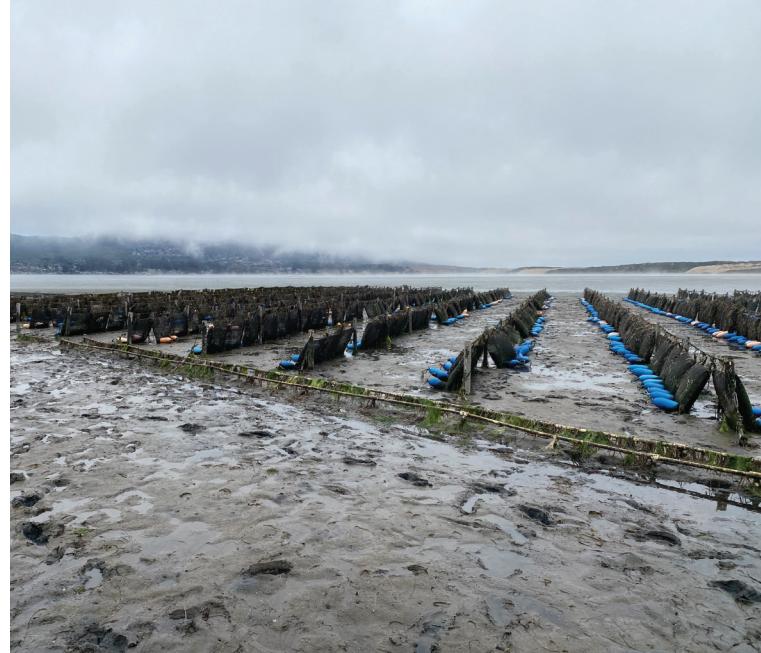
In Morro Bay, oysters are grown in mesh bags. If left undisturbed, oysters will grow in clumps. Traditionally, oyster farmers had to manually shake the bags to separate the shellfish. Instead of doing this by hand, oyster farmers in Morro Bay now use a clever method that lets the tides do this work. They string the oyster bags up on cables that are secured to posts anchored in the bottom of the bay. During low tides, the bags hang from the cables, but during high tides, floats on the bags rise and tip the oysters to the bottom of the bag. This periodic mixing of the oysters by the tides saves many hours of human labor.

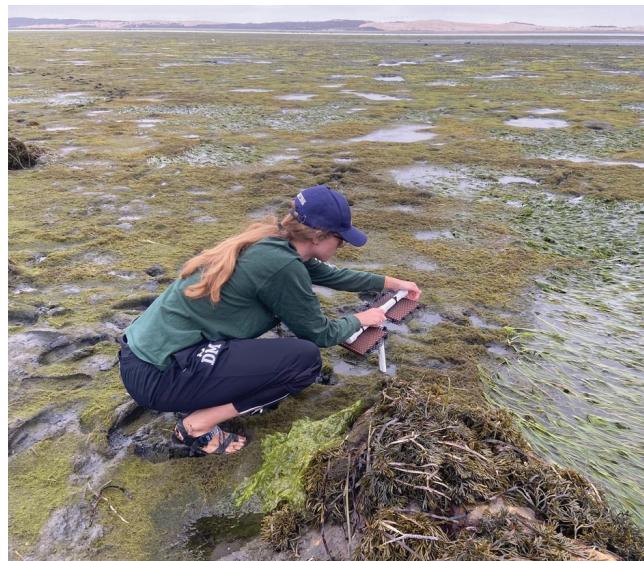
A graduate student places tiles in the bay where larvae of different marine animals, including Olympia oysters, will attach and grow. Photo courtesy of Kevin M. Johnson.

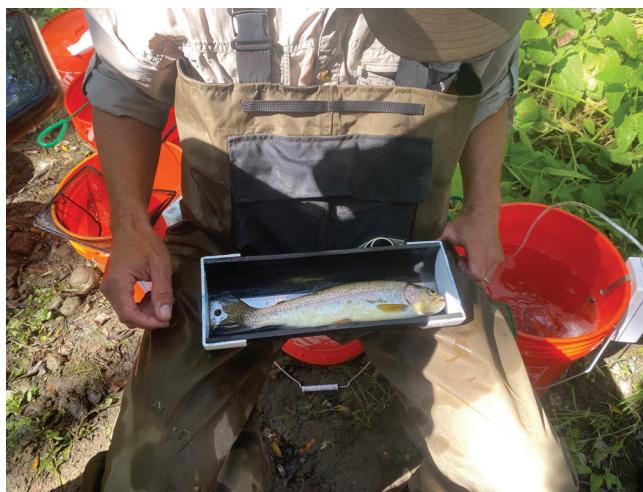
The method used to track fish for the project is called mark-recapture. Backpack electrofishers were used to temporarily stun and capture fish to be weighed and measured.

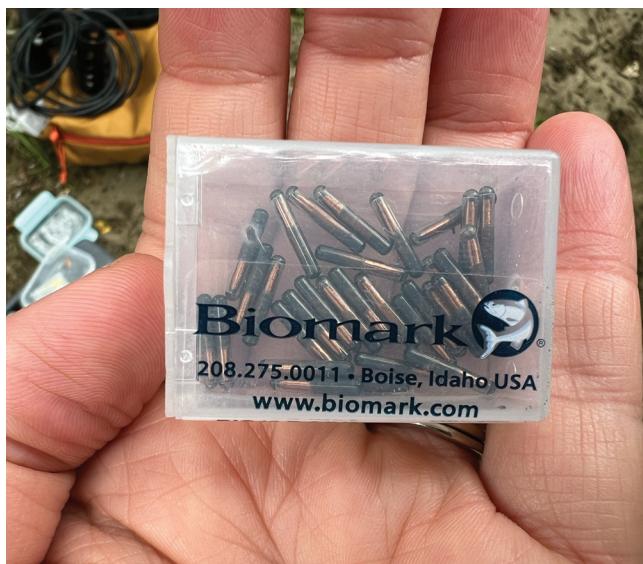
During initial capture, steelhead of sufficient size were anesthetized, implanted with a Passive Integrated Transponder (PIT) tag, and returned to the creek. These tags are small microchips that uniquely identify each fish, similar to the microchips used for dogs and cats.

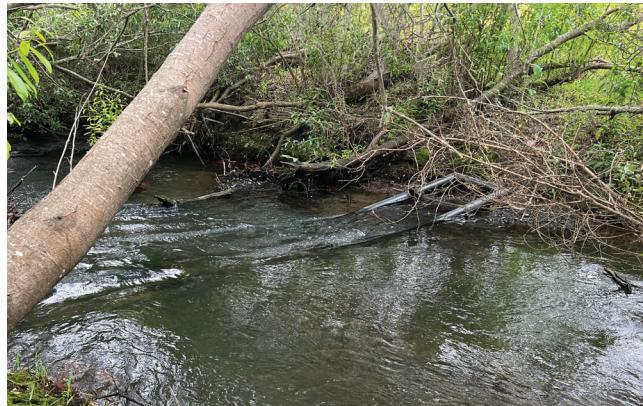
As tagged fish move through the creeks and into the estuary, we monitor their movements with stationary PIT-tag antennas in lower Chorro Creek. This special type of antenna stretches across the creek so that fish can easily swim over it. As fish pass by it, their unique identifiers are recorded. If tagged fish were recaptured during the study period, we weighed and measured them to track their growth.

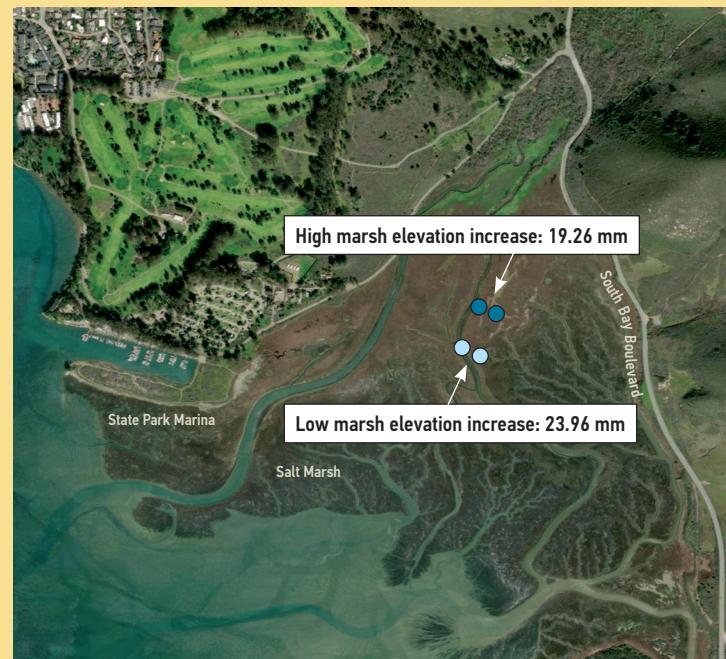
To track marsh elevation changes over time, the U.S. Geological Survey (USGS) monitors four sites in Morro Bay. This map shows the increase in marsh elevation at each site since 2013. Historical data indicates annual increases averaging 1.59 mm in the high marsh and 1.98 mm in the low marsh, enough to keep pace with the current rates of sea level rise. But if the rates of rising waters increase as they are projected to do, areas like Morro Bay's marsh habitat will flood more often and could eventually transition to mudflats or open water. The Estuary Program is working with USGS to develop adaptation strategies to reduce habitat loss and coastal flood risks.

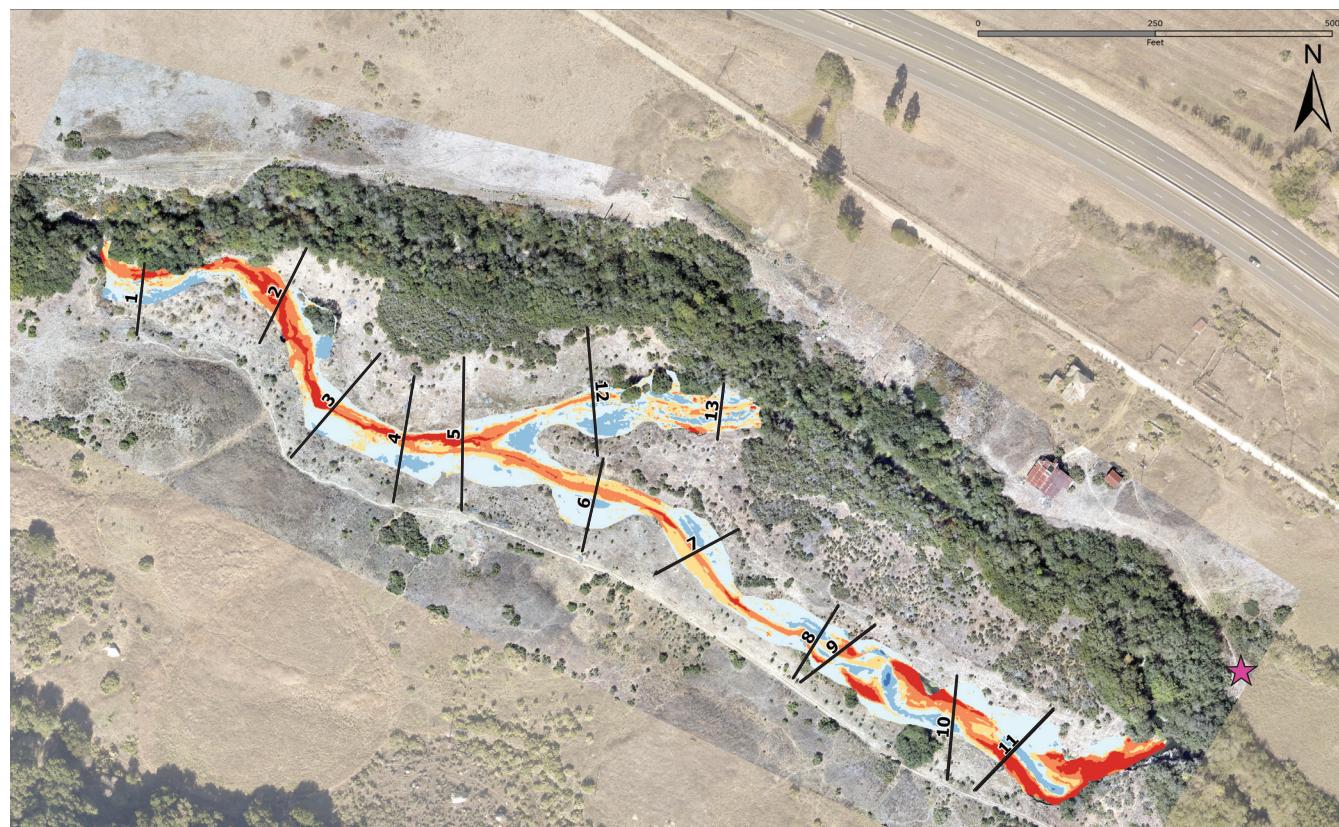
This aerial image of the Chorro Creek Ecological Reserve shows the creek channel and surrounding floodplain overlaid with elevation changes measured since 2021. The shades of orange and red denote areas where the elevation dropped, primarily in the creek channel where it was eroded by heavy storm flows. The shades of blue show where elevation increased. This was primarily in the floodplain areas where the flows spread out and slowed, leaving the sediment behind rather than carrying it down to the estuary. Figure courtesy of WRA, Inc.

Post-storm assessments of the site indicate that changes to channels in some restored areas could potentially impede the passage of fish through the creek. The site will require adaptive management to address areas of erosion, improve site stability, and ensure effective sediment trapping and habitat quality.

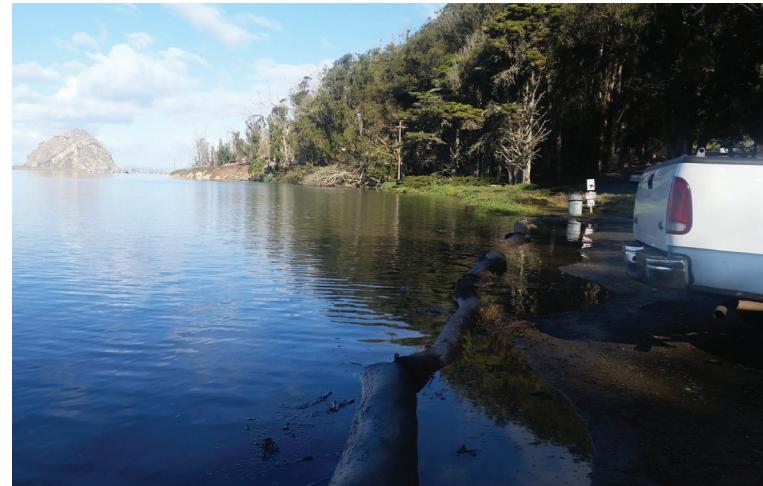
This is the parking area at Windy Cove during an extreme high tide. If sea levels rise to the higher end of the predicted range, portions of South Bay Boulevard and State Park Road near Windy Cove could face daily tidal flooding like this by 2060.

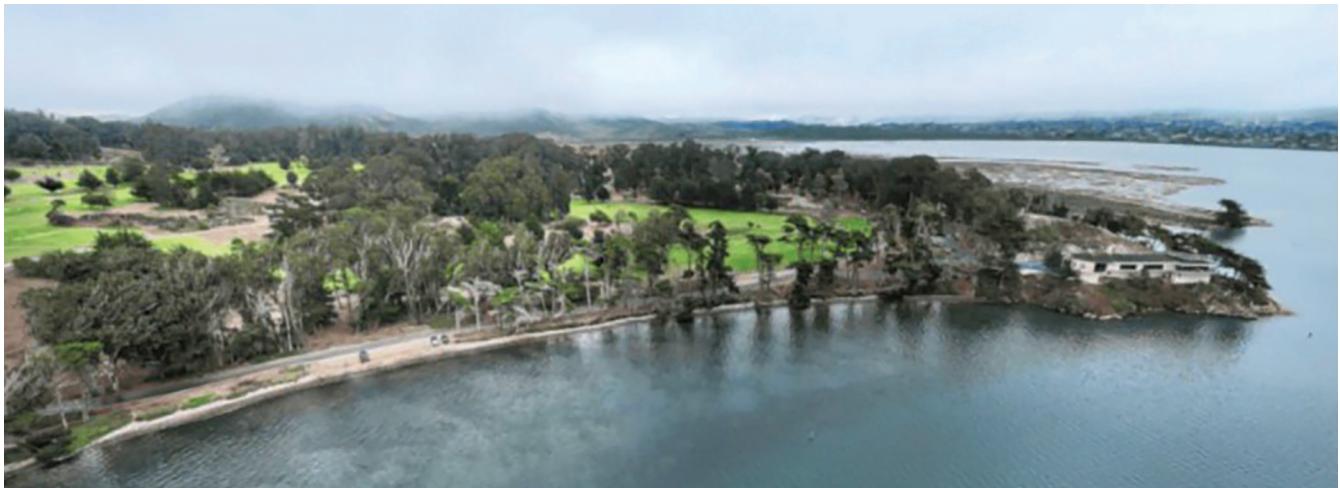
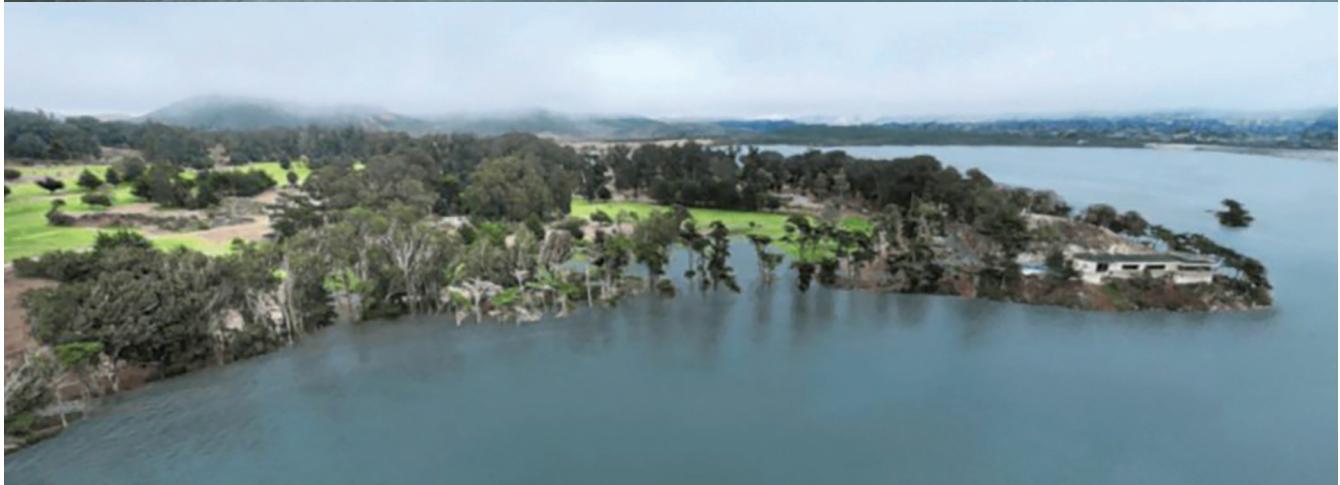
The Virtual Planet tool shows potential flood impacts. The top image shows State Park Road during current high tide conditions, while the bottom image shows the same area under 1.8 feet of sea level rise. Tools like this help visualize future impacts to infrastructure and habitats.

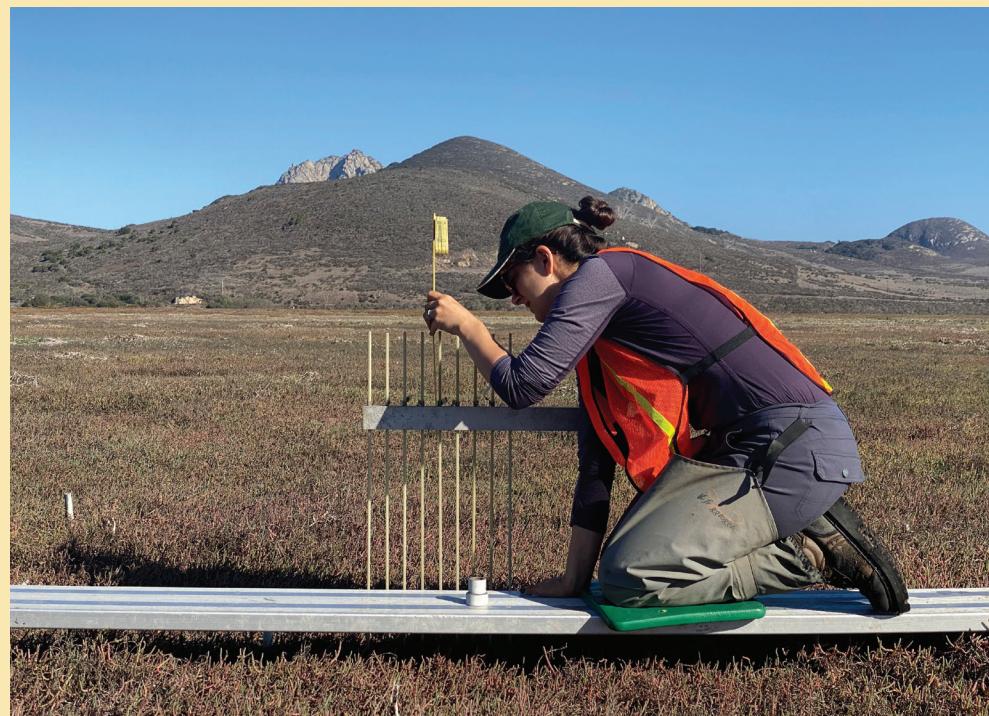
USGS staff use surface elevation tables to measure elevation changes of the marsh surface. In general, the salt marsh is gaining in elevation as sediment is deposited from Chorro and Los Osos Creeks. But if the rate of sea level rise accelerates in the future, this sensitive marsh habitat may eventually transition into mudflats.

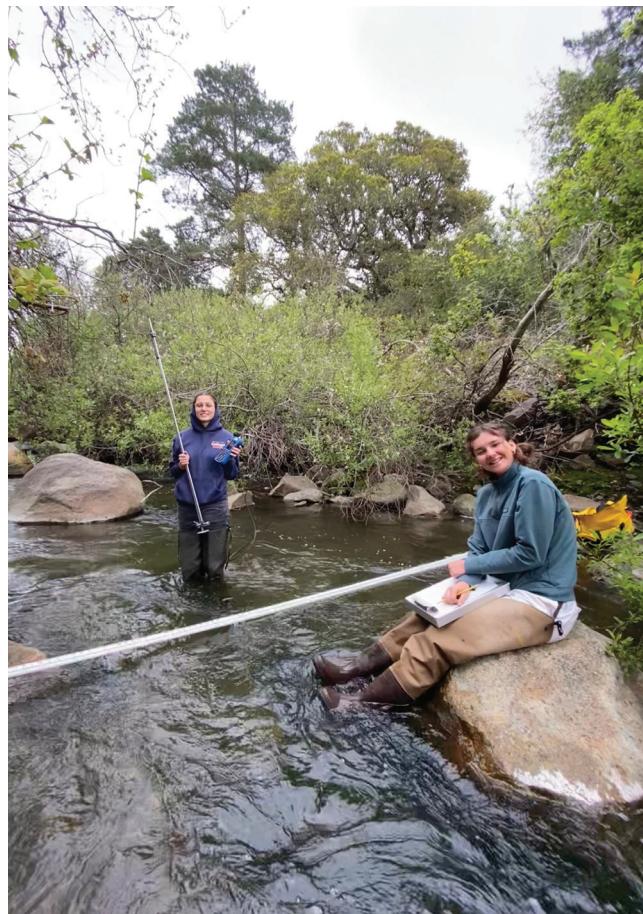
Estuary Program volunteers monitoring flow on Chorro Creek.
